# Francois's Hangar

## Gear inspection (AD 77-13-21 Part A)

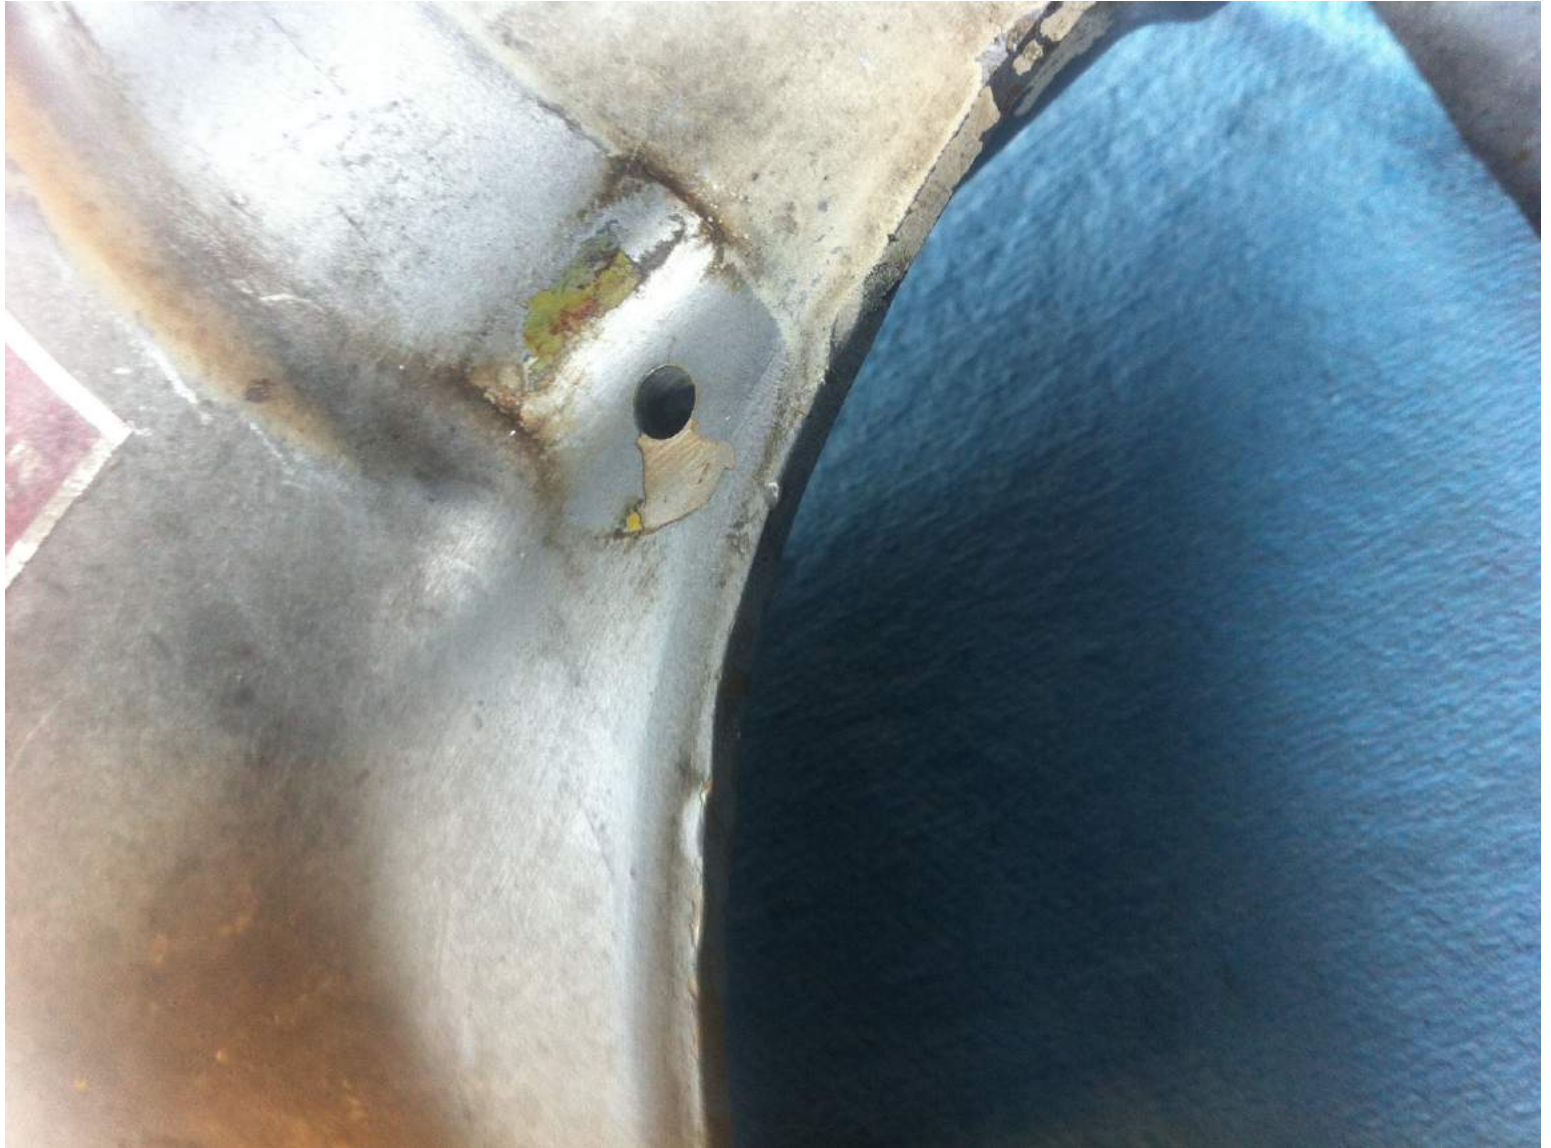
Long ago, on the Comanche tips there were calls for cleaning out stress concentration corners around the holes of the web of the main gear struts. Cracks were originating from that hole area and propagated until... well... gear collapse. Although they were documented as done in my logs, I

realized that such was not the case. So “radiusing” and smoothing for the hole and the web edge were in order for both struts. Luckily no cracks were to be found. Braking while cornering seems to be a big stressor on these parts.

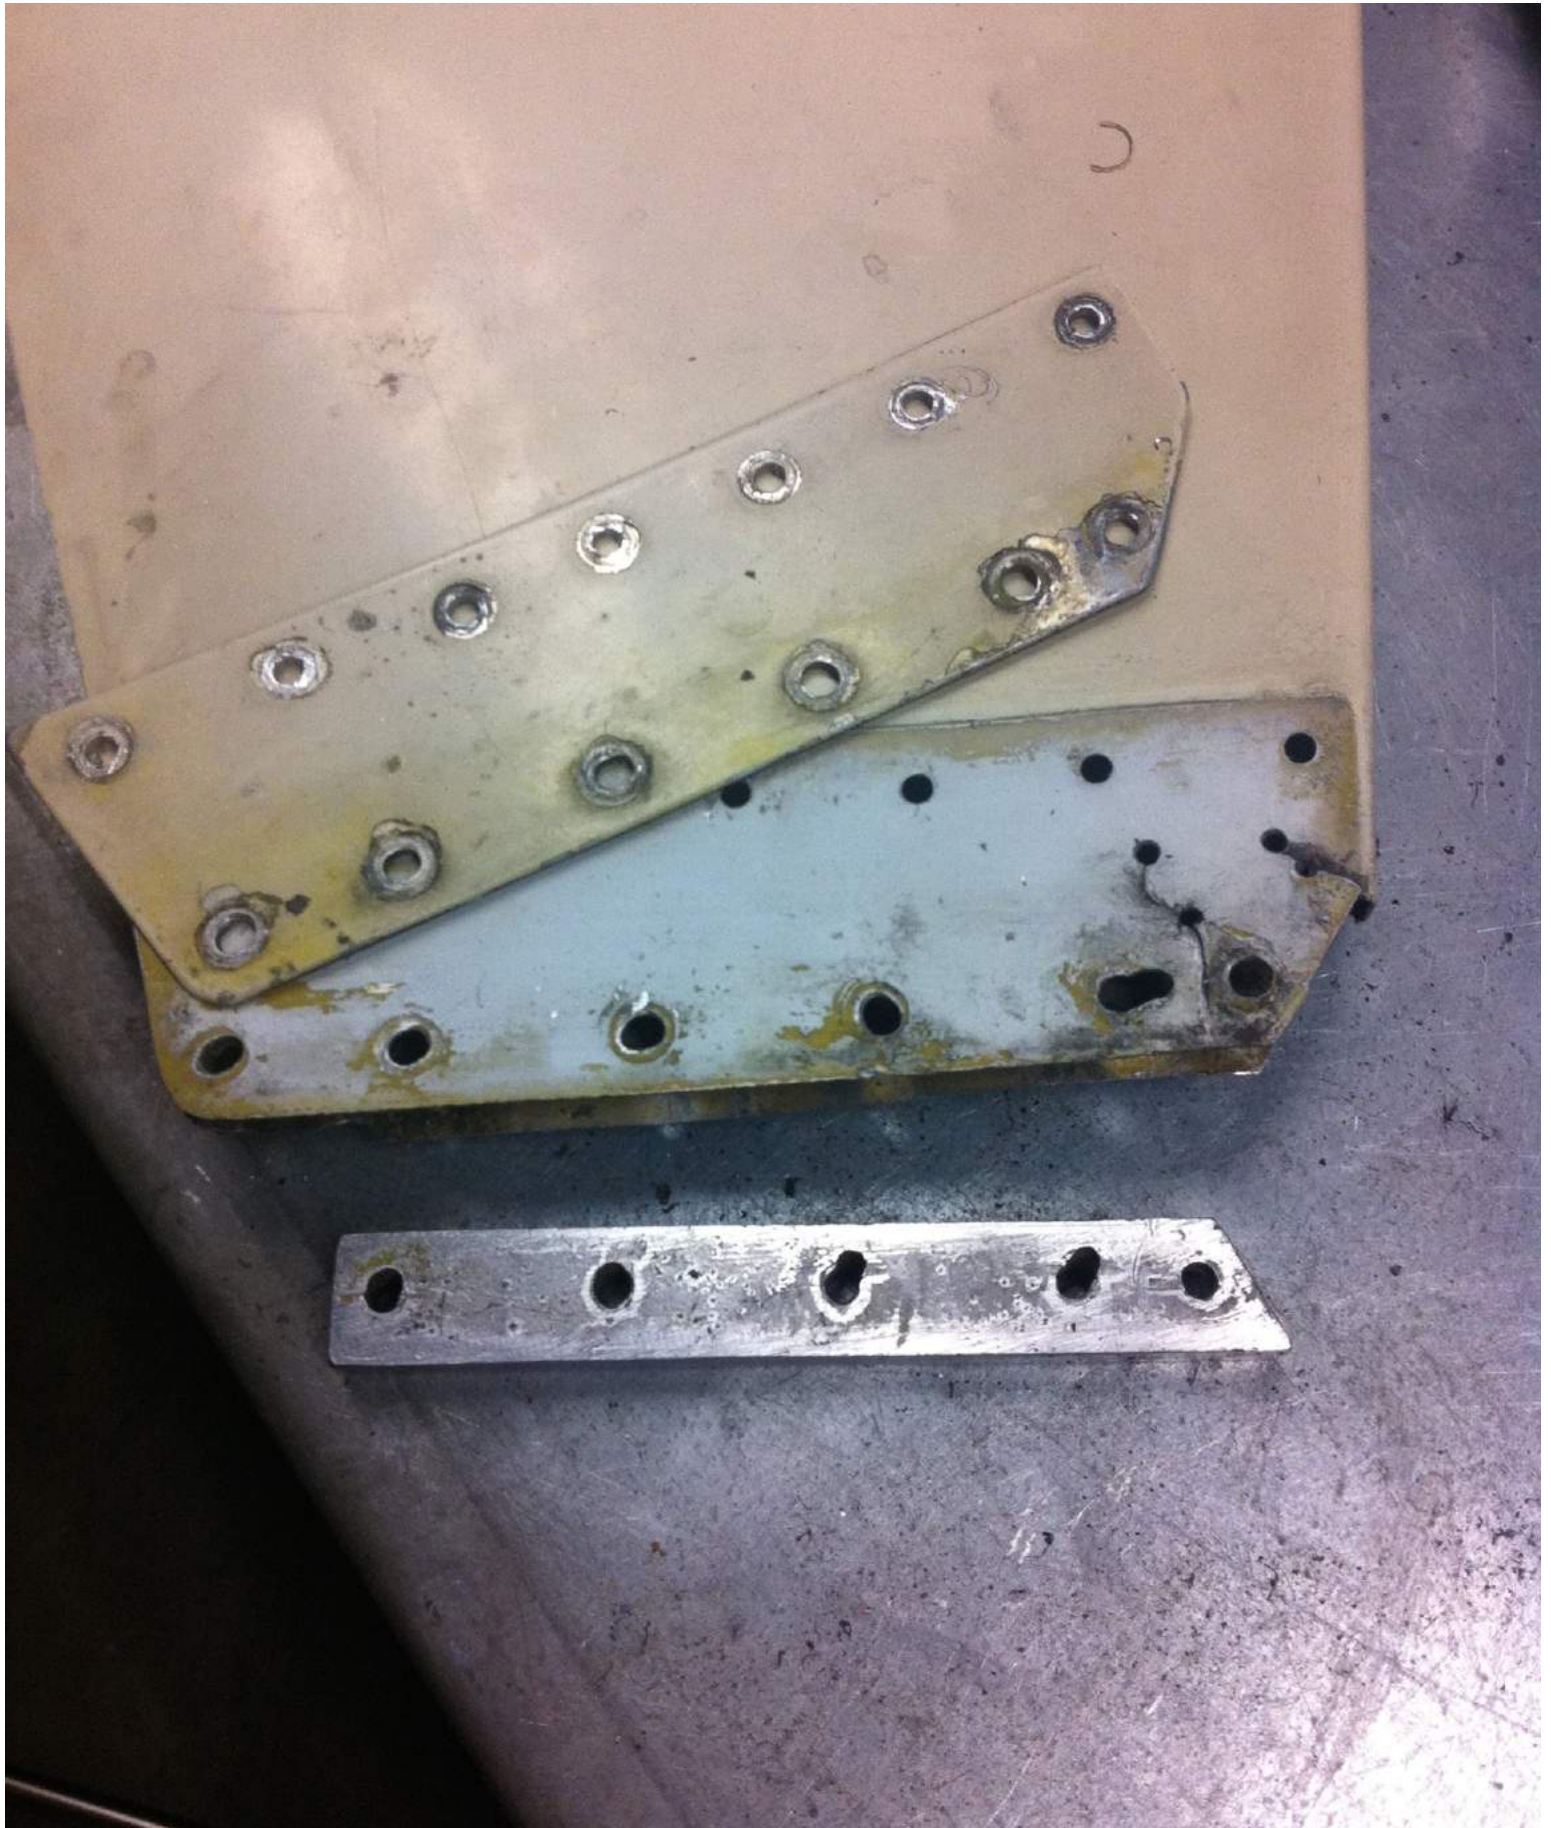
Landing gear doors tend to also take a beating. While I did the conduits, some time ago, I made the hinges tighter by drilling a #30 hole and inserting a 1/8 SS welding rod as the hinge pin. That made the door much stiffer and I did not pay much attention to them after that. However, stripping them led to discover other issues that needed attention. A few pictures are worth a proportional number of words on the quality of these repairs...

Yikes. Redoing the ugly patch plates (albeit re-using the same unaligned holes on the door portion) and with a mill I re-fabricated the spacer block, it yielded something like this:

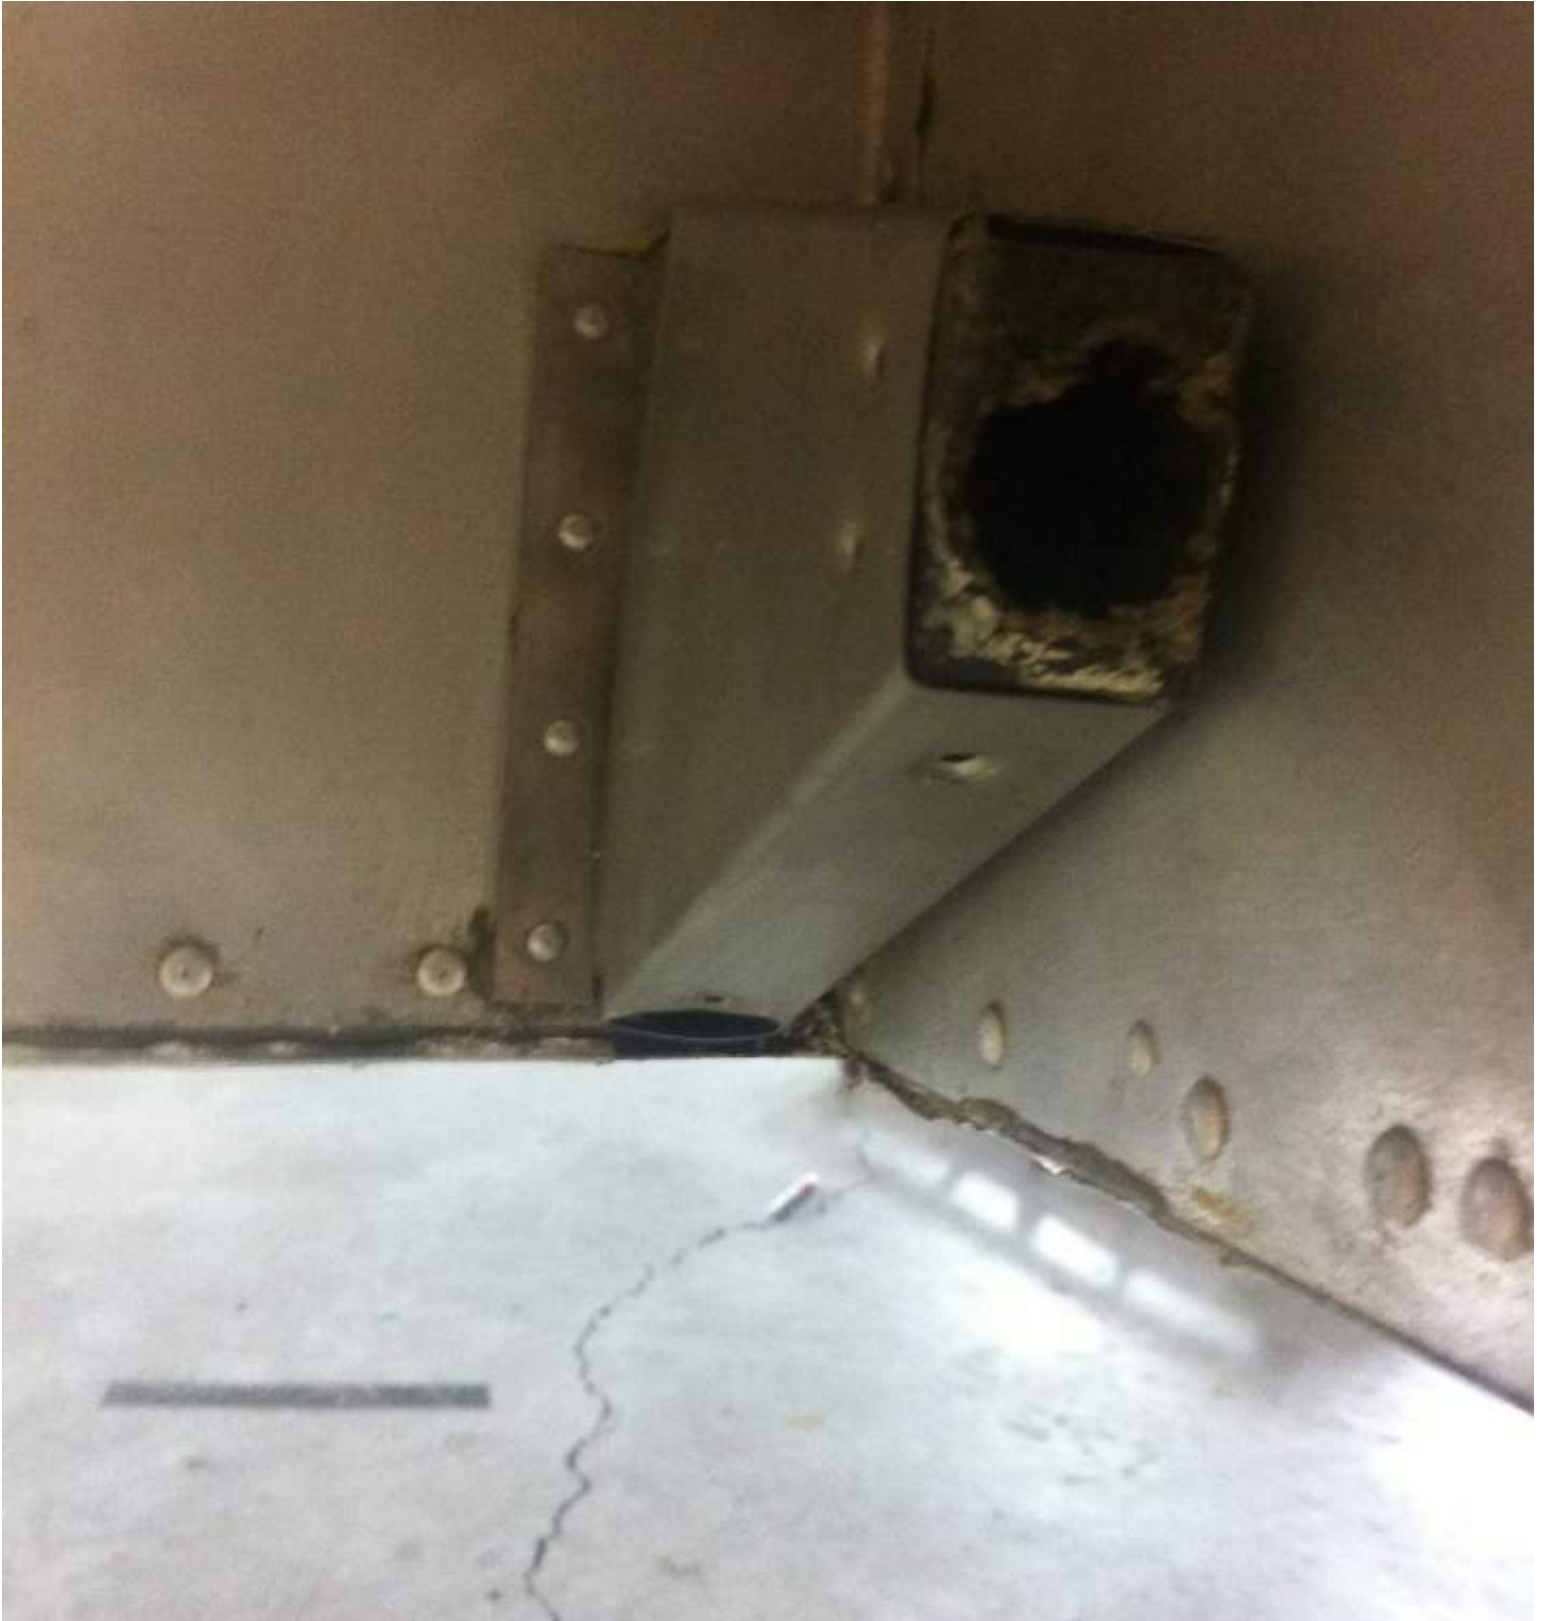
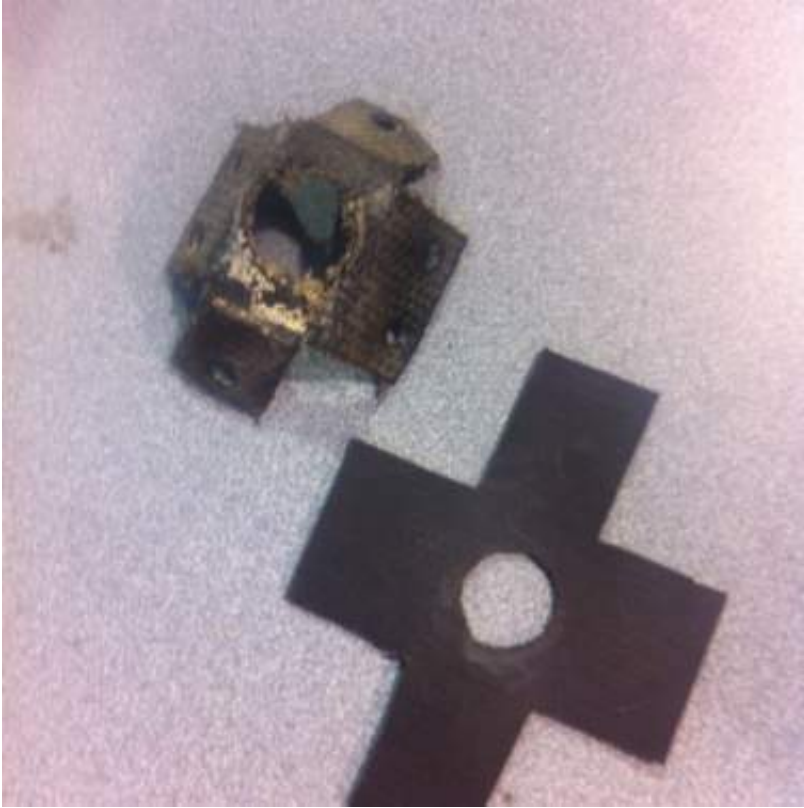
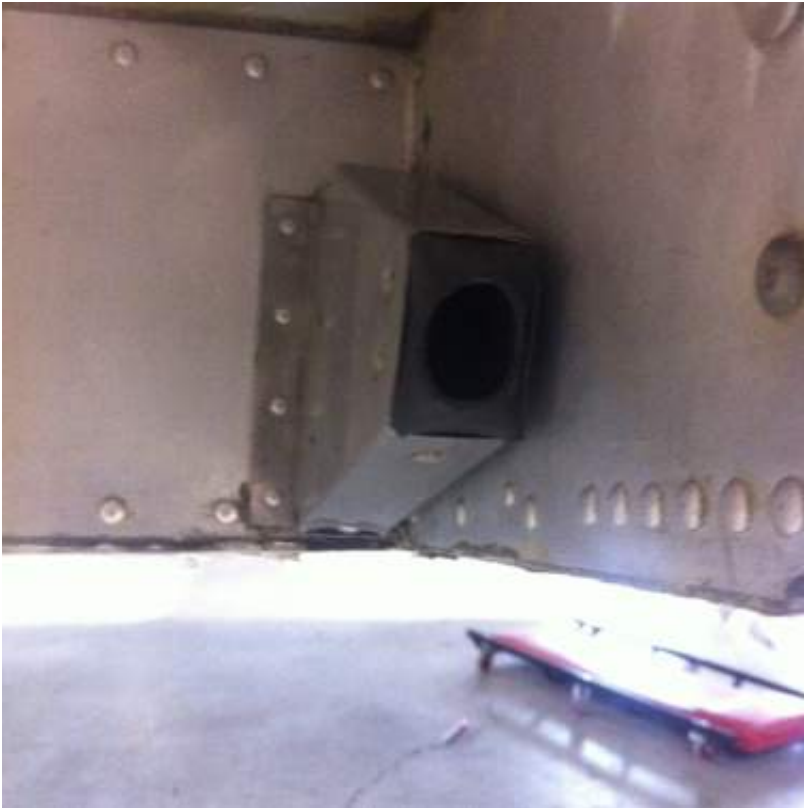
Another call for TLC here: the nose gear pushrod exit seal was showing its age. Time to replace. Using rubberized baffle material, I cut my own and using soft rivets. I re-installed it. It will contribute to less cold air into the cabin, I'm sure.

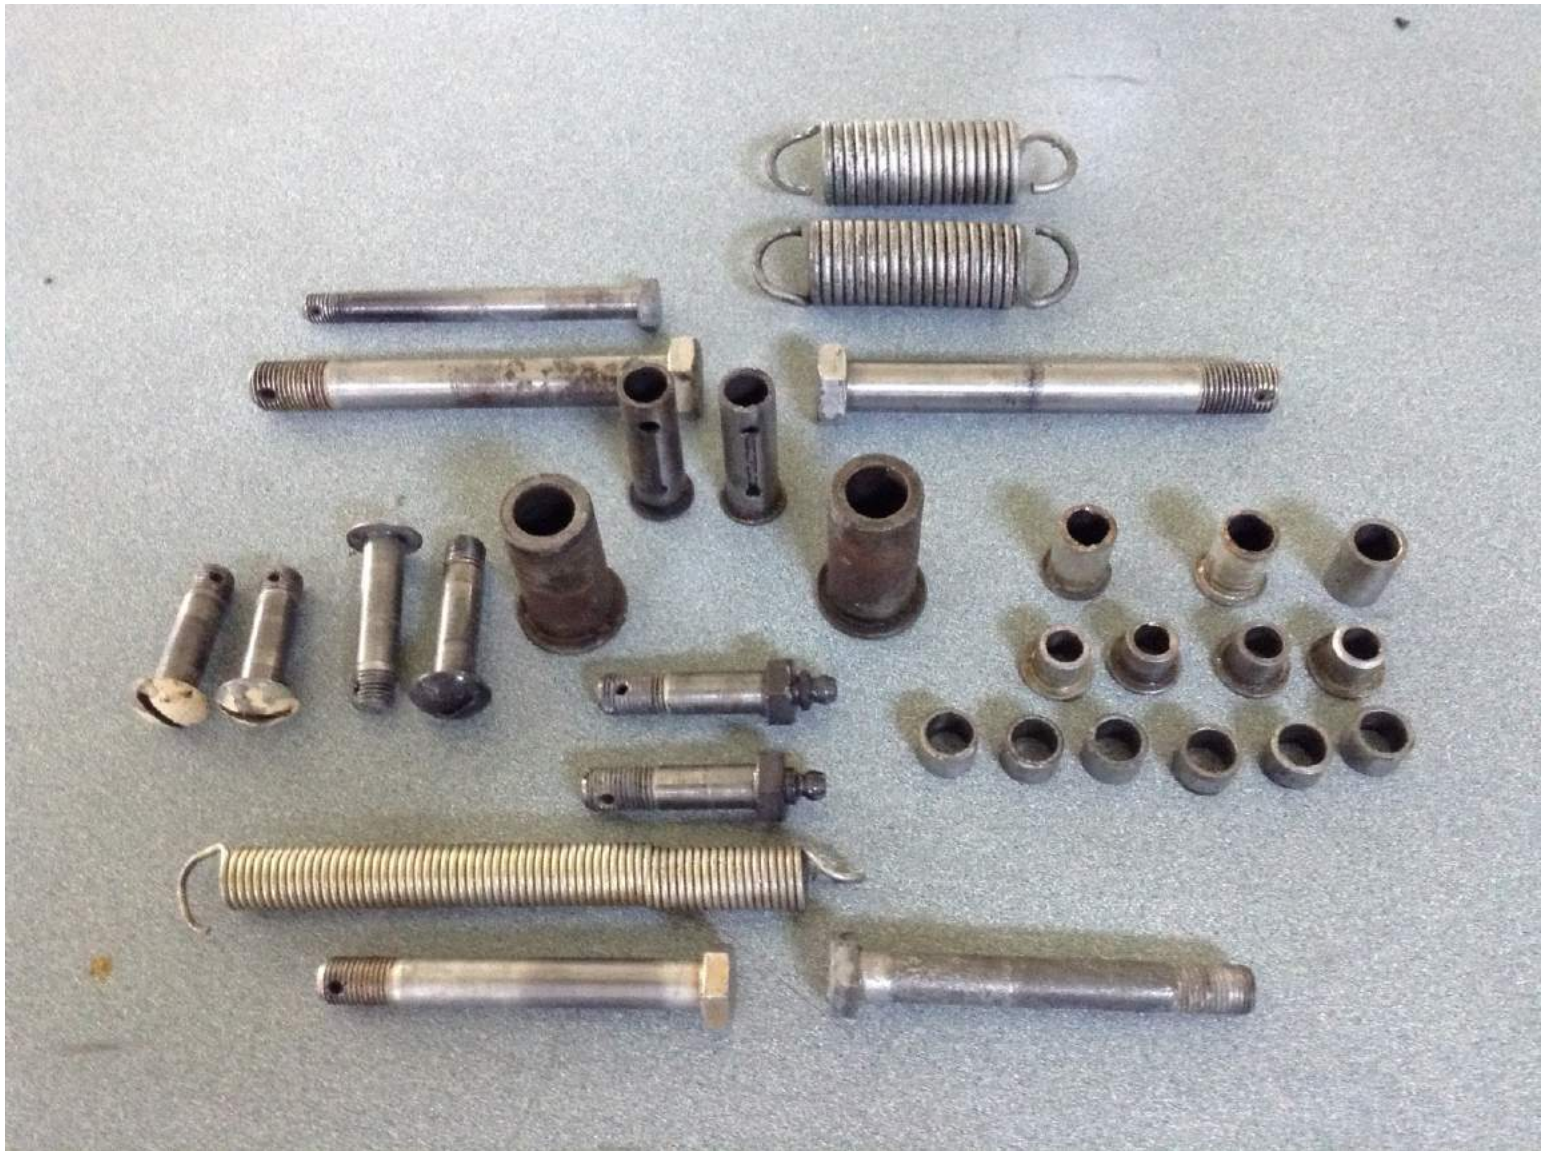
Unfortunately, I do not have photographs of that central stage, but suffice to say that Piper SL 782B was used as the method of compliance. One caveat here, although I had a complete set of go/no-go gauges, they are often useless whenever some items are worn in an oval fashion. Too many measurements I took were falsely showing good, as one dimension axis exceeded the service limit. So every measurements showing good on the gauges were also done with bore measuring gauges. Every bushings were also ball honed to improve lubrication. Here were my findings:

Bushing removal and re-insertion as usual, heat with a propane torch to extract and a press bench to re-insert. Any diameter reaming done on a drillpress. Measurements to the sidebrace threads were done at a machine shop equipped to do such. Luckily were found within service limits. Also, I replaced the nose gear springs (487-292) as they were no longer showing the service tension (which I cannot find anymore...sorry)

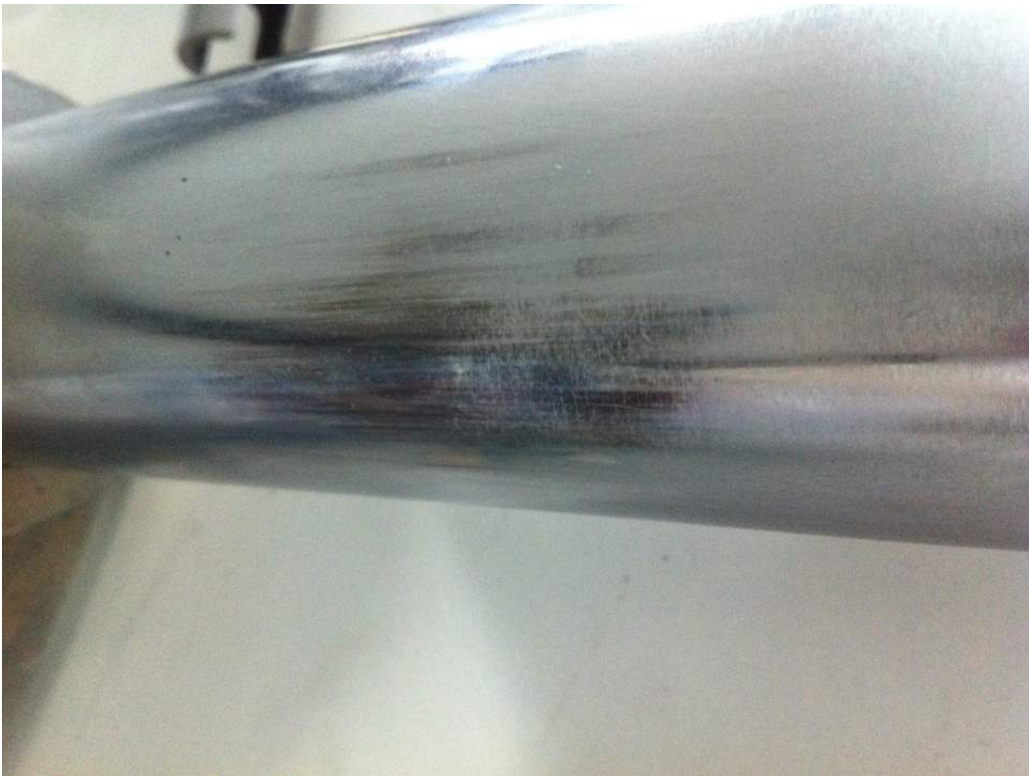
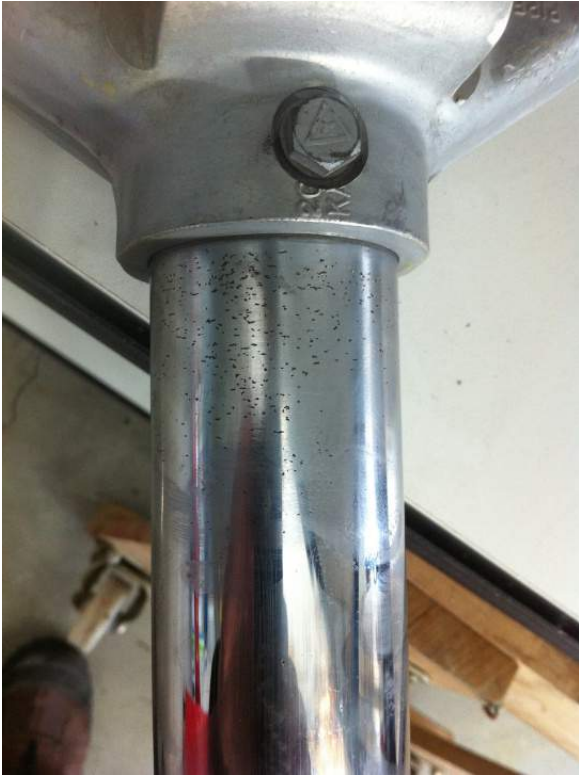
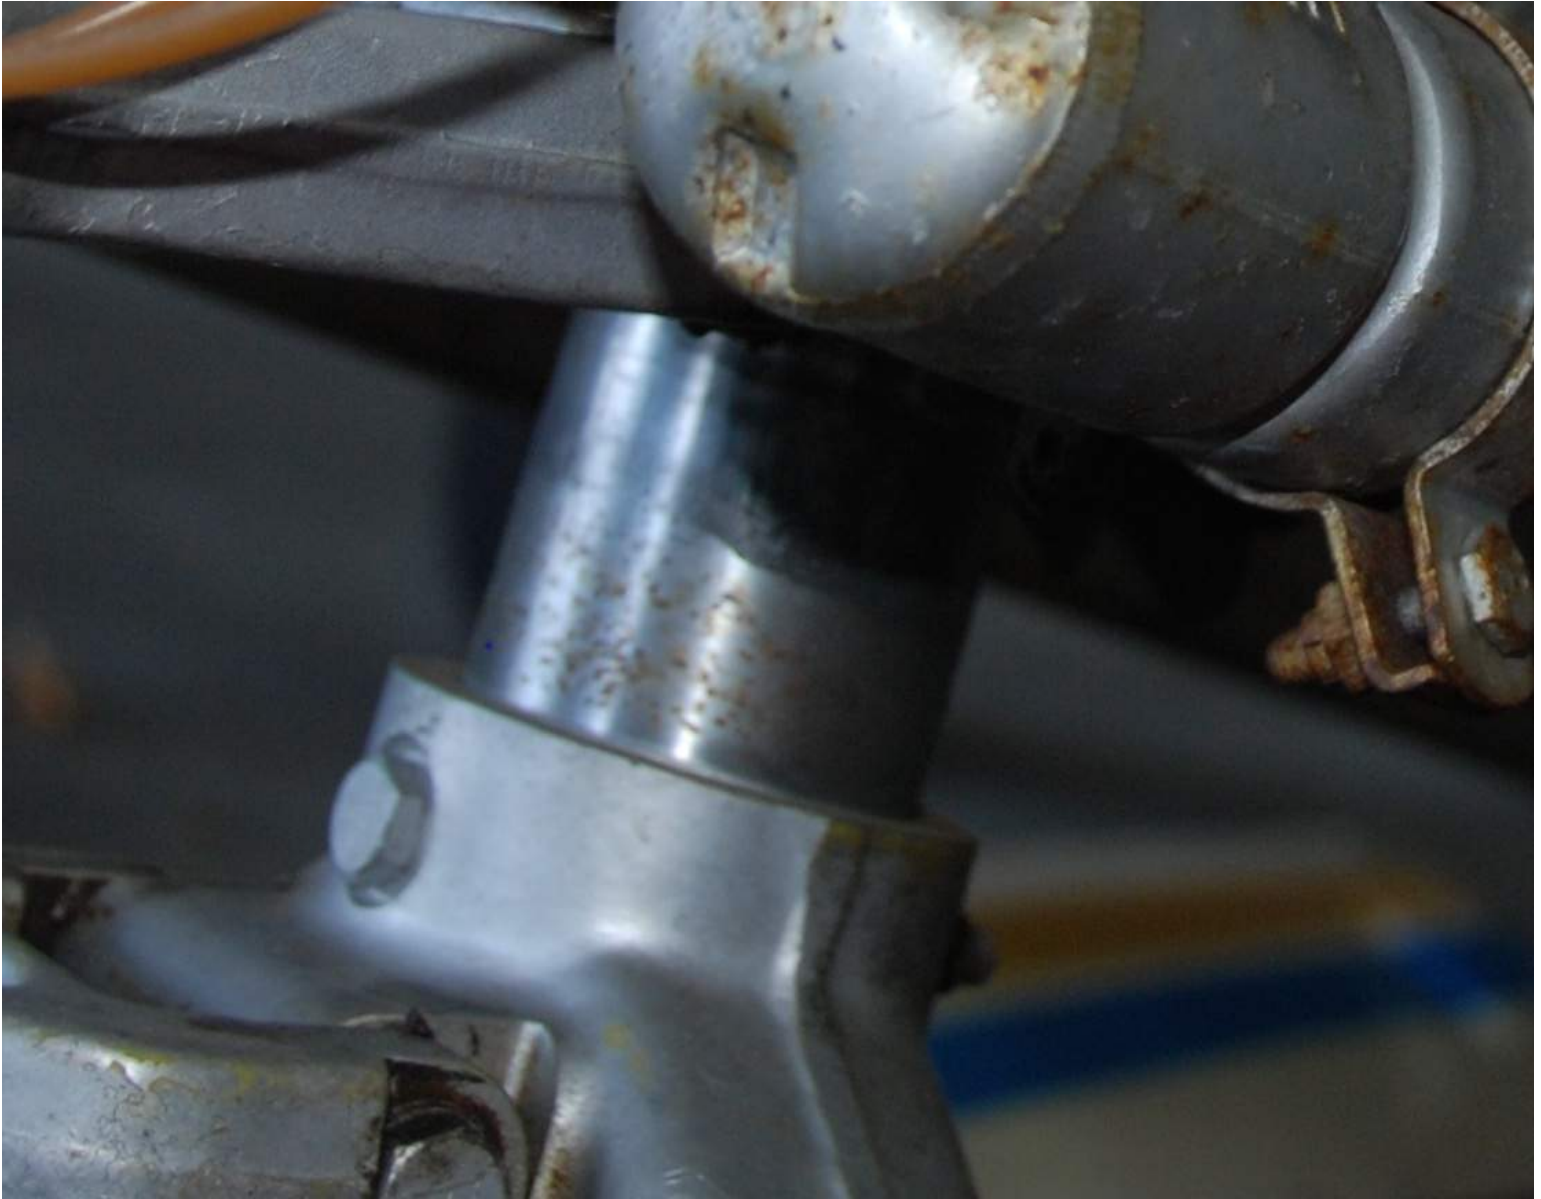
This is typical of a 10-20 year old oleo. Pitting and corrosion. So Off they must go. Wait. Identify and index the parts before parting them-out. These are match drilled. If the fit is so-so in the leg, one can always re-index them and precision re-drill, but chrome plated steel is a pretty tough material to get through. I elected to stamp a number underneath the leg where the holding bolt head is (yes there is a direction) and dremel-out a corresponding number of notches on the end of the sleeve. Putting the leg in a padded vise, a propane torch was sufficient to break the interference fit.

What I found-out also is that two of the legs (the nose and left gear) were not straight. I can't recall the out of straightness value, but that was in the order of 0.020". So.... that had to go for overhaul with a note. A bit of caution here: There are a few certified shops to doing such work, but also other outfits who are specialized in the hydraulic actuators and for the printing machinery who are used to work on much tighter tolerances. They all can rectify and re-grind cylinders, the real challenge is they must know and understand the mechanical relationships of where there is to be an interference

fit and so on. The nose oleo also has an inside piston/ring that must be properly fitted. Bottom line, my take is to pick someone knowledgeable on the parts and where they go. Anyhow the folks at Montreal Chrome were very knowledgeable and did a fabulous job. They successively ground re-plated a number of times to bring back the straightness, as they measured the interior and it was perfectly straight. Also, the interference fit dimensions were right on. They took care to plug the holes where the pins and the close tolerance bolts go as not to gift me of another fight later on. CDN\$ 375 (USD225) a piece was the damage. Not bad.

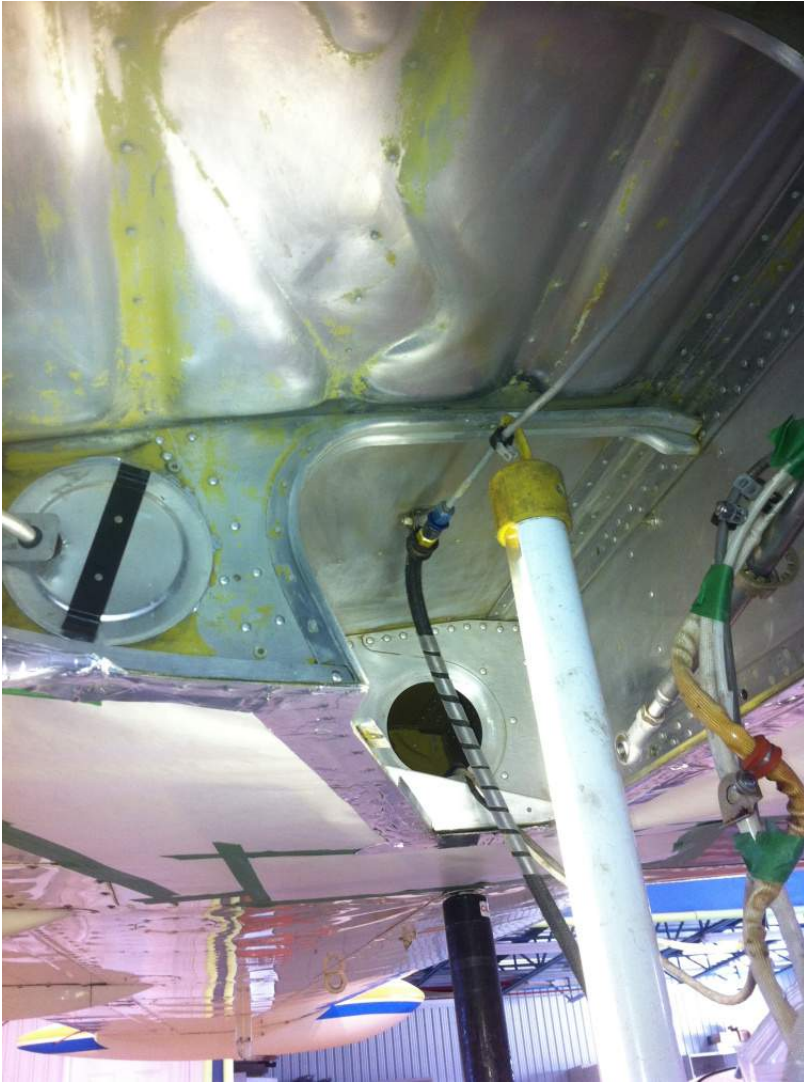
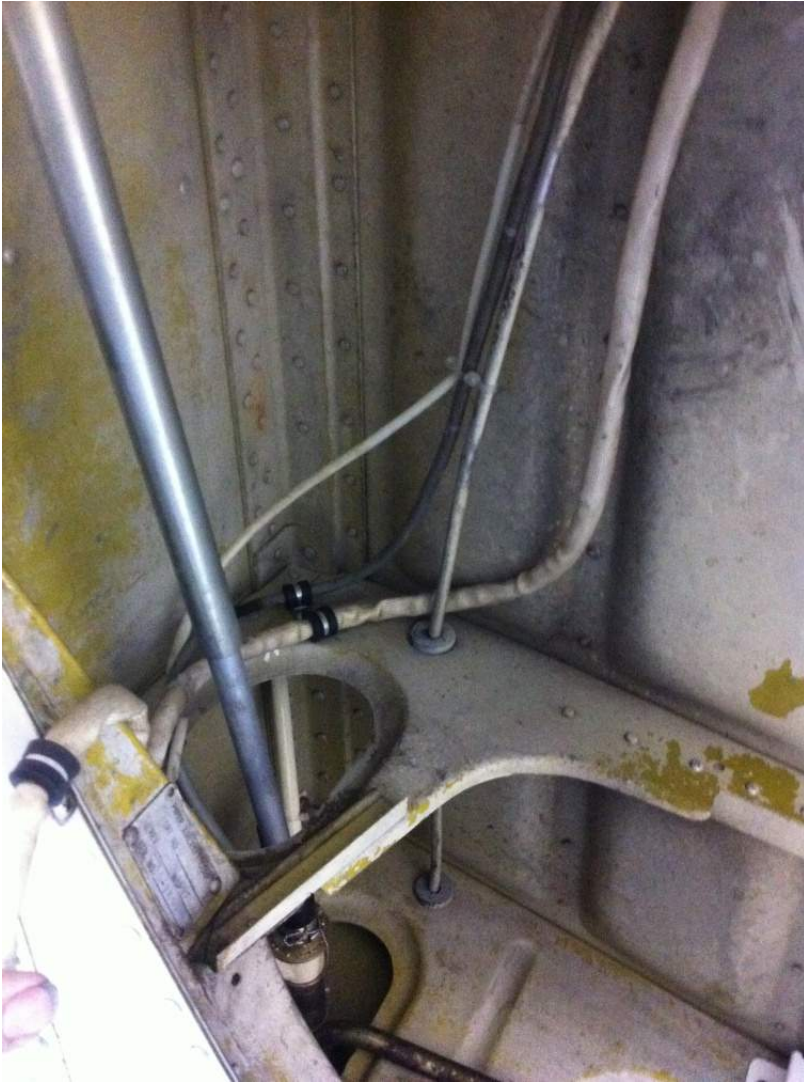
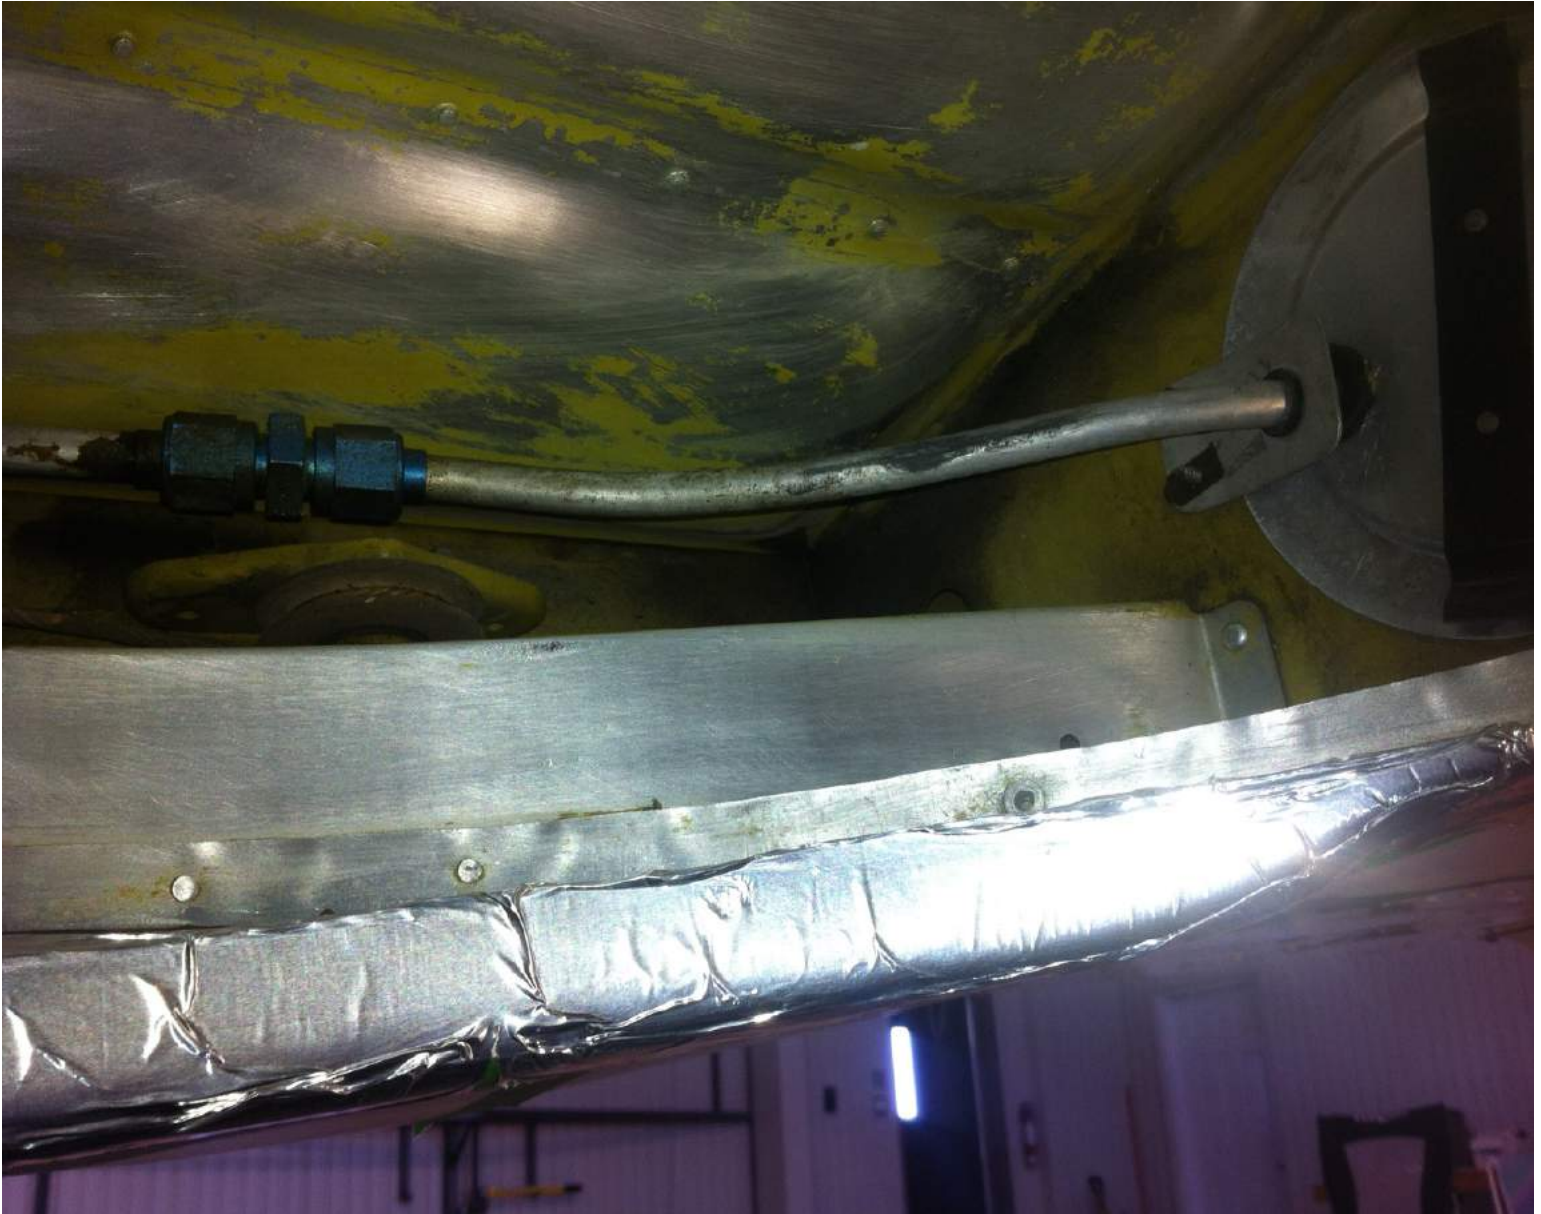
While all this funny stuff is happening, I elected to clean the old wells as they suffered from some 48 years of soiling, obviously something needed to be done. Aluminum is the kind, so same drill as the other parts, more corners, rivets and unfortunately much less comfortable positions to deal with (Thanks Rachel for your help there !).

Once paint stripped, the Alumiprep and Alodine are much harder to apply. I used a spray bottle for the alumiprep (doubled concentration) and let it sit a little, scotchbried it as much as I could and then rinsed with a lot of water. Alodine was applied with a paint brush. It doesn't take much and for a short period of time to work (particularly if the stuff is fresh). Rinsing with ample water and protecting oneself, obviously.

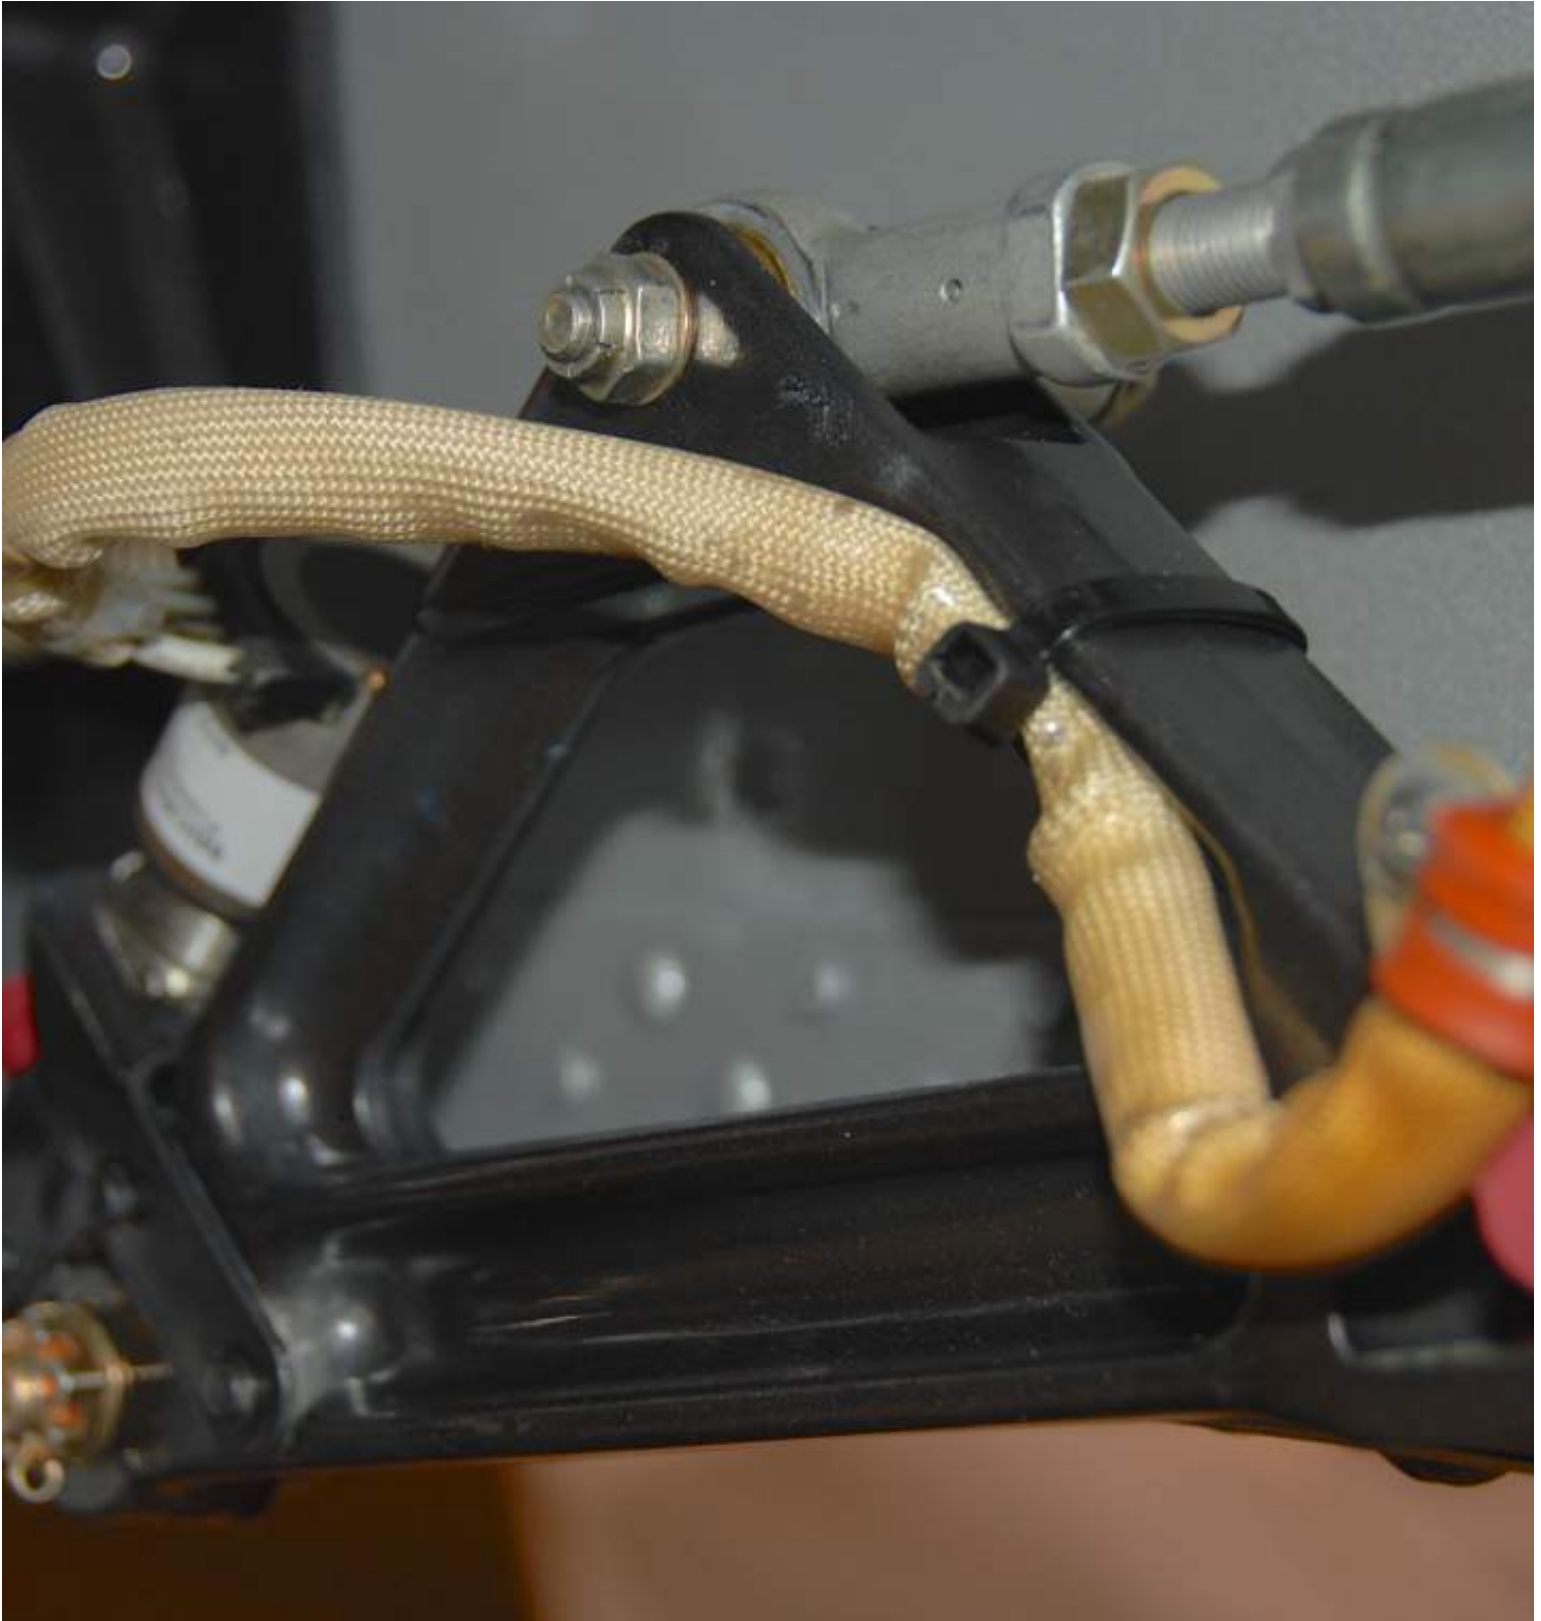
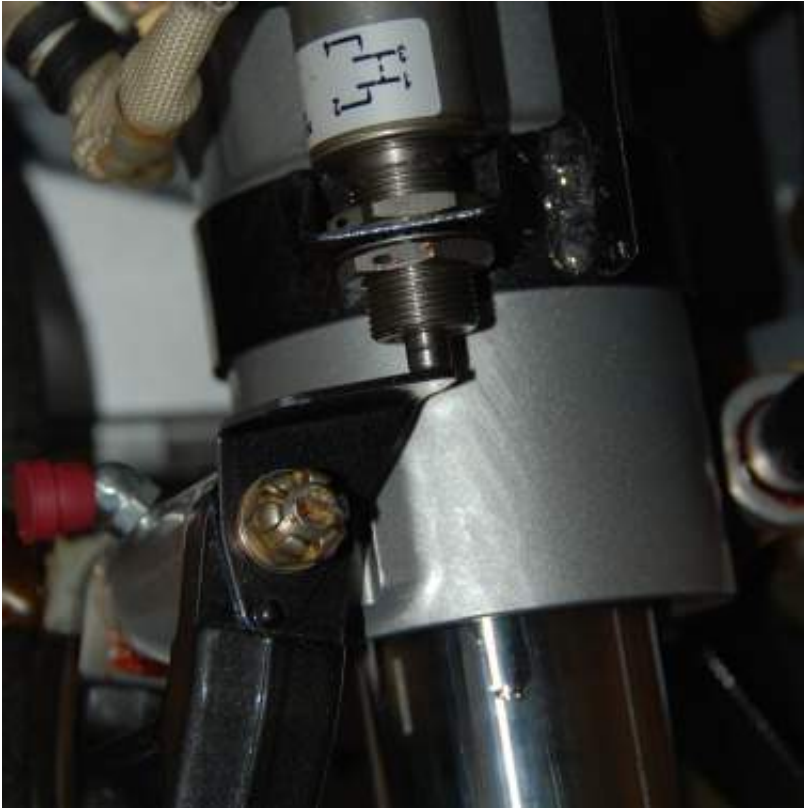
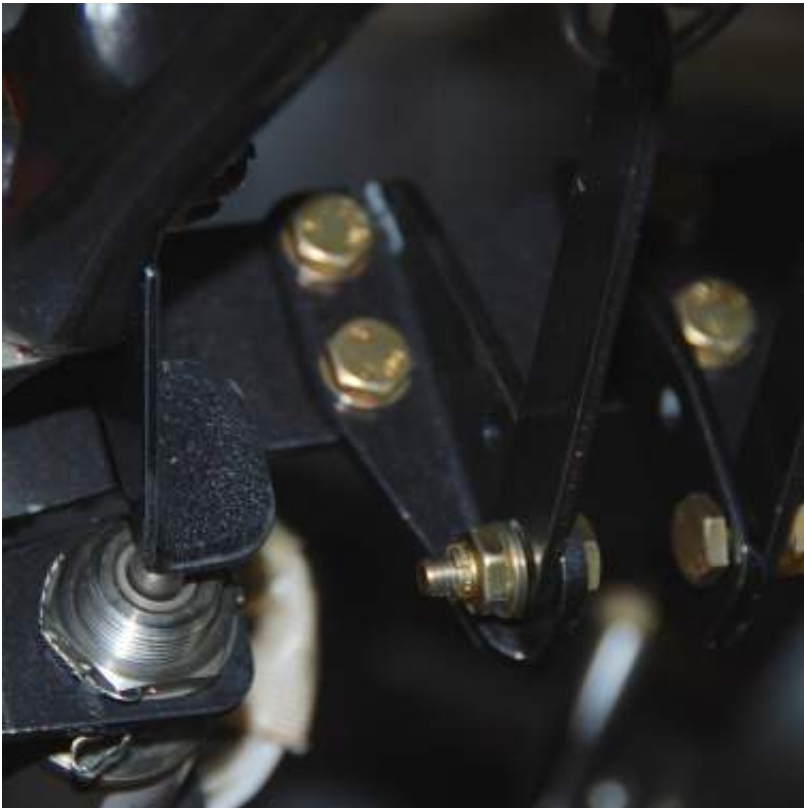
One side note here. There is an assembly error that is common with the main gear conduit bearing bolt and the washer schedule. The bolt attaches both the overcenter spring swivel and the conduit bearing to the sidebar arm. Firstly, the bolt head has to face forward. It is not the most comfortable position to install-remove that bolt and that is probably why it is often installed backward. Secondo, there should be one washer between the overcenter spring swivel bushing and the sidebar arm to prevent the bushing to drive itself into the sidebar aluminum.
