# SERVICE NO. 1266 BULLETIN

Date: December 16, 2014

#### FUEL WARNING PLACARD AND POH INSPECTION

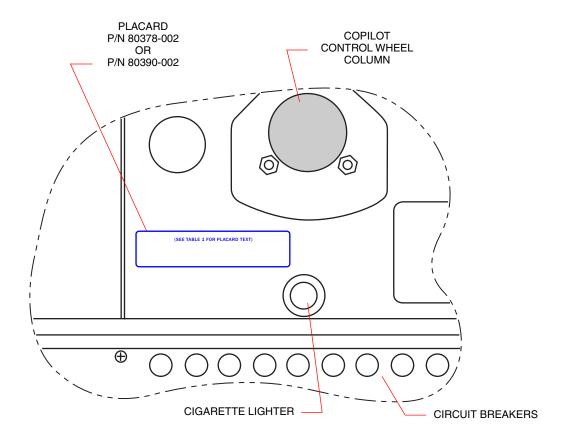
**Figure 1**Warning Placard - PA-24-250 (FI), PA-24-260 (FI), PA-24-260 "C" and PA-24-400 Comanche

WARNING PLACARD, LOWER RIGHT SIDE OF INSTRUMENT PANEL

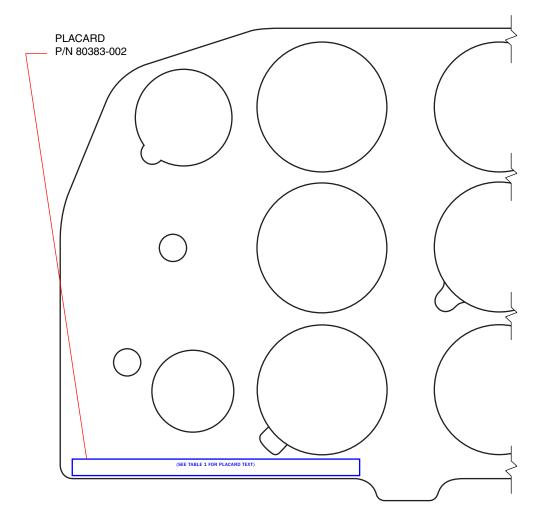
**Figure 2** Warning Placard - PA-31 and PA-31-300

WARNING PLACARD, LOWER LEFT CORNER OF LEFT INSTRUMENT PANEL

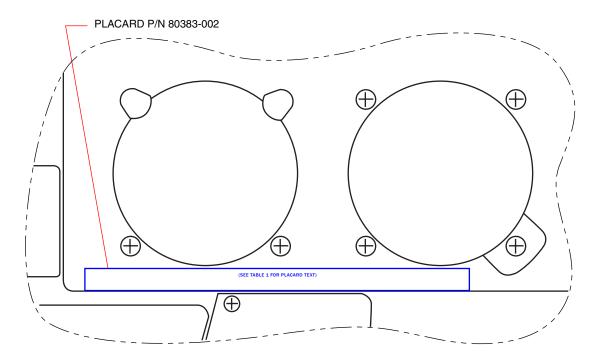
Figure 3 Warning Placard - PA-31P Navajo

WARNING PLACARD, LOWER LEFT CORNER OF MAIN INSTRUMENT PANEL

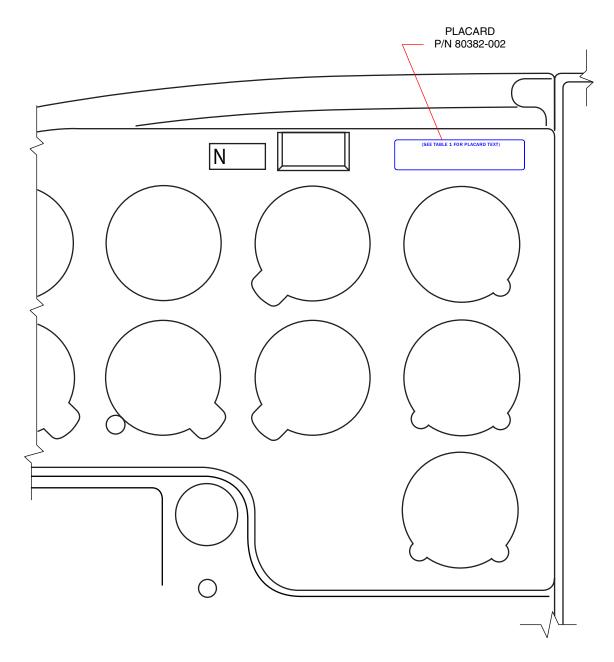
Figure 4

WARNING PLACARD, UPPER LEFT INSTRUMENT PANEL, ADJACENT TO THE COMPASS DEVIATION CARD AZTEC "E" SHOWN
