Airworthiness Directive

AD 64-09-05

Airworthiness Directives; Piper Model PA-30 Aircraft
PDF Copy (If Available):

64-09-05 PIPER: Amdt. 721 Part 507 Federal Register April 25, 1964. Applies to Model PA-30 Aircraft Serial Numbers 30-1 to 30-321 Inclusive.

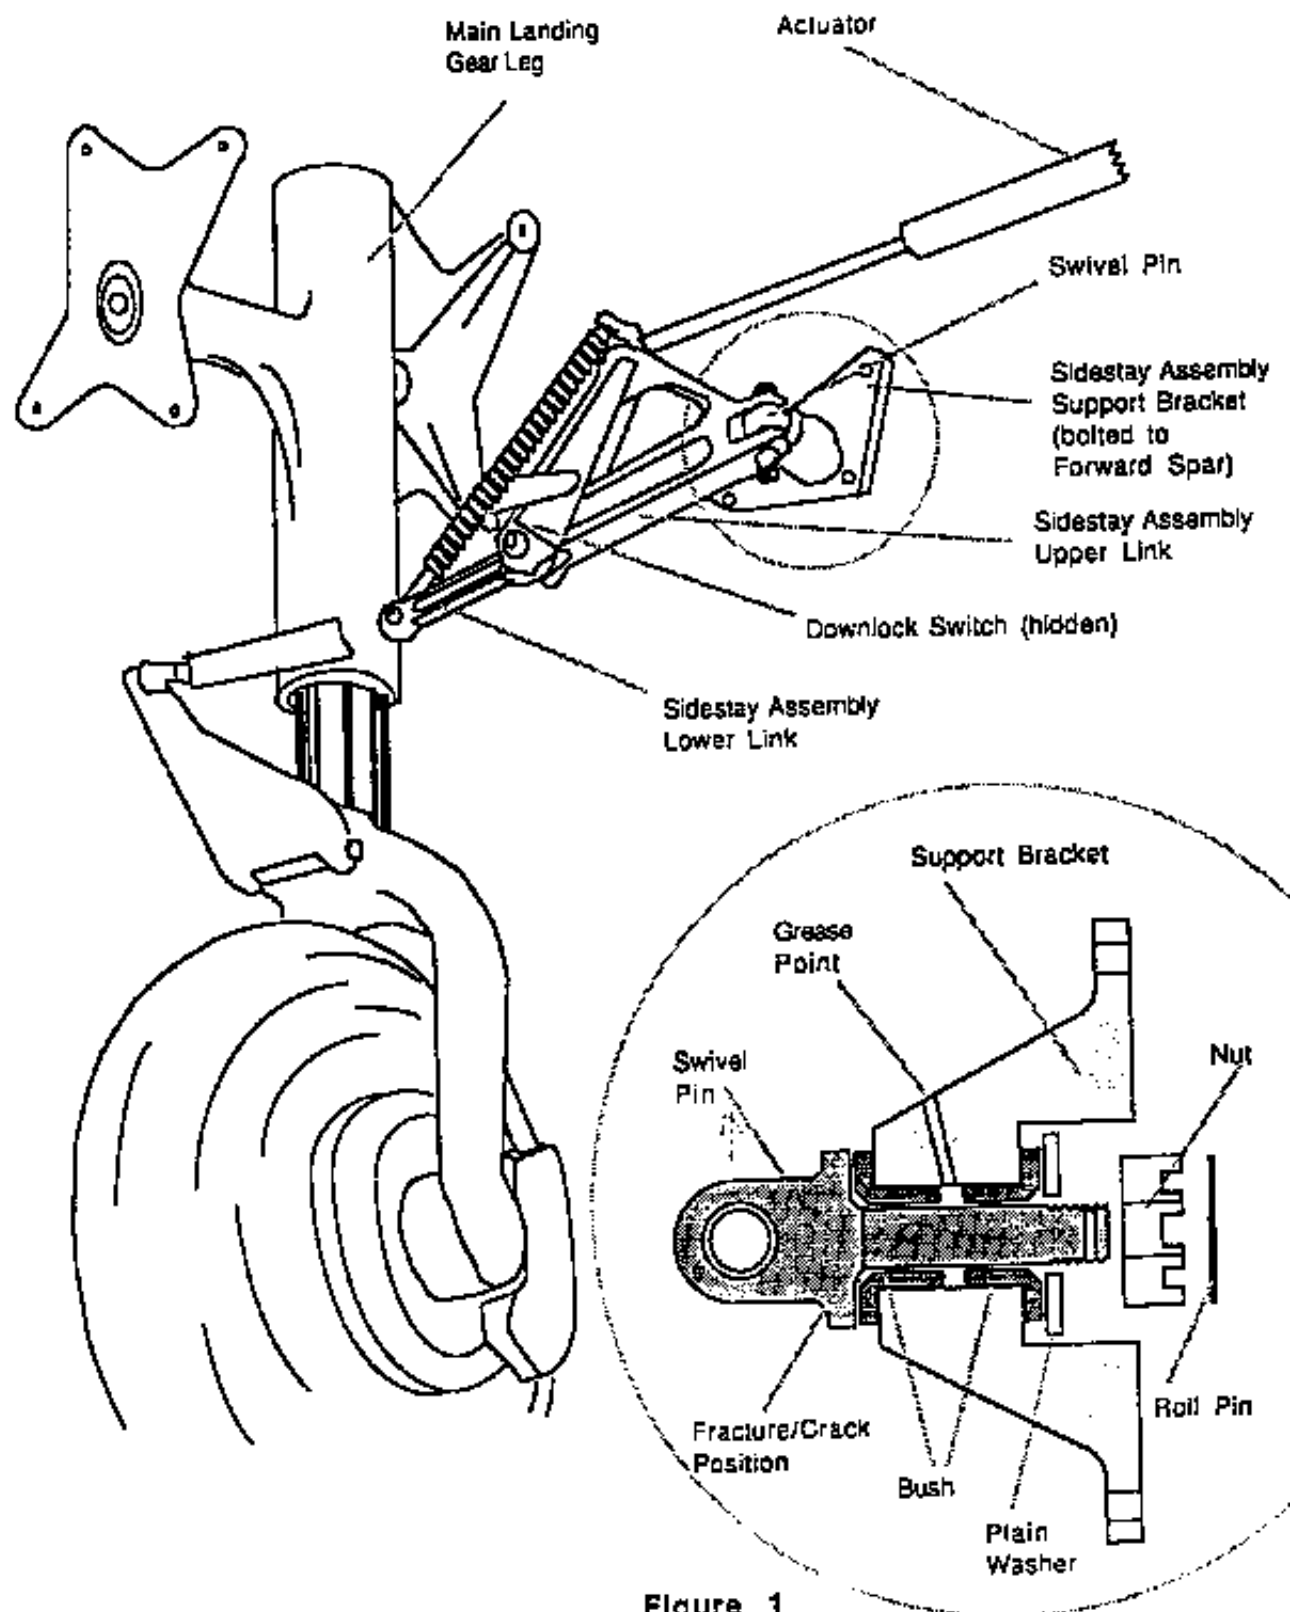
Figure 1

the 5/8-inch diameter main gear sidebrace stud, P/N 78717-02.

- The embossed number of 95363 on the bracket forging is not the bracket assembly P/N.
- The bracket assemblies identified with casting number 67073-2 or 67073-3 contain a 9/16-inch diameter main gear sidebrace stud, P/N 67543, and two-piece bushing, P/N 67026-2 and 67026-3.
- Model PA-28R-180 airplanes, serial numbers 28R-30004 through 28R-31270; and Model PA-28R-200 airplanes, serial numbers 28R-35001 through 28R-35820 and 28R-7135001 through 28R-7135062, are equipped from the factory with bracket assemblies identified with casting number 67073-2 and 67073-3.
- P/N 67543 main gear sidebrace studs are 9/16-inch in diameter.

(2) Ream the existing two-piece bushings to an inside diameter of .624-inch to .625-inch, chamfer the head side of the bushing to accommodate the radius in the shank of the main gear sidebrace stud, and install the 5/8-inch stud, P/N 78717-02 (or FAA-approved equivalent part number). No repetitive inspections will be required by this AD when this action is accomplished on both the left and right bracket assemblies. If the bushings cannot be reamed while installed in the bracket (i.e., the bushings are loose), then install a main gear sidebrace bracket assembly, P/N 95643-06 (or FAA-approved equivalent part number), P/N 95643-07 (or FAA-approved equivalent part number), P/N 95643-08 (or FAA-approved equivalent part number), or P/N 95643-09 (or FAA-approved equivalent part number), as applicable. Models PA-28R-180 and PA-28R-200 with serial numbers as specified in the Appendix to this AD may be equipped with a bracket casting identified with casting number 67073-2 or 67073-3 and may require the following modification to P/N 78717-02 (or FAA-approved equivalent part number) for proper installation:

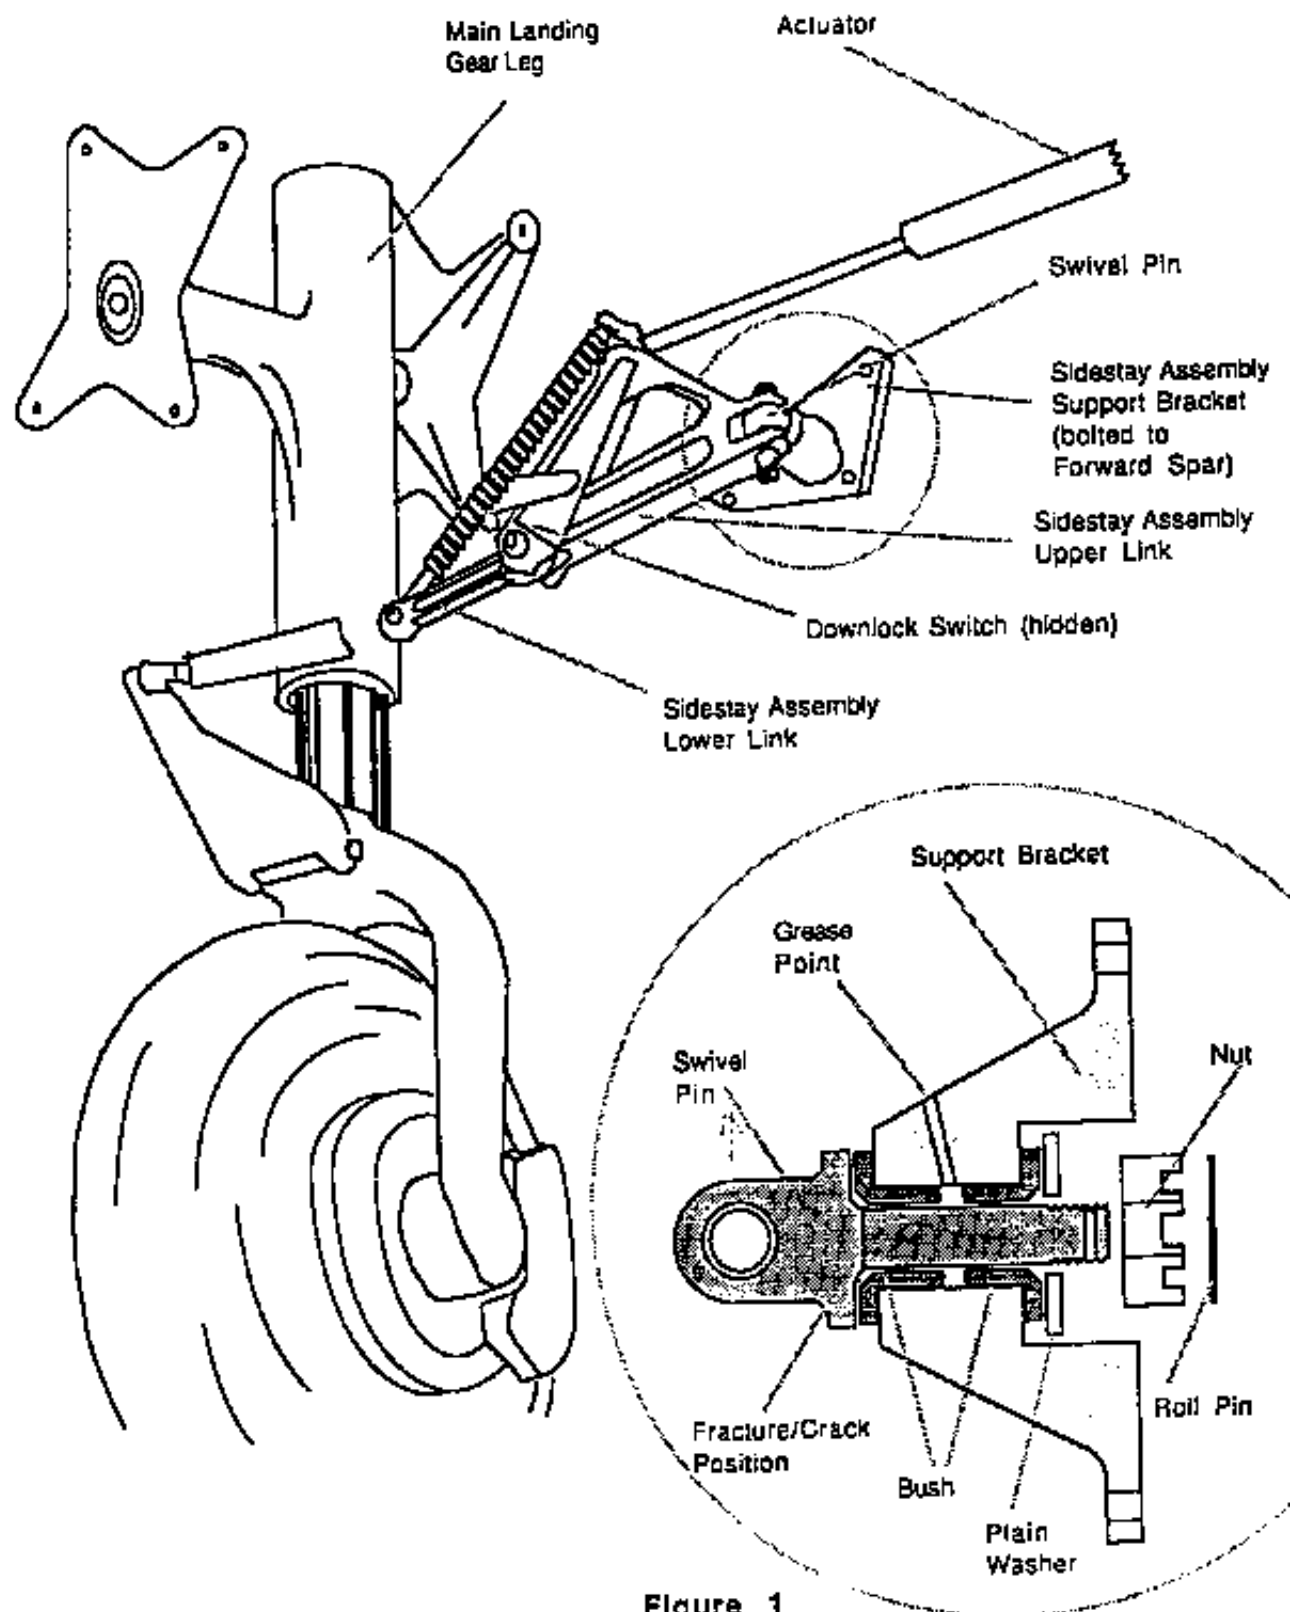
Figure 1

the 5/8-inch diameter main gear sidebrace stud, P/N 78717-02.

- The embossed number of 95363 on the bracket forging is not the bracket assembly P/N.
- The bracket assemblies identified with casting number 67073-2 or 67073-3 contain a 9/16-inch diameter main gear sidebrace stud, P/N 67543, and two-piece bushing, P/N 67026-2 and 67026-3.
- Model PA-28R-180 airplanes, serial numbers 28R-30004 through 28R-31270; and Model PA-28R-200 airplanes, serial numbers 28R-35001 through 28R-35820 and 28R-7135001 through 28R-7135062, are equipped from the factory with bracket assemblies identified with casting number 67073-2 and 67073-3.
- P/N 67543 main gear sidebrace studs are 9/16-inch in diameter.
