Service Letter No. 422

SUBJECT: Rework of Propeller Spinner Assembly

MODELS AFFECTED: PA-30 Twin Comanches, Serial Nos. 30-1 to 30-348 inclusive

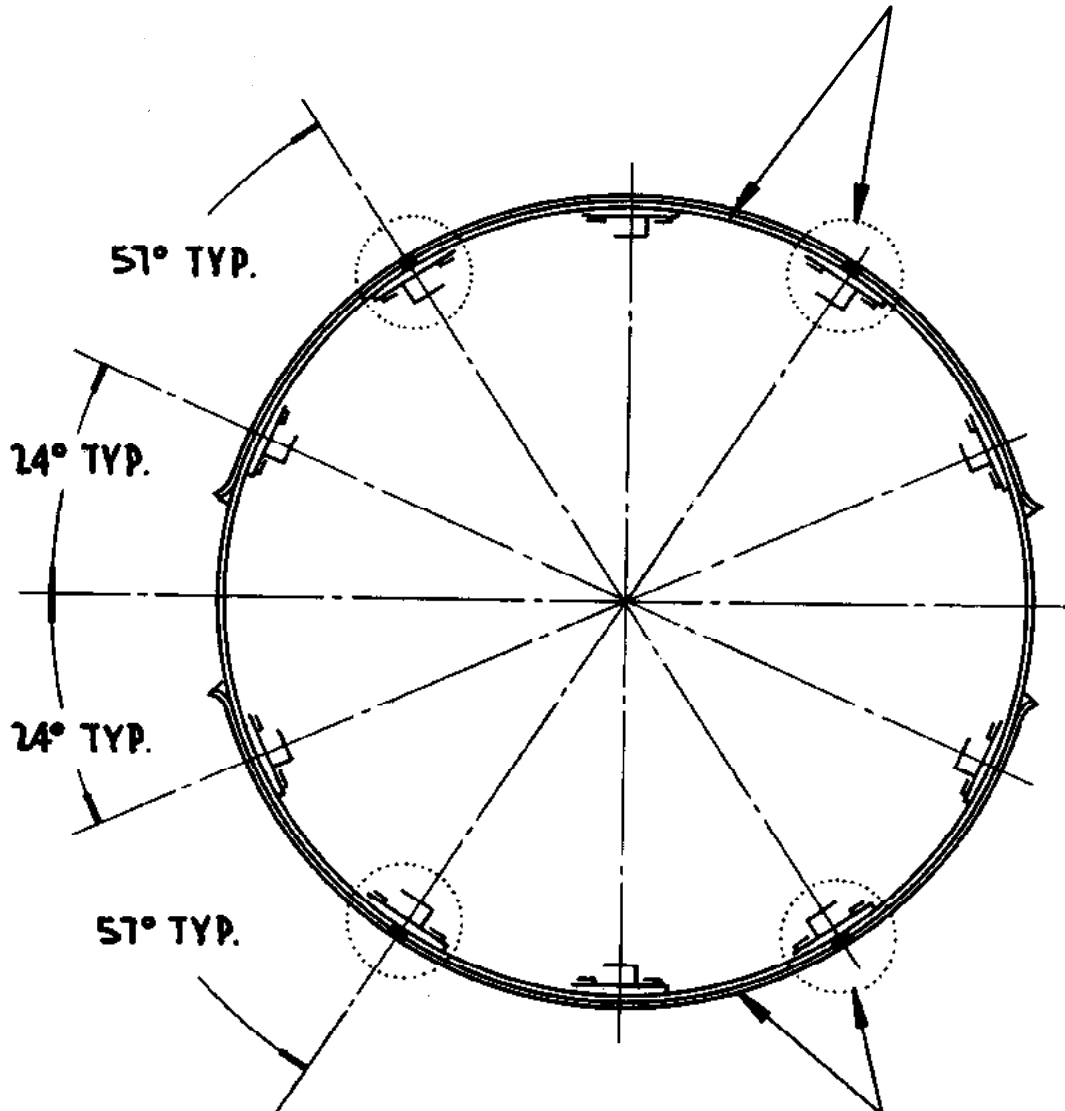
SKETCH A
KIT 756 796
Spinner Attachment

We have had reports which indicate that the propeller spinner attaching screws on the subject aircraft are chafing the spinner. In some cases the screw head had chafed sufficiently to wear through the spinner.

.189/.191 HOLE (4 REQ.)
ANCHOR NUT NAS686A3 (4 REQ.)
RIVET AN426AD3-4 (8 REQ.)
(ADD TO 23815 BULKHEAD ASSY.)

.189/.191 HOLE (4 REQ.)
(ADD TO 23818 SPINNER ASSY.)

SCR. AN526-1032128 (4 REQ.)
(AT INST.)

In order to correct this situation we have added four (4) additional screws to each spinner. These screws are installed midway between existing screws. Refer to sketch on the reverse side of this service letter.

It is suggested that the spinners on the aircraft serial numbers shown above be reworked not later than the next 100 hour inspection.

Kit Number 756 796 will be provided on a no charge basis by the Service Spares Department. Distributors may submit their orders for a sufficient number of kits to comply with this service letter.
