SERVICE LETTER

No. 623

Piper Aircraft Corporation

Subject: Inspection of Rajay Alternate Air Valve Bracket

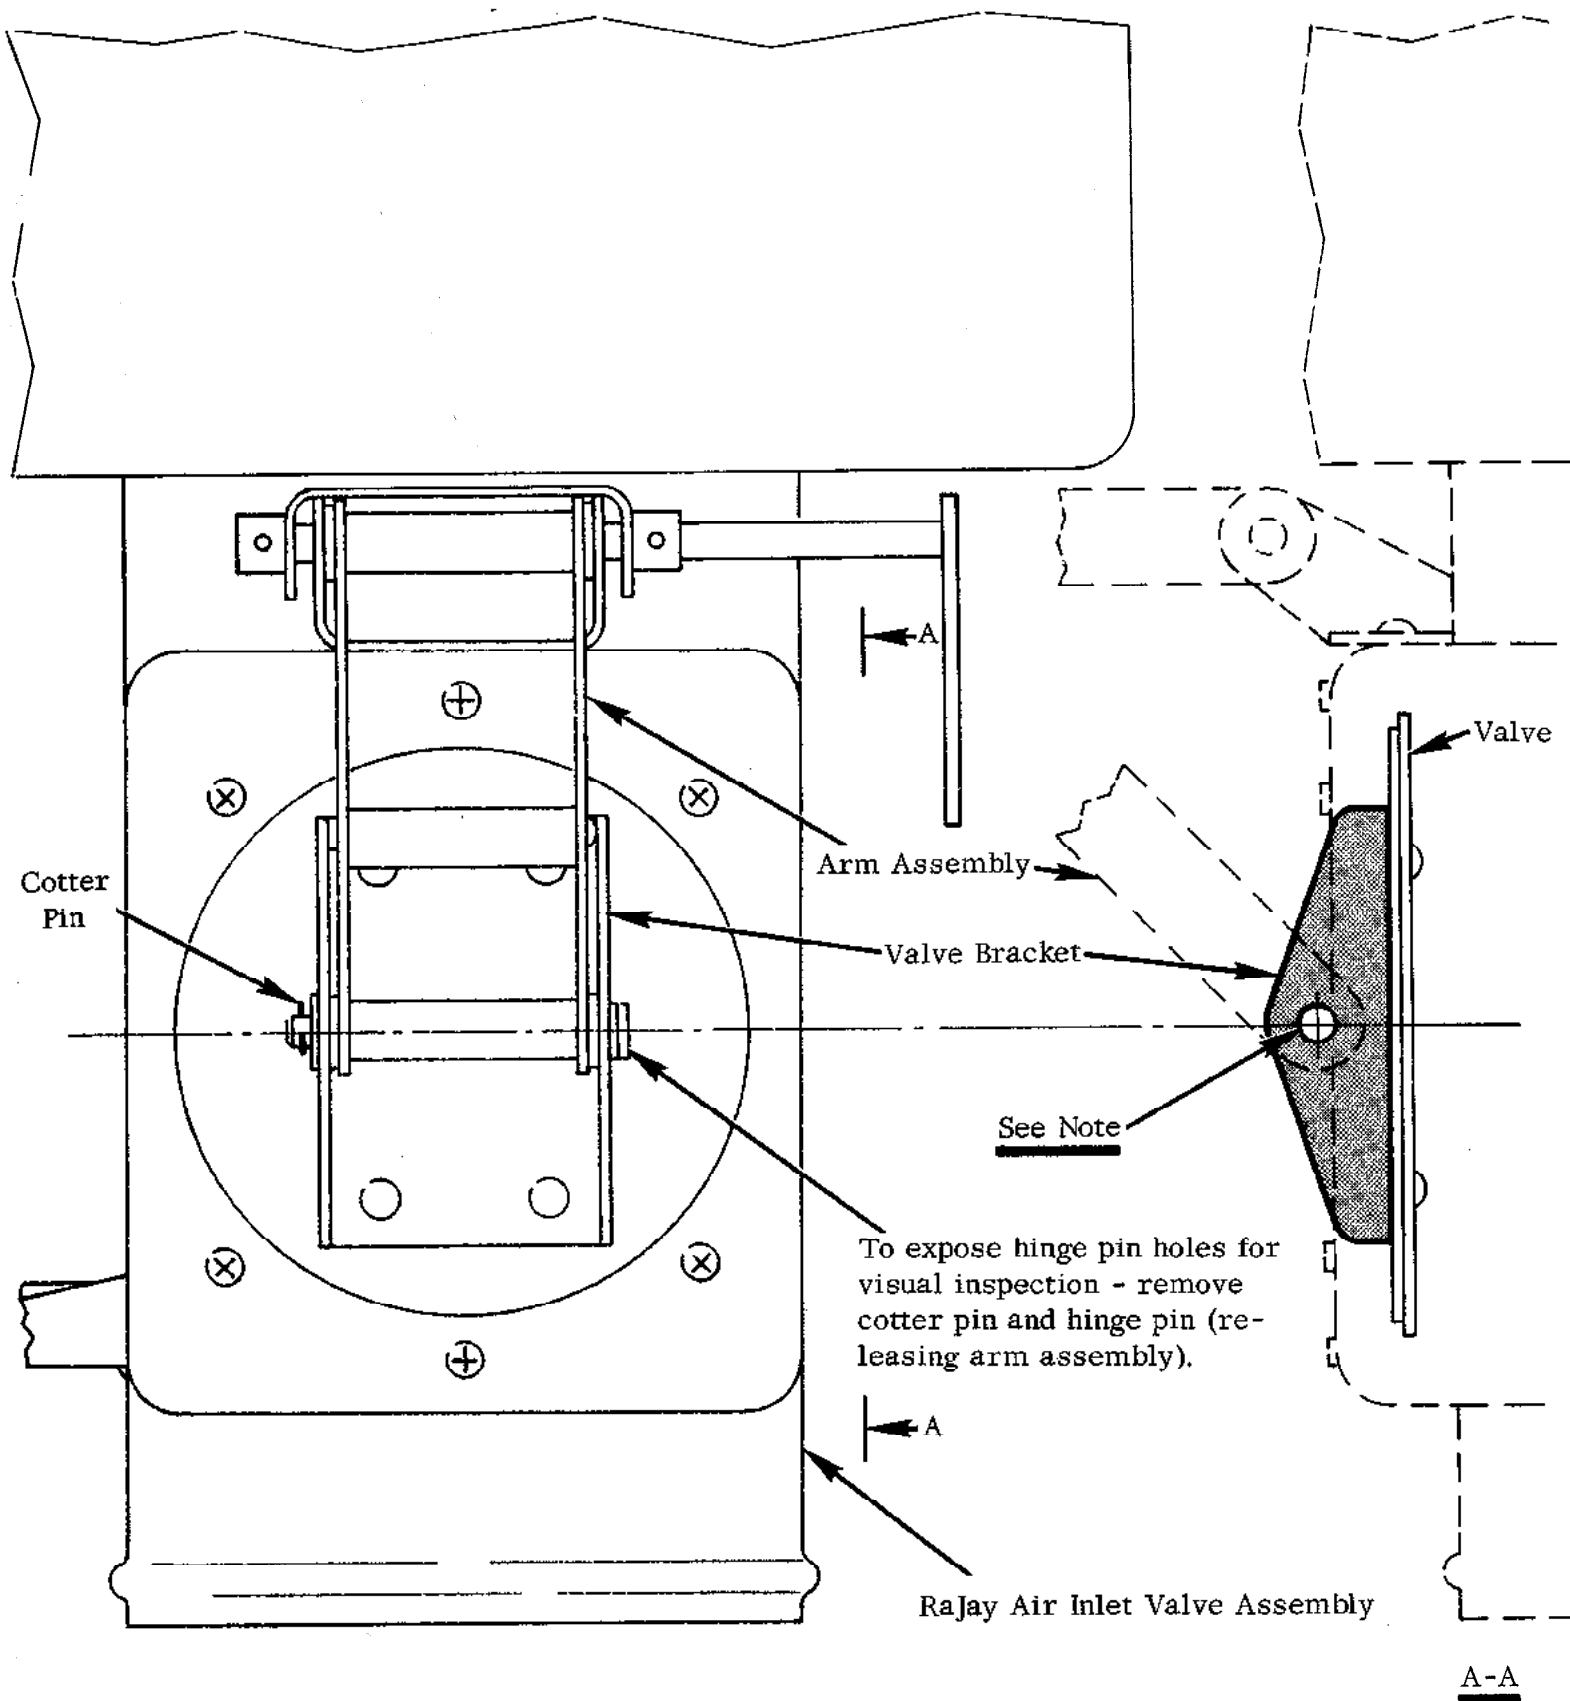
A survey of field reports recently received indicates that the alternate air inlet valve brackets with brass reinforced hinge pin holes are also subject to wear.

1. Gain access to the engine air inlet filter assembly in accordance with PA-30/39 Service Manual Section VIIIA, paragraph VIIIA 27 through 31 inclusive.
2. Inspect alternate air inlet valve bracket hinge pin holes for excessive wear, as evidenced by hole elongation exceeding 1/16 inch. Should elongation exceed 1/16 inch, replace alternate air inlet valve and bracket assembly.

NOTE - Inspect Rajay Alternate Air Inlet Valve Bracket hinge pin holes (2) for wear elongation exceeding 1/16 inch. Replace if required with new alternate air inlet valve and bracket assembly Rajay Part No. RJ0605-5/-71.

One (1) each (per engine) Alternate Air Inlet Valve and Bracket Assembly, Rajay Part No. RJ0605-5/-71, if required per Instructions, above.
