SERVICE LETTER

No. 627

Piper Aircraft Corporation

Propeller Installation

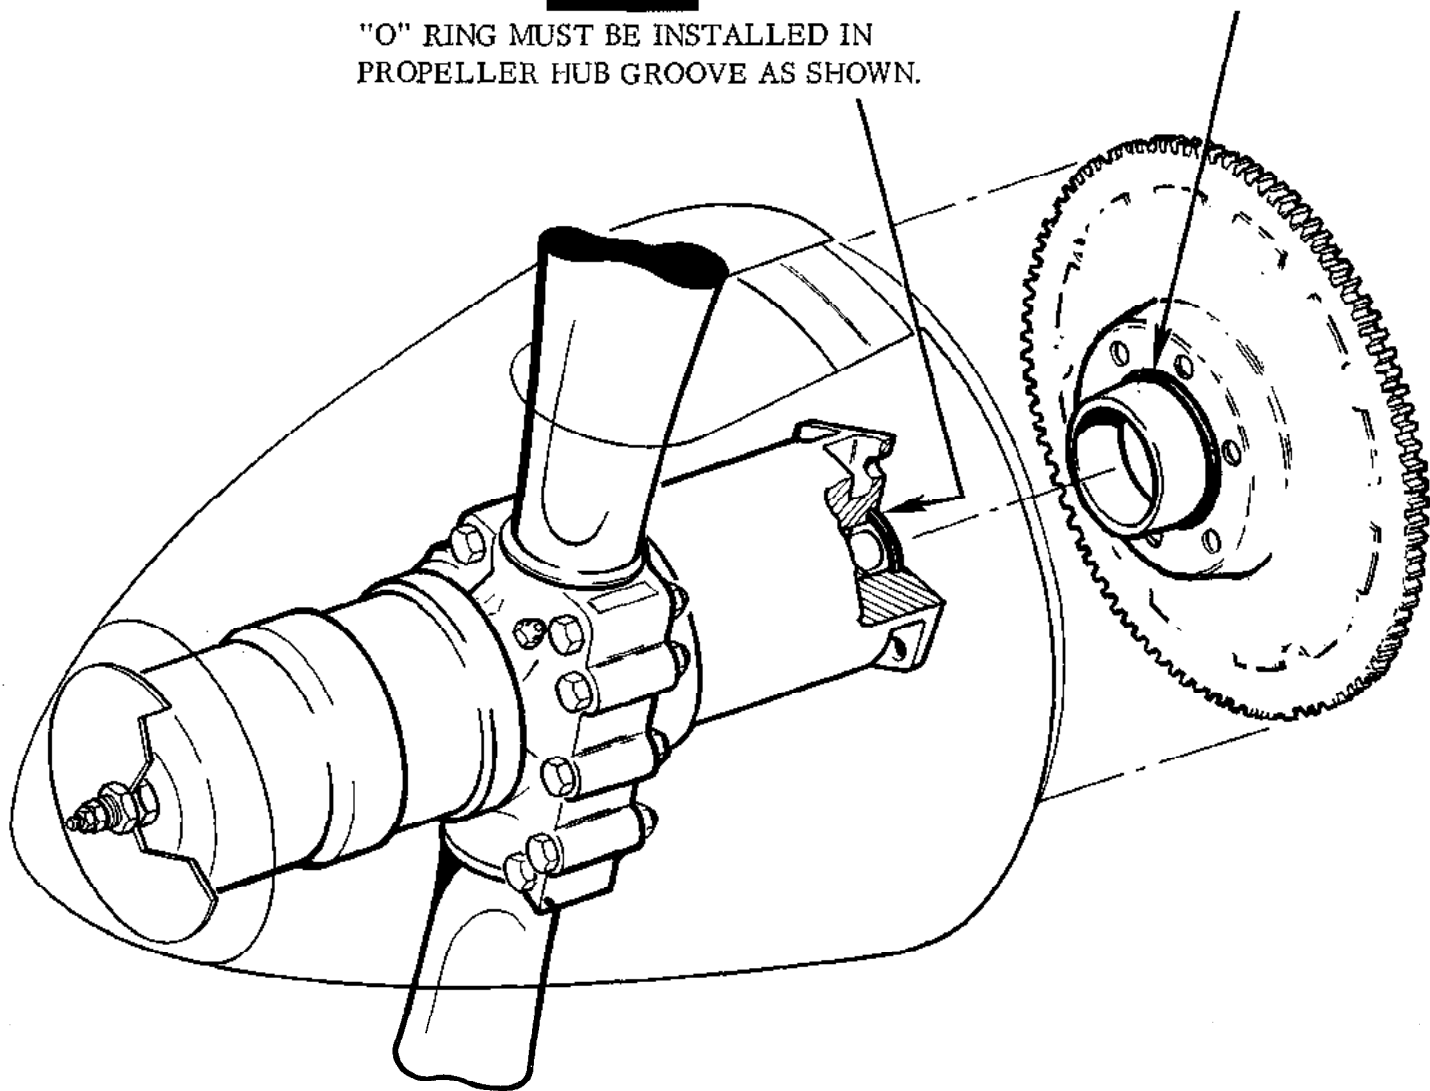
A recent report was received concerning the loss of a propeller on one of the above referenced aircraft during aircraft operation. A subsequent investigation revealed that the affected propeller had been recently removed and was apparently incorrectly installed -- with indications of (1) inadequate propeller mounting bolt torque and (2) incorrect installation of an extra "o" ring between the prop flange and the engine crankshaft flange.

CORRECT

"O" RING MUST BE INSTALLED IN
PROPELLER HUB GROOVE AS SHOWN.

INCORRECT

DO NOT INSTALL "O" RING
OVER CRANKSHAFT FLANGE.

next fifteen hours of operation, loosen the propeller mounting bolts and slide the propellers forward on the shaft so that the area between the prop flange and the engine crankshaft flange is exposed to view. Visually check to insure that no "o" ring is installed on the shaft in this area.

- A. If an "o" ring exists in this location, the "o" ring must be discarded and the propeller should be removed from the aircraft and inspected to insure that the proper "o" ring is correctly installed in the propeller hub groove -- as shown in attached sketch.
3. Reinstall propeller, insuring that prop mounting bolts are properly torqued.
4. Make appropriate log book entry.
