SERVICE LETTER

No. 637

Piper Aircraft Corporation

Subject: Rajay Service Letter No. 19, dated September 5, 1972.

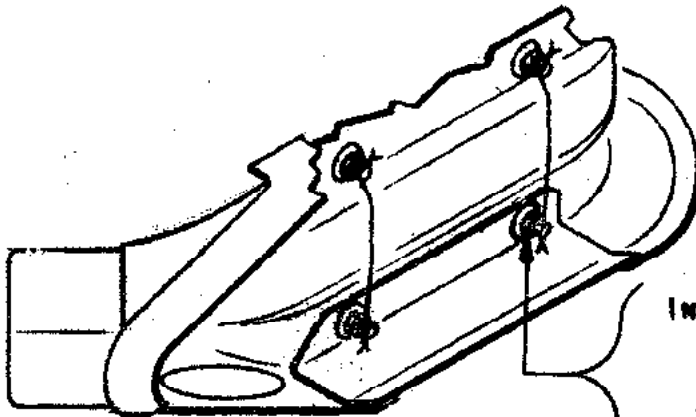
THERE HAVE BEEN ISOLATED REPORTS OF THE TURBOCHARGER INDUCTION DUCT RETAINING STUDS BACKING OUT AND BEING INGESTED INTO THE COMPRESSOR SECTION OF THE TURBOCHARGER. TO PRECLUDE THIS FROM OCCURRING ON ANY FUTURE INSTALLATIONS, A REVISED ASSEMBLY WILL BE USED AS SHOWN BELOW:

**INSTALL:
NAS 183-4-8 STUD
AN 310-4 NUT
4 EACH REQUIRED
SAFETY WIRE (.030 DIA.) PER
MS 33540 TOP TO BOTTOM AS SHOWN
2 PLACES**
