# SERVICE LETTER

No. 667A

Piper Aircraft Corporation

Stabilator Attachment Bolts

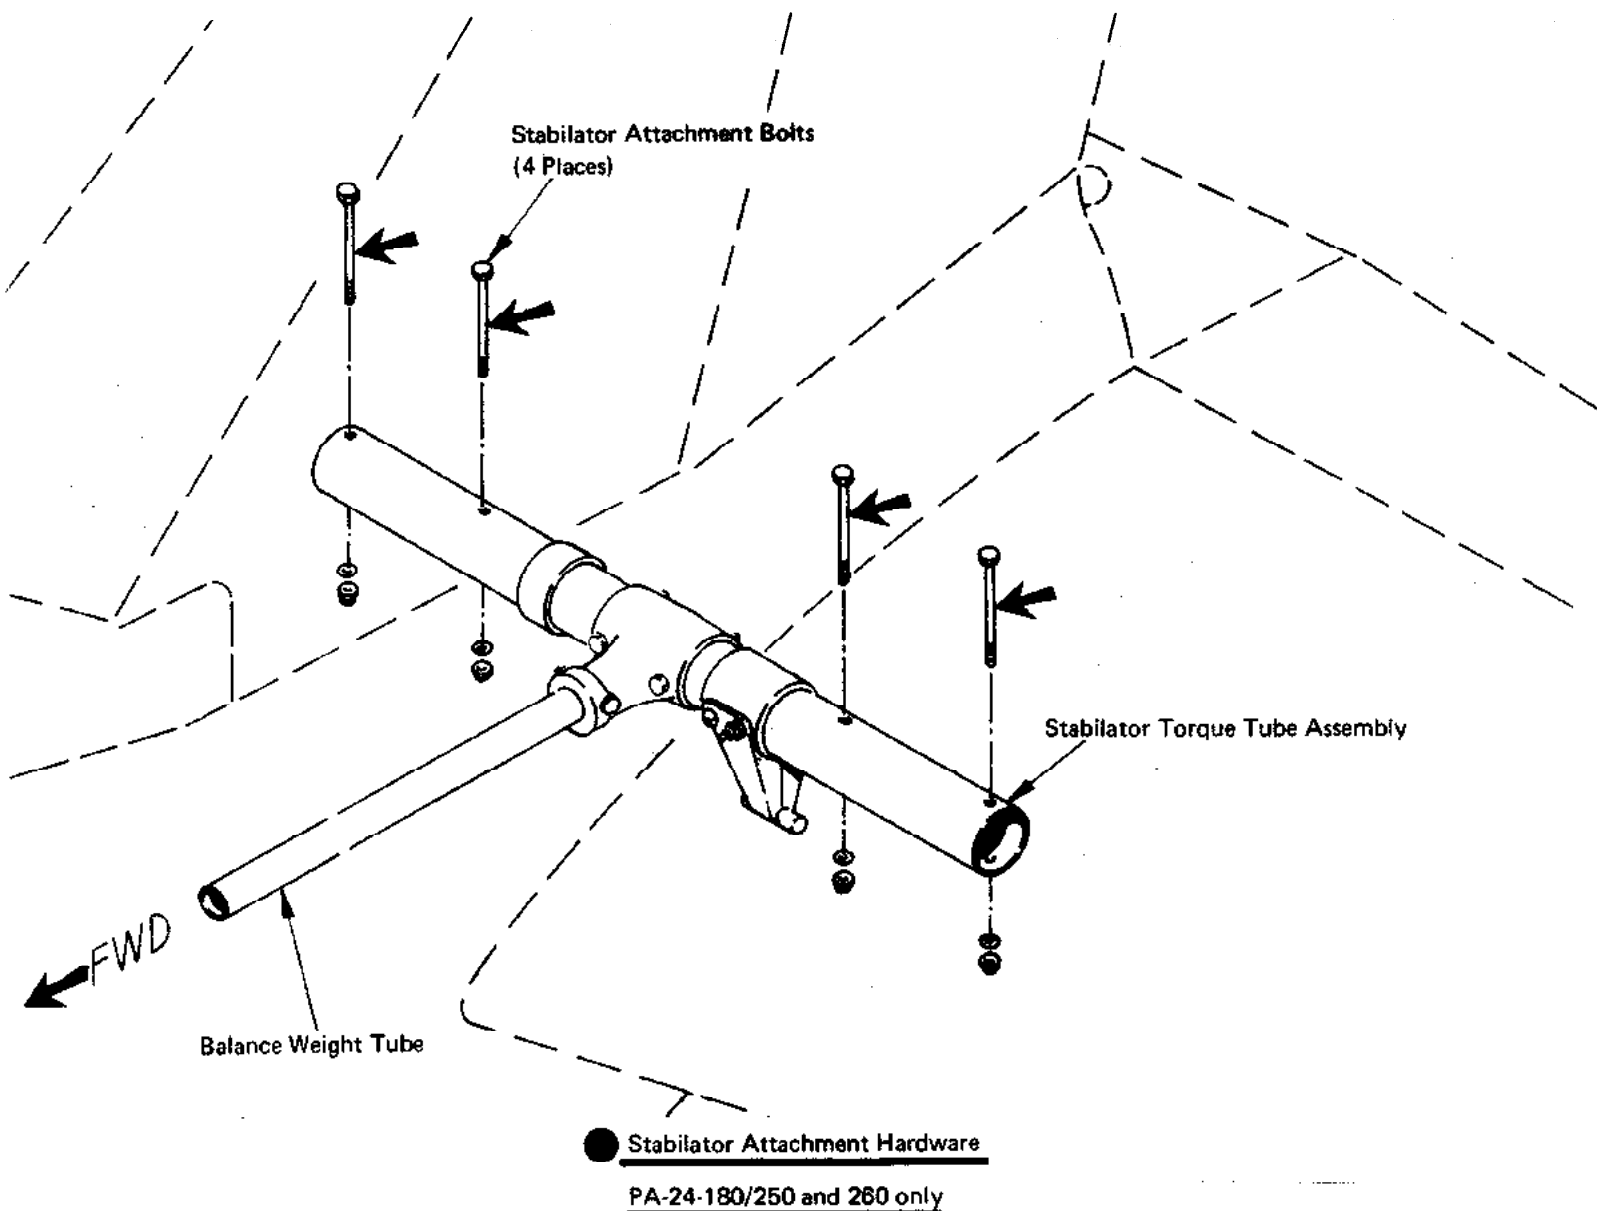
It has been determined that the stabilator attachment bolts on the above referenced aircraft may corrode. This situation has occurred primarily on high time aircraft at least five years old and/or operating in areas likely to induce corrosion -- near salt water, etc.

Bolt AN174-C32A P/N 502 329 (Corrosion Resistant) or Bolt AN174-32A P/N 402 329 (Non-Corrosion Resistant)  
 Washer AN960-416L P/N 407 585  
 Nut MS20365-428C P/N 404 888

PA-23-235/250/250 Six Place, PA-24-400 and PA-30 only

Bolt AN175-C32A P/N 502 342 (Corrosion Resistant) or Bolt AN175-32A P/N 402 342 (Non-Corrosion Resistant)  
 Washer AN960-516 P/N 407 566 (PA-23-235/250 and 250 Six Place only)  
 Washer AN960-516L P/N 407 586 (PA-24-400 and PA-30 only)  
 Nut MS20365-524C P/N 404 889

Remove existing stabilator attachment bolts, washers and nuts, indicated on sketch, and install new bolts and attaching hardware.  
**CAUTION:** Remove and replace one bolt at a time. Refer to sketch for correct replacement hardware identification and proper assembly of bolts, washers and nuts.

2. Correct torque value for bolts is as follows:

- a. PA-24-180/250 and 260 - torque to 30-40 inch lbs.
- b. PA-23-235/250/250 (Six Place) and PA-24-400 - torque to 60-85 inch lbs.
- c. PA-30 - Refer to the Twin Comanche Service Manual (Section 4 - paragraph 49) which states that the nuts ("holding the stabilator to the torque tube") should "be tightened just enough to take the play out of the washers."
