SERVICE LETTER

No. 707

Modified Flyball Assembly to Improve RPM Control
-- reference attached Hartzell Service Letter No. 75,
dated November 16, 1973.

SERVICE LETTER NO. 75

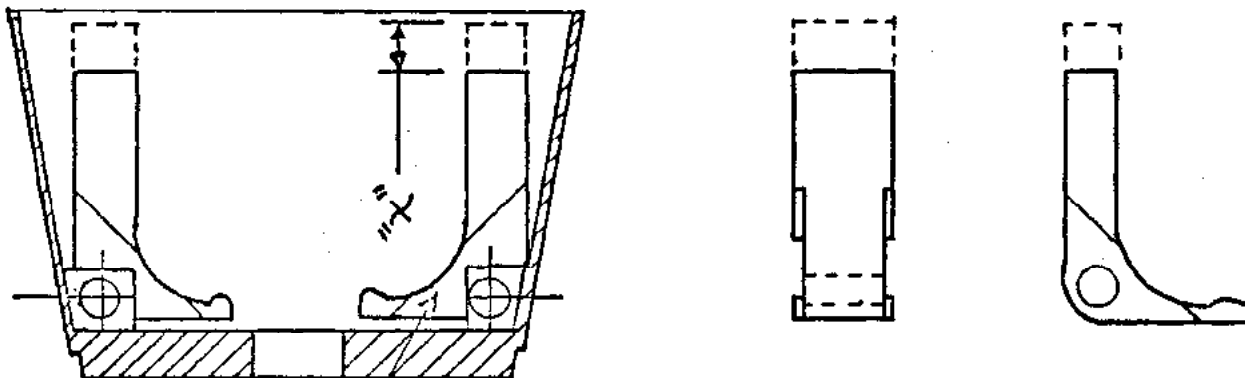
A-153(A)-(C) FLYWEIGHT (SEE CHART)
(MATERIAL GROUND FROM
SIDES ON "A" MODIFICATION)

- 1) Determine flyweight assembly needed using parts listed in this letter.
- 2) The flyweight assembly can be changed by:
 - a) removing cover assembly
 - b) removing flyweight assembly locking ring
 - c) removing flyweight assembly
 - d) placing new flyweight assembly in place
 - e) replacing lock ring, making sure it is in place
 - f) replacing cover gasket 50672, and
 - g) installing cover assembly
