SERVICE LETTER

No. 777

Piper Aircraft Corporation

Fin Front Spar Modification.

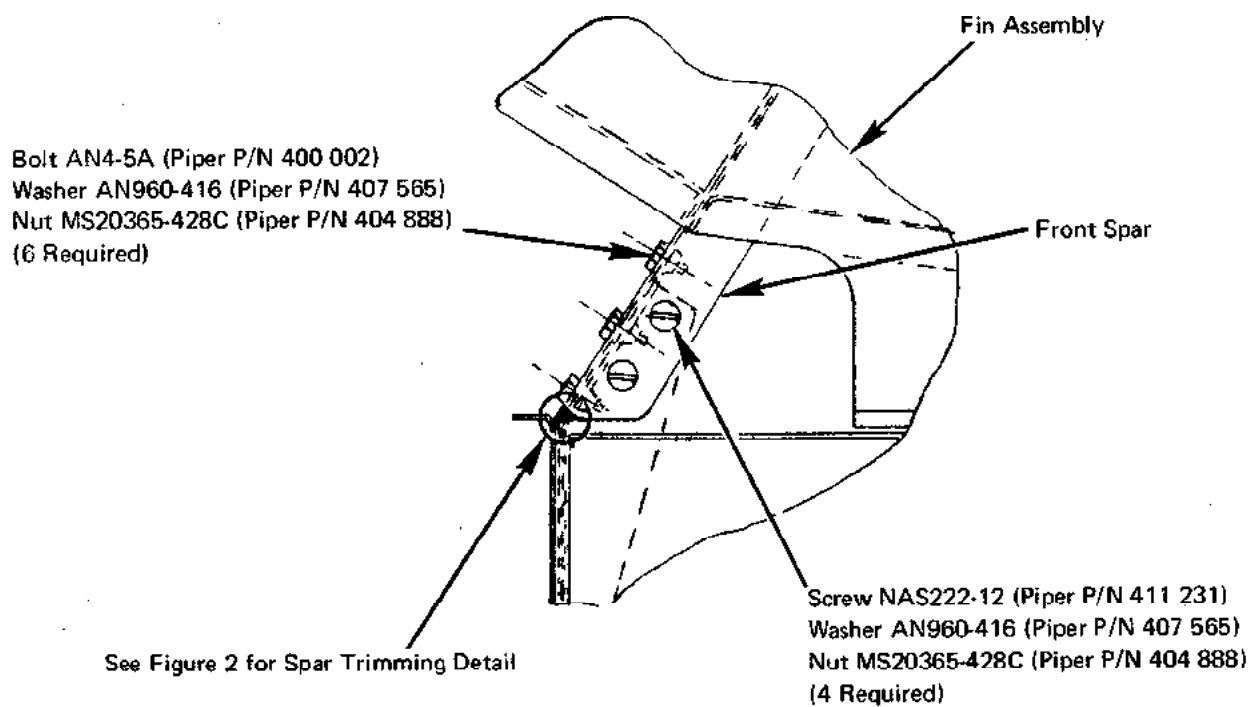
FIGURE 1

FAA Airworthiness Directive #75-12-06 dated June 5, 1976 required a repetitive inspection of the PA-24 Comanche series Fin Front Spar to Fuselage Attachment Channel bend relief holes for evidence of cracks; repair or replace cracked channels/straps if cracks are detected...etc. We have been advised that, in the near future, the FAA is planning a similar action relative to the PA-30 and PA-39 Twin Comanche series.

Since it is necessary to physically remove the Fin Assembly to gain visual access to the channel relief holes (as the Fin Front Spar extends over the relief holes approximately 1/2 to 2/3 of the relief hole diameter), this service release provides instructions to modify the Fin Front Spar to eliminate repetitive removal of the fin and to enable an easy visual inspection.

(FIN FRONT SPAR ATTACHMENT)

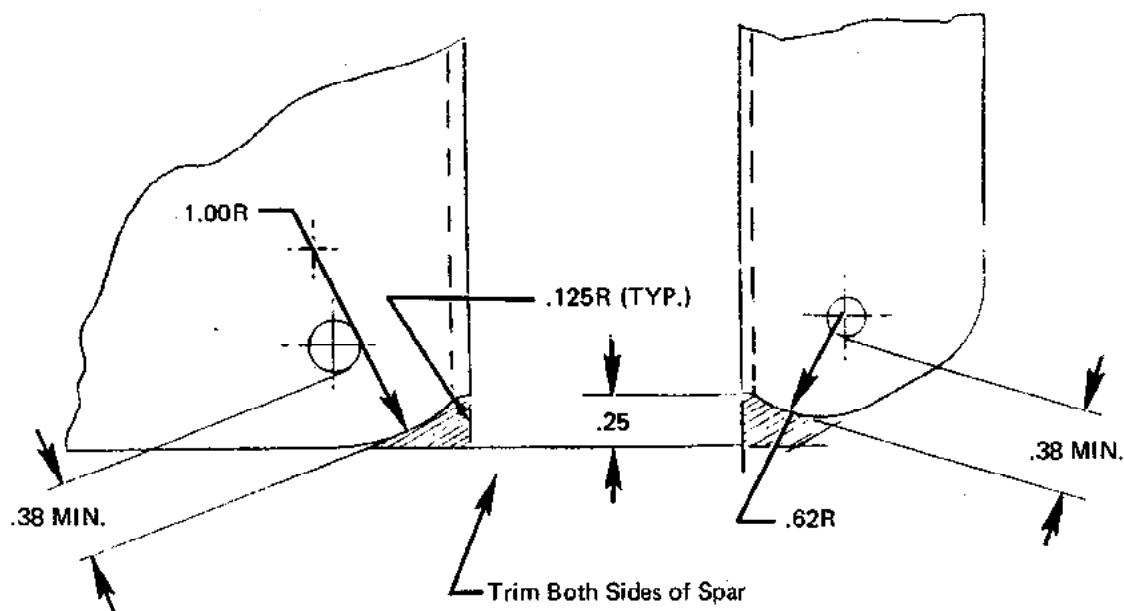
FIGURE 2

(SPAR TRIMMING DETAIL)

Refer to "Spar Trimming Detail" instructions on reverse side of this service release.

Please contact your Piper Field Service Facility to make arrangements for this modification which will simplify access to and visual inspection of the Fin lower Front Spar area.
