AIRWORTHINESS DIRECTIVES FINAL RULES: 97-01-01 R1

AD NUMBER: 97-01-01 R1

SUBJECT HEADING: Airworthiness Directives; The New Piper Aircraft, Inc. PA-24, PA-28R, PA-30, PA-32R, PA-34, and PA-39 Series Airplanes

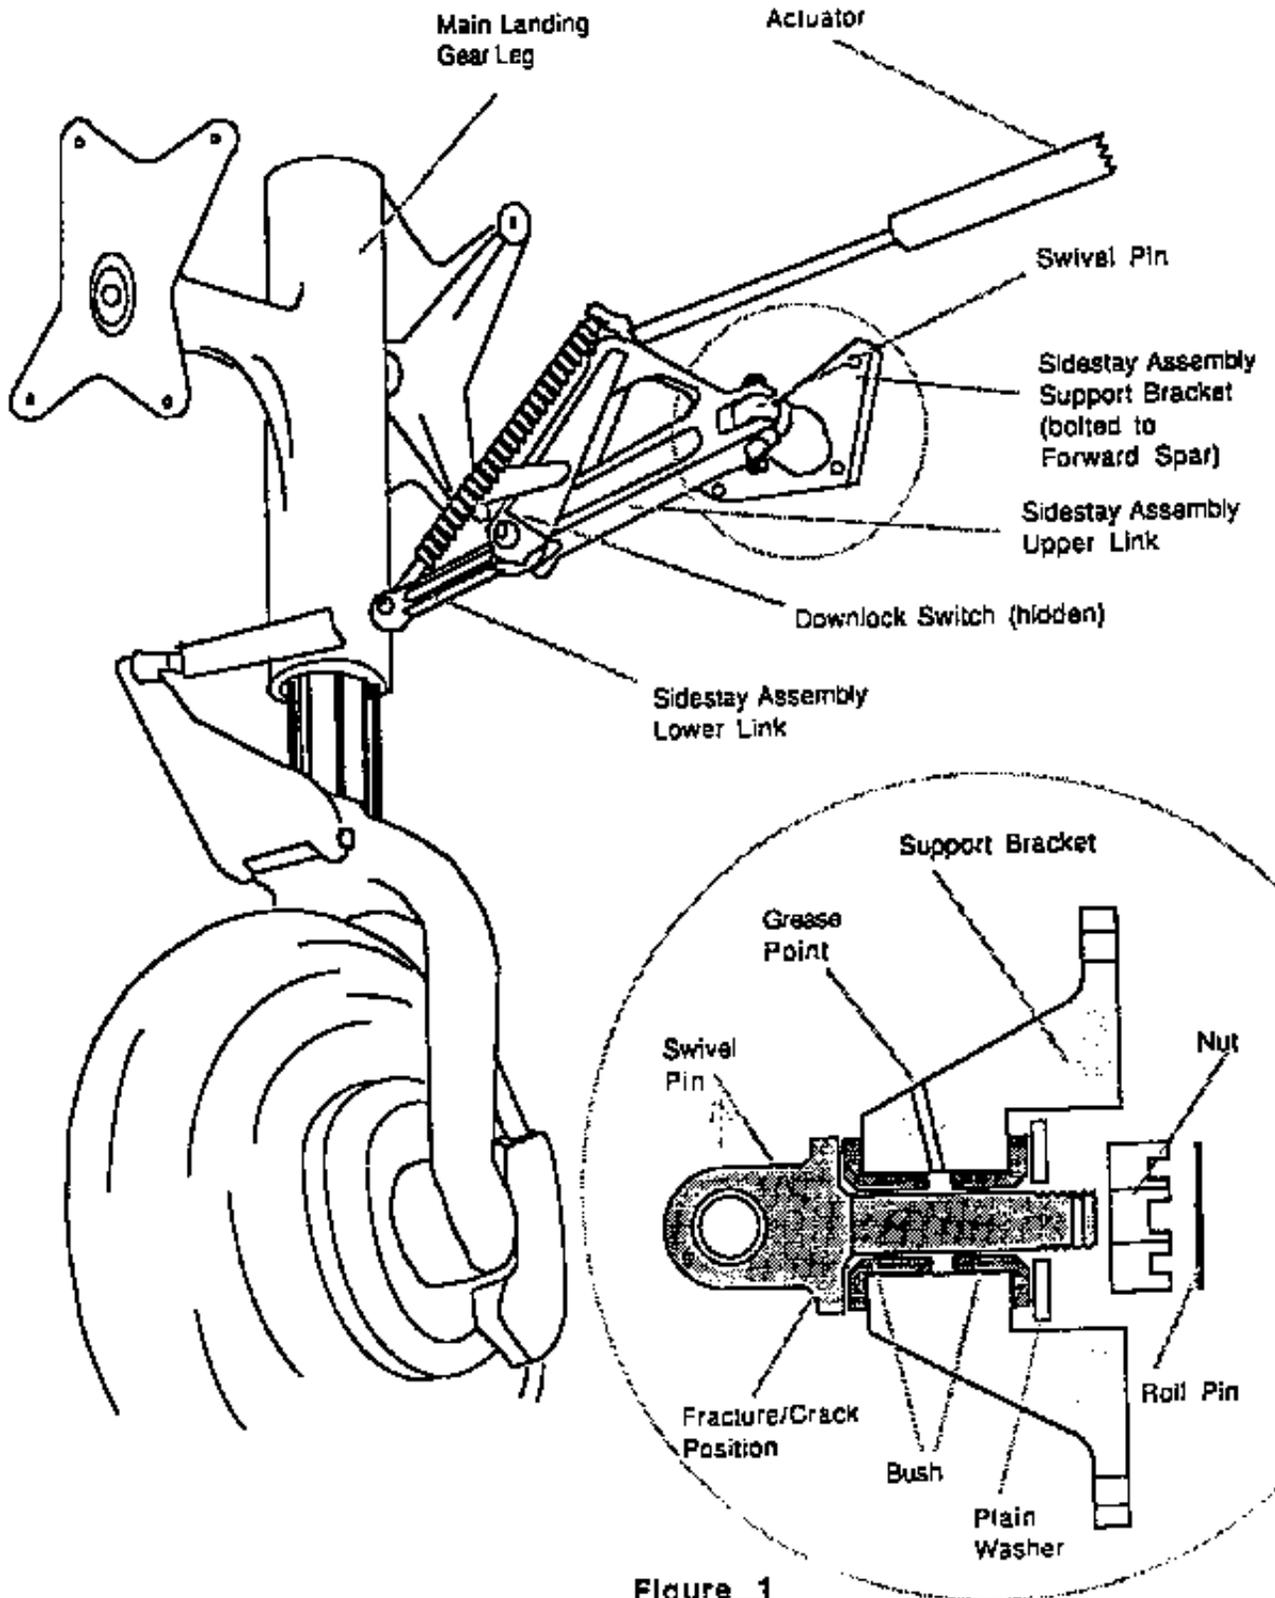
(a) Remove both the left and right main gear sidebrace studs from the airplane in accordance with the instructions contained in the Landing Gear section of the maintenance manual, and inspect each main gear sidebrace stud for cracks, using Type I (fluorescent) liquid penetrant or magnetic particle inspection methods. Figure 1 of this AD depicts the area of the sidebrace stud shank where the sidebrace stud is to be inspected.
