# SERVICE LETTER

No. 667A

Piper Aircraft Corporation

Stabilator Attachment Bolts

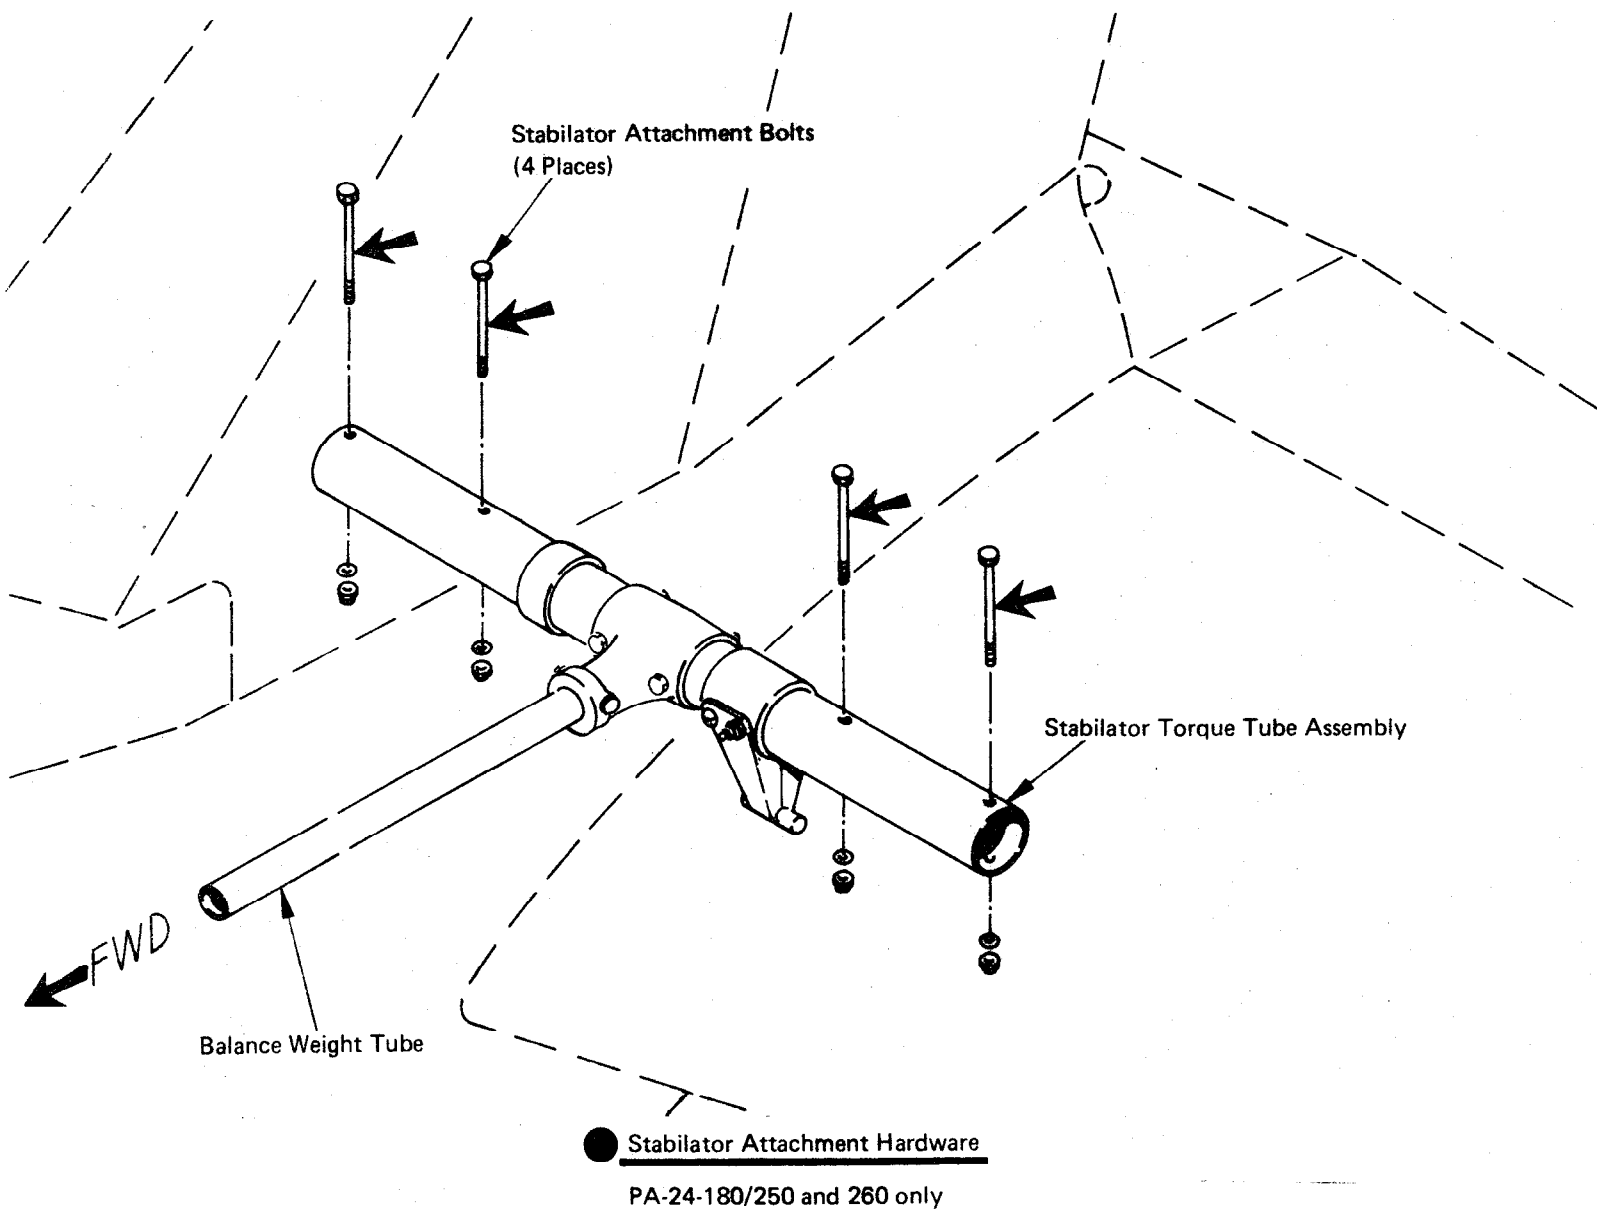
It has been determined that the stabilator attachment bolts on the above referenced aircraft may corrode. This situation has occurred primarily on high time aircraft at least five years old and/or operating in areas likely to induce corrosion -- near salt water, etc.

Remove existing stabilator attachment bolts, washers and nuts, indicated on sketch, and install new bolts and attaching hardware.  
**CAUTION:** Remove and replace one bolt at a time. Refer to sketch for correct replacement hardware identification and proper assembly of bolts, washers and nuts.

2. Correct torque value for bolts is as follows:

- a. PA-24-180/250 and 260 - torque to 30-40 inch lbs.
- b. PA-23-235/250/250 (Six Place) and PA-24-400 - torque to 60-85 inch lbs.
- c. PA-30 - Refer to the Twin Comanche Service Manual (Section 4 - paragraph 49) which states that the nuts ("holding the stabilator to the torque tube") should "be tightened just enough to take the play out of the washers."

Bolt AN174-C32A P/N 502 329 (Corrosion Resistant) or Bolt AN174-32A P/N 402 329 (Non-Corrosion Resistant)  
 Washer AN960-416L P/N 407 585  
 Nut MS20365-428C P/N 404 888

PA-23-235/250/250 Six Place, PA-24-400 and PA-30 only

Bolt AN175-C32A P/N 502 342 (Corrosion Resistant) or Bolt AN175-32A P/N 402 342 (Non-Corrosion Resistant)  
 Washer AN960-516 P/N 407 566 (PA-23-235/250 and 250 Six Place only)  
 Washer AN960-516L P/N 407 586 (PA-24-400 and PA-30 only)  
 Nut MS20365-524C P/N 404 889
