#### **14 CFR Part 39**

**[Docket No. FAA–2022–0891; Project Identifier AD–2022–00585–A,E,R;  
Amendment 39–22432; AD 2023–09–09]**

### **Airworthiness Directives; Various Airplanes, Helicopters, and Engines**

Final rule.

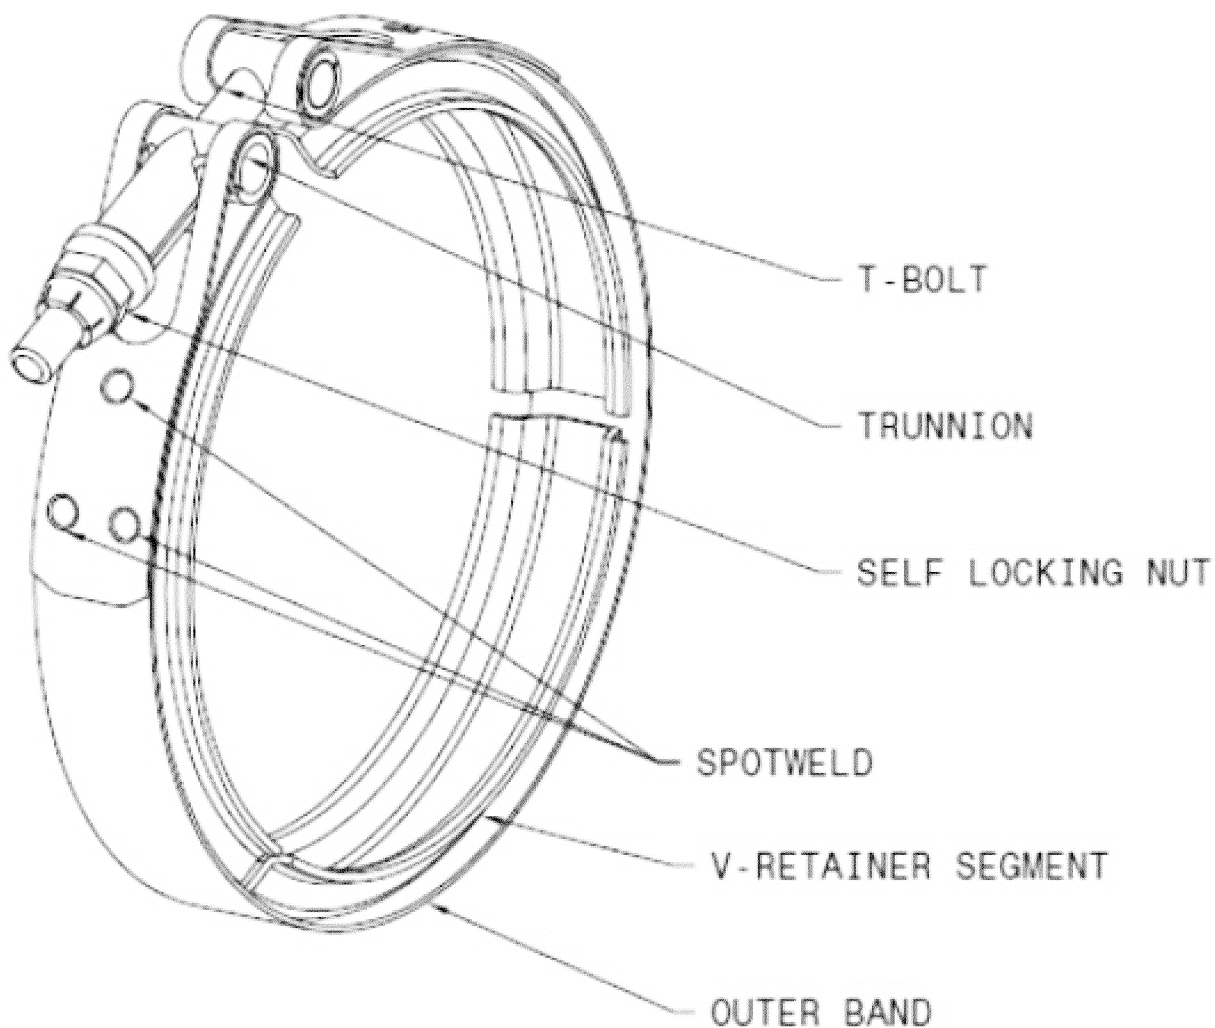
**Figure A**

The final report concluded that the common denominator in the incidents and accidents reviewed is the spot-welded, multi-segment exhaust tailpipe v-band coupling (see Figure A). These couplings come in either two or three segment varieties. The segments are the number of v-retainer segments, which are attached to the outer band via spot welds. Although multi-segment exhaust tailpipe couplings can also be riveted, the riveted couplings do not create an unsafe condition.

### **Spot-welded, multi-segment exhaust tailpipe v-band coupling**

The majority of the events studied by the working group indicated fatigue failure of spot-welded, multi-segment exhaust tailpipe v-band couplings as a result of stress corrosion cracking that originated at or near a spot weld. This is the same unsafe condition identified in the other v-band coupling AD actions previously referenced. The data studied by the working group contained evidence of pre-existing cracking of the couplings, known embrittlement at the spot weld locations simply due to that manufacturing method, and outer band cupping on the multi-segment couplings (which is the result of age, over-use, and potential over-torqueing). The working group also found that many of the couplings had safety wire across the bolt end. The safety wire could be helpful if there was a bolt or nut failure (extremely rare events) or the nut was missing. However, the safety wire was of no value when the failure was transverse band cracking and total separation at the spot weld. The data studied by the working group indicated many accidents were due to v-band couplings that were of the multi-segment, spot-welded design, when used in a specific location (the tailpipe to the turbocharger exhaust housing flange on turbocharged reciprocating engine-powered aircraft).

This condition, if not addressed, could lead to failure of the spot-welded, multi-segment exhaust tailpipe v-band coupling, leading to detachment of the exhaust tailpipe from the turbocharger and allowing high-temperature exhaust gases to enter the engine compartment. This could result in smoke in the cockpit, in-flight fire, and loss of control of the aircraft. The FAA is issuing this AD to address the unsafe condition on these products.
