# SERVICE BULLETIN

No. 496

Piper Aircraft Corporation

Stabilator Balance Weight Tube Replacement.

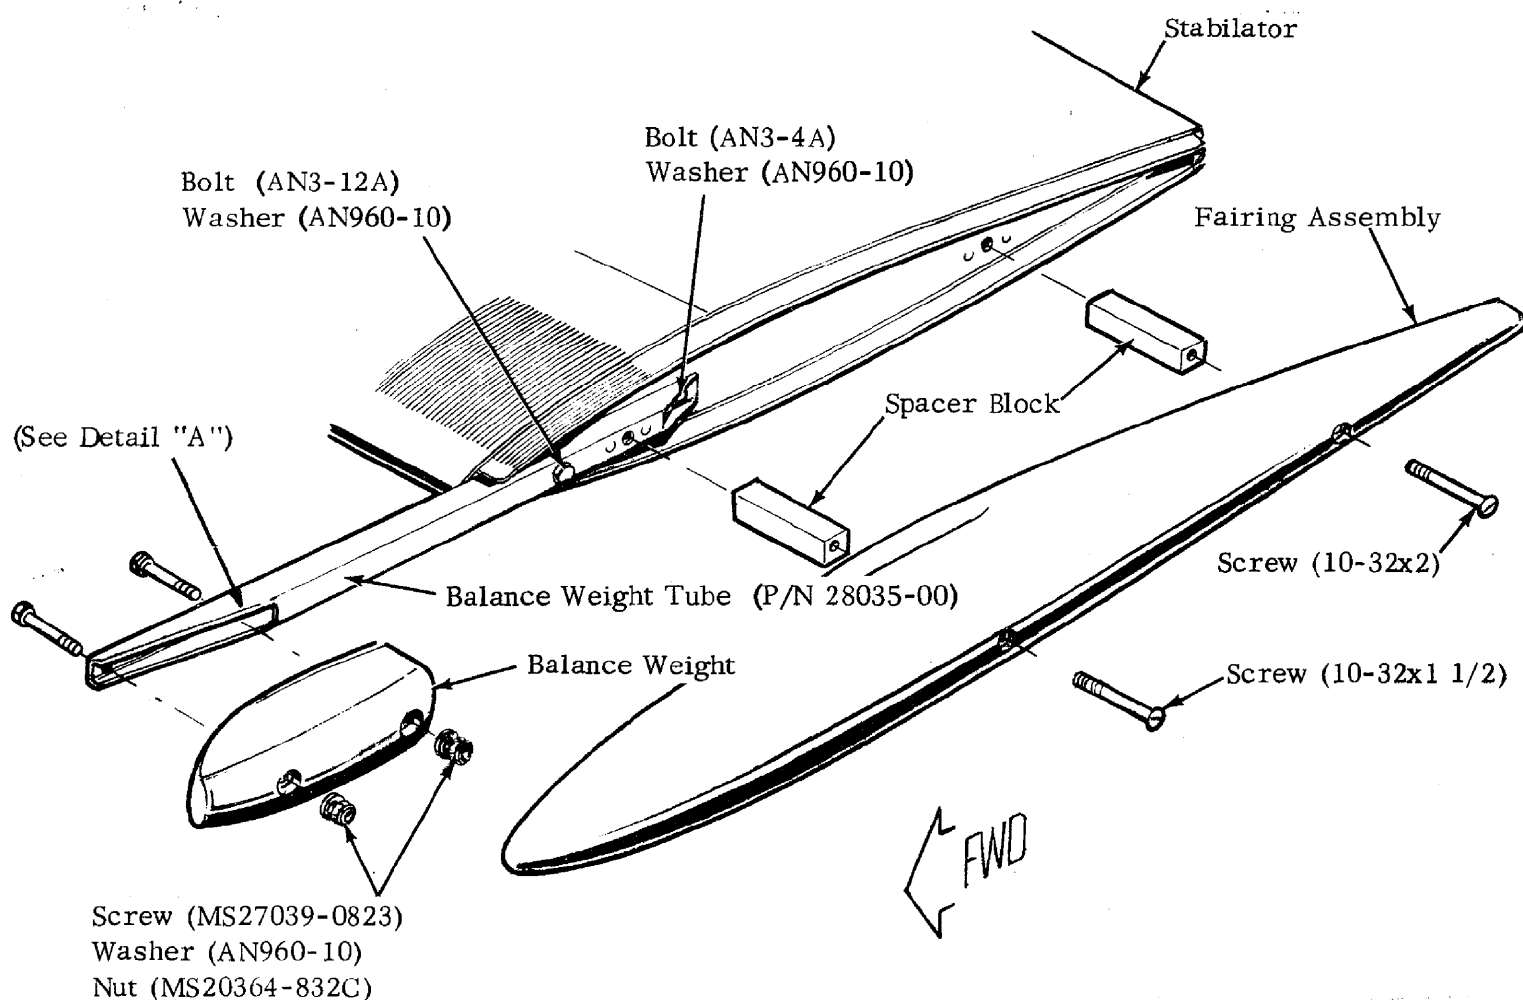
Detail "A" :

Piper Service Letter No. 687 dated June 19, 1974, announced the availability of Stabilator Modification Kit Piper Part Number 760 747 for the above referenced aircraft. Recent factory testing indicates that cracks may develop in the stabilator balance weight tube assembly (part number 28035-00, supplied with the above referenced modification kit) in the corners of the balance weight cutout.

Previous Tube - "squared" corners

New Tube - rounded cutout

This service release provides material to replace the stabilator balance weight tubes on aircraft that have had stabilator modification kit, Piper part number 760 747 previously installed. New stabilator balance weight tubes are provided and are redesigned with a reshaped balance weight cutout (radius cut corners) to preclude corner cracks.

1. Remove fairing assembly and balance weight from left and right stabilators.
2. Remove existing balance weight tubes and install new tubes P/N 28035-00.  
Torque bolts to 20-25 inch pounds.
3. Reinstall balance weight and torque screws to 7-9 inch pounds.
4. Reinstall fairing assembly.
5. Make appropriate log book entry.
