## SERVICE BULLETIN

DATE: December 1, 1997 Service Bulletin No. 505B (Supersedes  
Service Bulletin No. 505A) Engineering  
Aspects are FAA Approved

SUBJECT: Inspection of Crankshaft I.D. for Corrosion

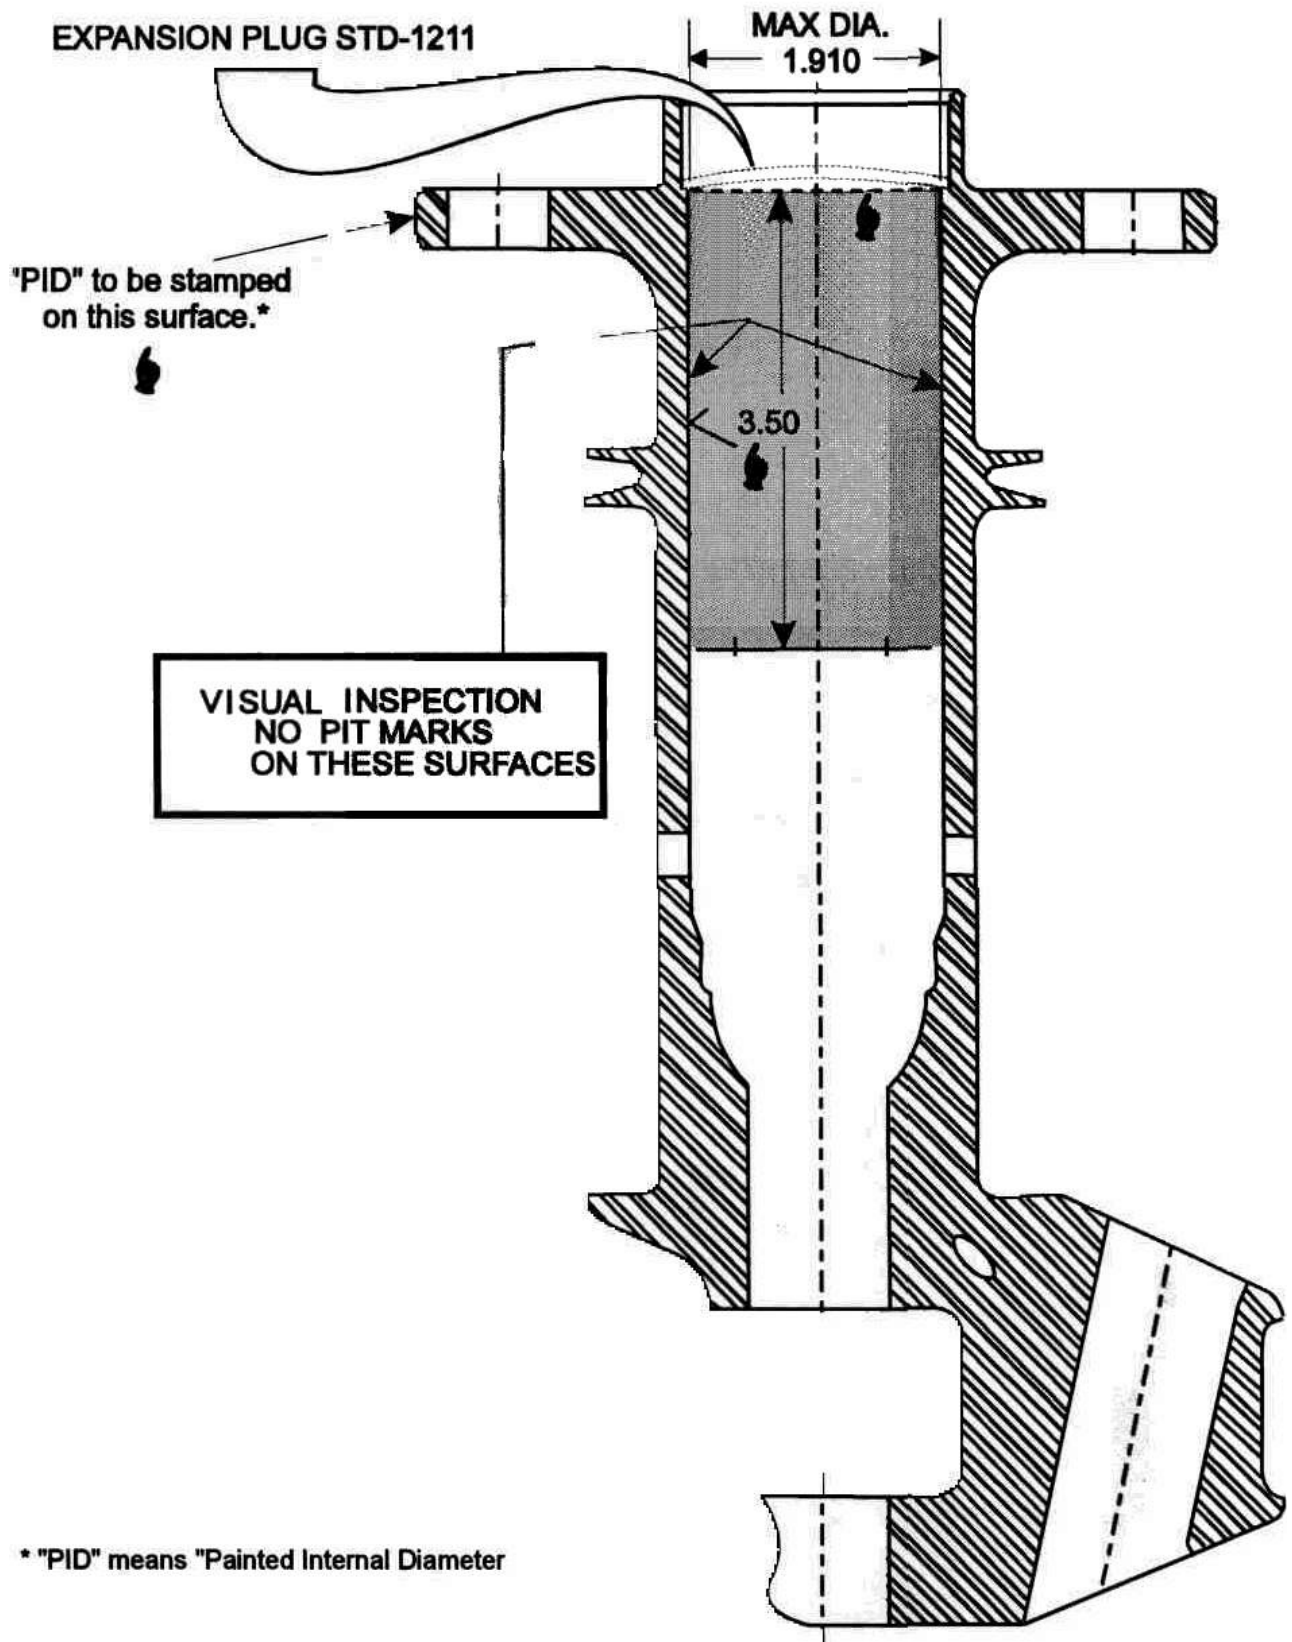
Figure 1. Area to be Inspected

TIME OF COMPLIANCE: **Uncoated Crankshafts (no "PID" stamped on flange OD, see Figure 1)**

- e. Make a visual inspection from the crankshaft flange inward using a flashlight and magnifying glass (power 4x). A small, right angle, dental examination mirror might be helpful. The above defined area should be clear of pit marks and corrosion.
- f. If during visual inspection any pitting resulting from corrosion is found, the crankshaft must be removed from service immediately or subjected to FPI according to Section II of this Service Bulletin on page 3. Removal of corrosion results in a clean surface that may have an irregular appearance indicated by slight waviness. This condition is deemed acceptable provided the maximum allowable diameter has not been exceeded. Pitting is characterized by holes or fissures of indeterminate depth and direction.

- a. Remove the propeller in accordance with the manufacturer's instructions.
- b. Remove expansion plug (P/N STD-1211) (if installed) from end of crankshaft by piercing a 1/8" to 3/16" hole in center of plug.
- c. Measuring in from the crankshaft end, clean the first 3.50 inches of the inside crankshaft wall behind the expansion plug seat.
- d. Remove surface corrosion using a suitable tool which will follow the existing contour of the I.D. and fine abrasive cloth (see Figure 1). Prior to removing the corrosion, precaution must be taken to ensure that the material removed cannot contaminate the engine.

SURFACE CORROSION MUST BE REMOVED UNIFORMLY FROM THE CRANKSHAFT I.D. BUT THE I.D. CANNOT EXCEED 1.910 INCHES.
