# Francois's Hangar

## Gear inspection (AD 77-13-21 Part A)

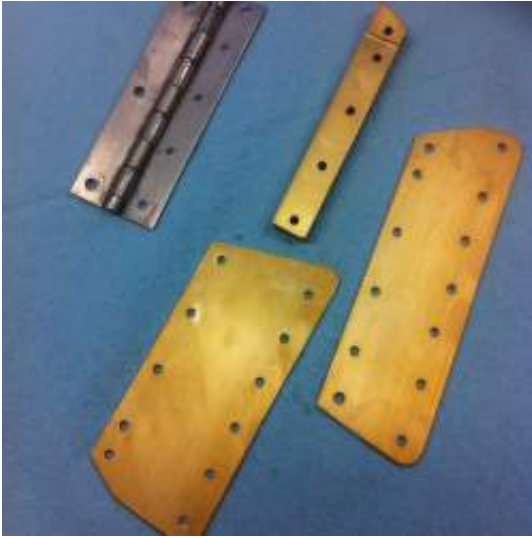
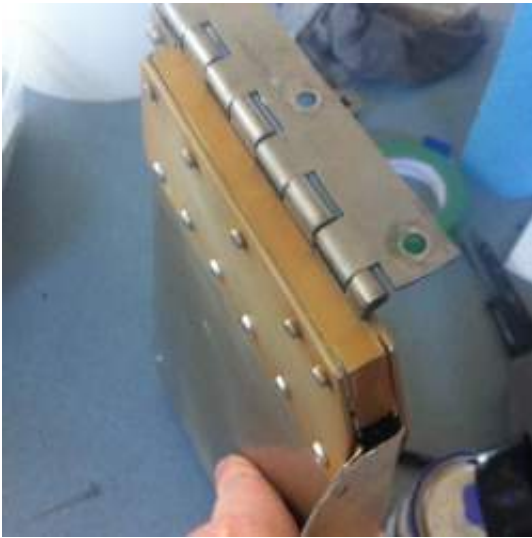
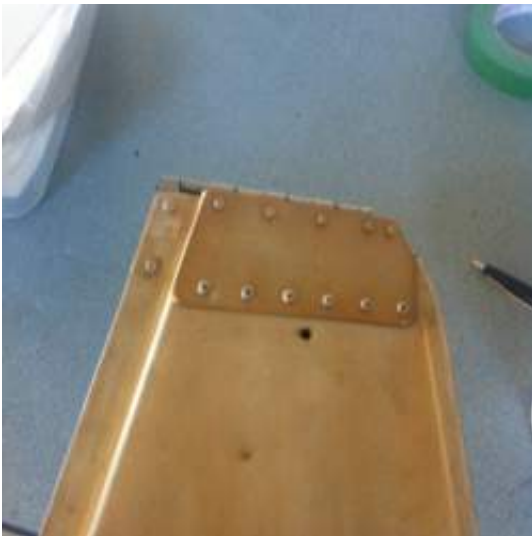
Landing gear doors tend to also take a beating. While I did the conduits, some time ago, I made the hinges tighter by drilling a #30 hole and inserting a 1/8 SS welding rod as the hinge pin. That made the door much stiffer and I did not pay much attention to them after that. However, stripping them led to discover other issues that needed attention. A few pictures are worth a proportional number of words on the quality of these repairs...

Yikes. Redoing the ugly patch plates (albeit re-using the same unaligned holes on the door portion) and with a mill I re-fabricated the spacer block, it yielded something like this:

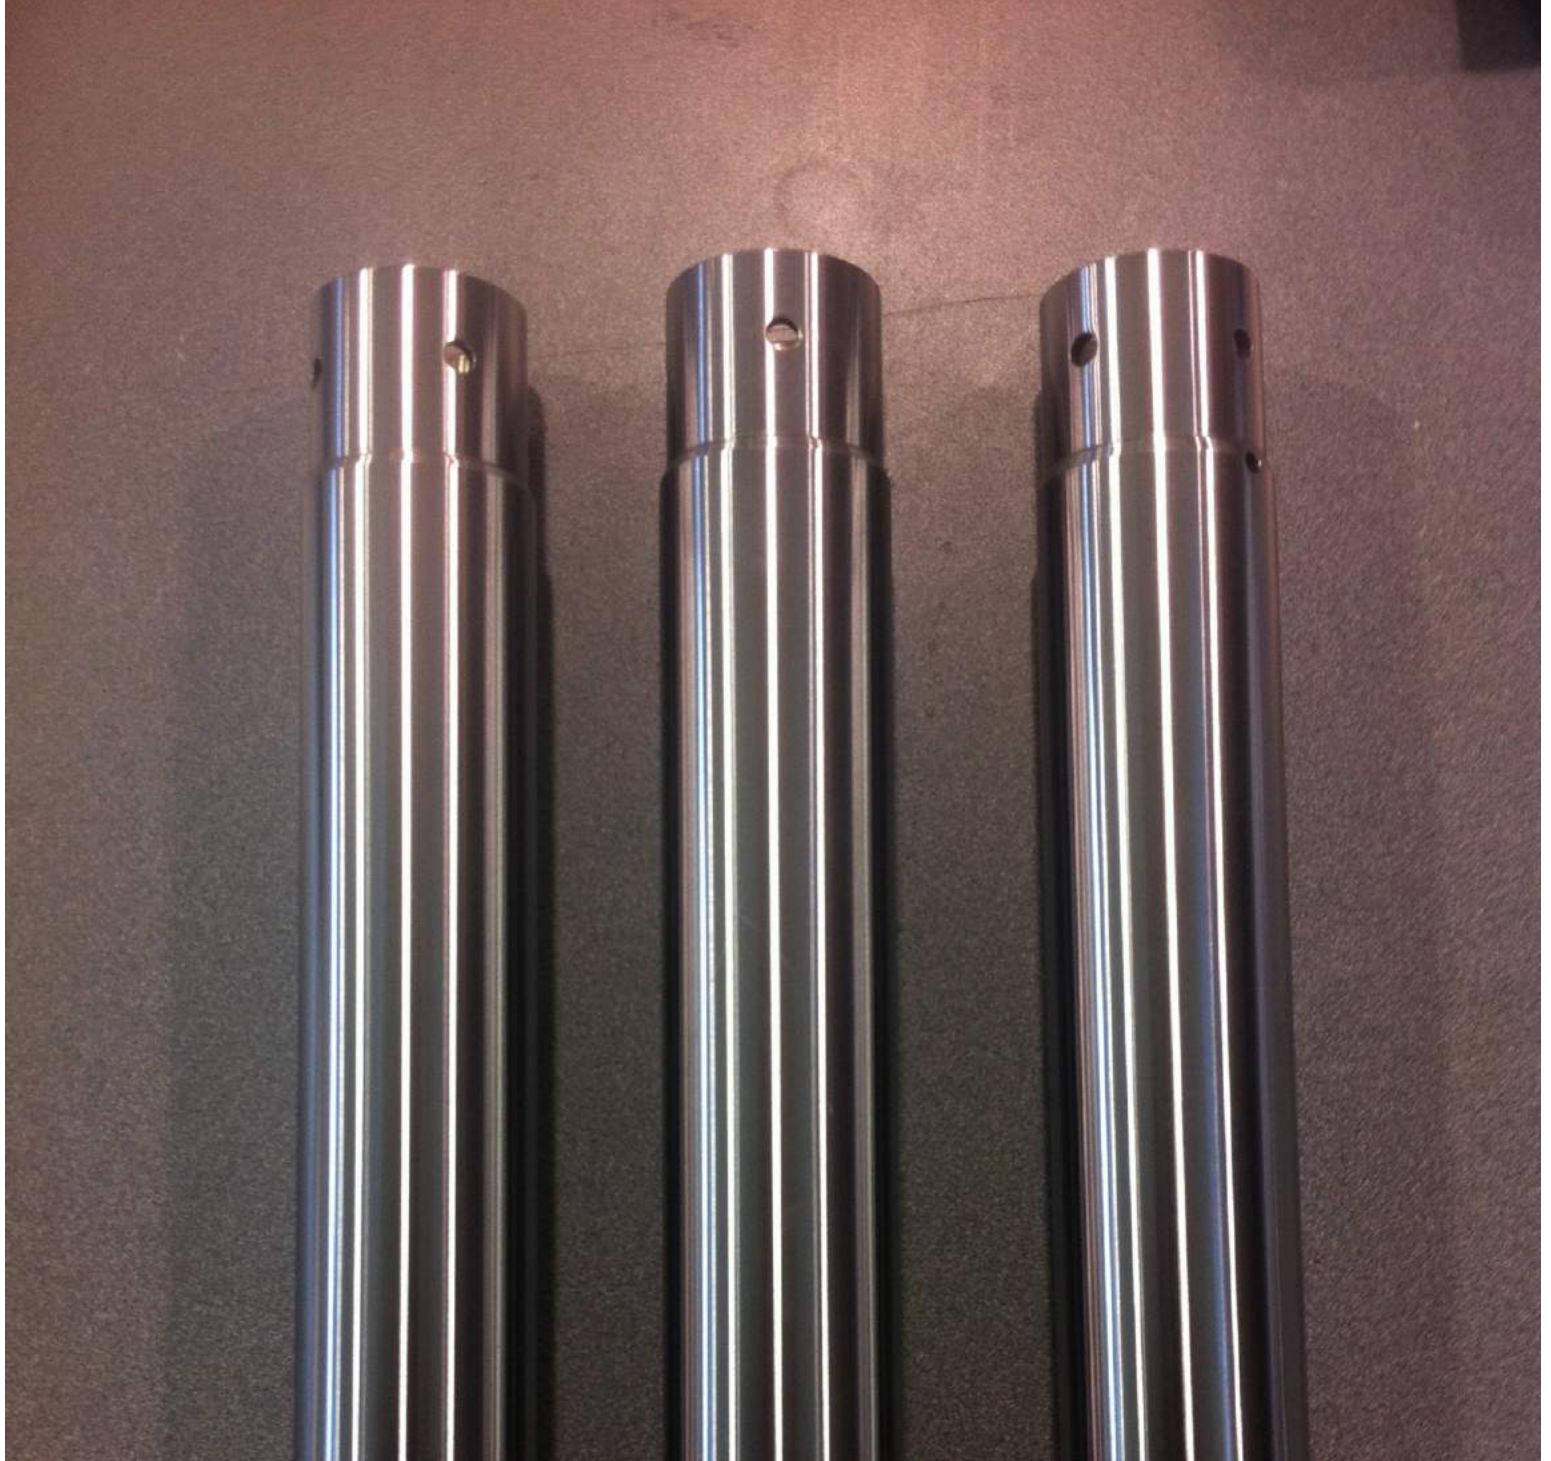
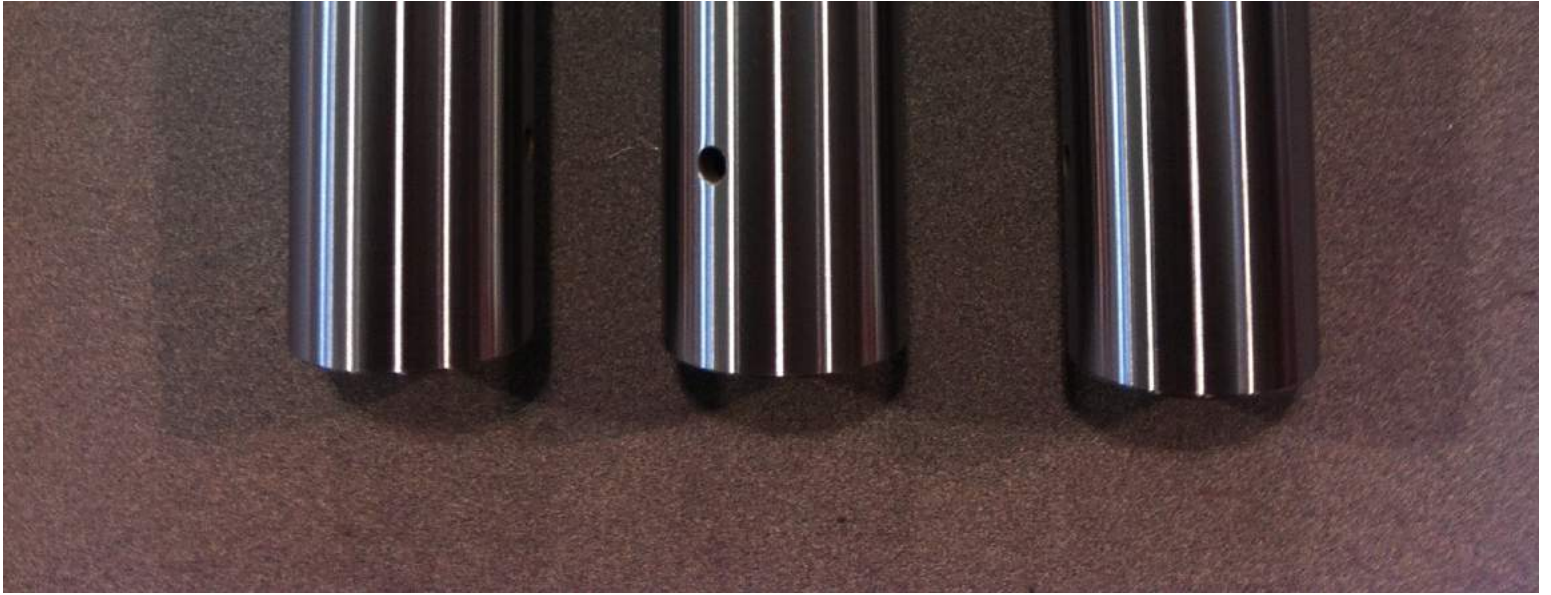
This is typical of a 10-20 year old oleo. Pitting and corrosion. So Off they must go. Wait. Identify and index the parts before parting them-out. These are match drilled. If the fit is so-so in the leg, one can always re-index them and precision re-drill, but chrome plated steel is a pretty tough material to get through. I elected to stamp a number underneath the leg where the holding bolt head is (yes there is a direction) and dremel-out a corresponding number of notches on the end of the sleeve. Putting the leg in a padded vise, a propane torch was sufficient to break the interference fit.

What I found-out also is that two of the legs (the nose and left gear) were not straight. I can't recall the out of straightness value, but that was in the order of 0.020". So.... that had to go for overhaul with a note. A bit of caution here: There are a few certified shops to doing such work, but also other outfits who are specialized in the hydraulic actuators and for the printing machinery who are used to work on much tighter tolerances. They all can rectify and re-grind cylinders, the real challenge is they must know and understand the mechanical relationships of where there is to be an interference

fit and so on. The nose oleo also has an inside piston/ring that must be properly fitted. Bottom line, my take is to pick someone knowledgeable on the parts and where they go. Anyhow the folks at Montreal Chrome were very knowledgeable and did a fabulous job. They successively ground re-plated a number of times to bring back the straightness, as they measured the interior and it was perfectly straight. Also, the interference fit dimensions were right on. They took care to plug the holes where the pins and the close tolerance bolts go as not to gift me of another fight later on. CDN\$ 375 (USD225) a piece was the damage. Not bad.

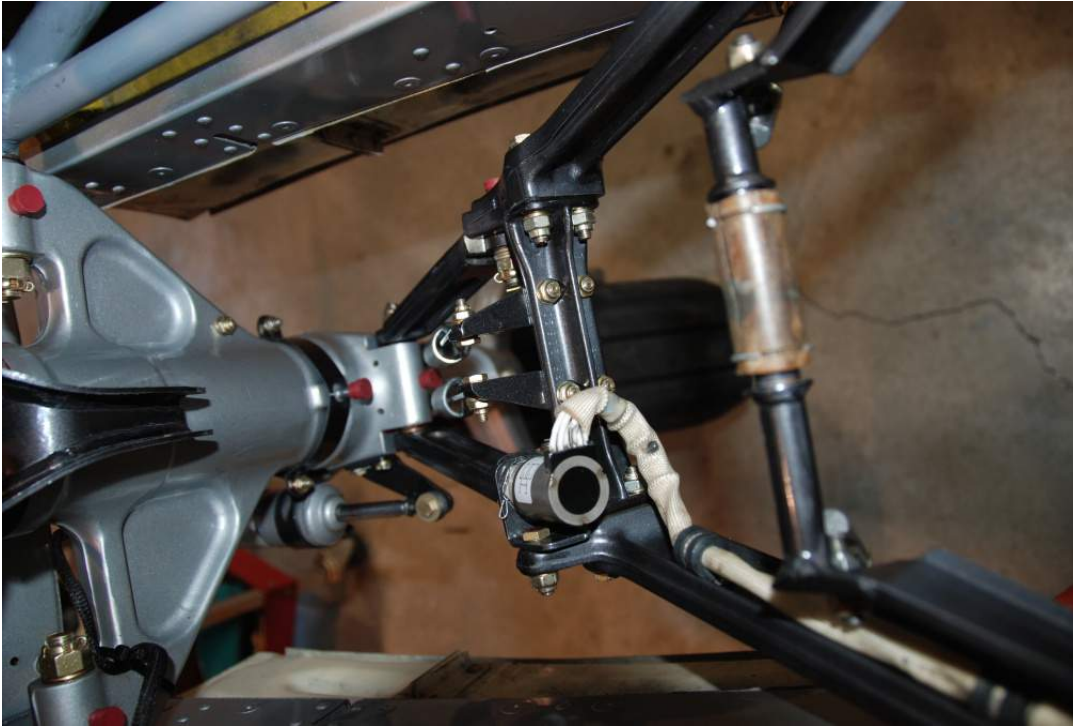
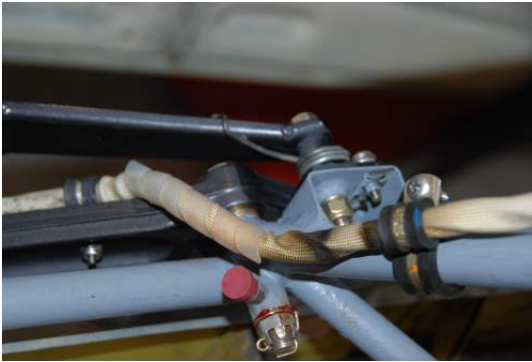
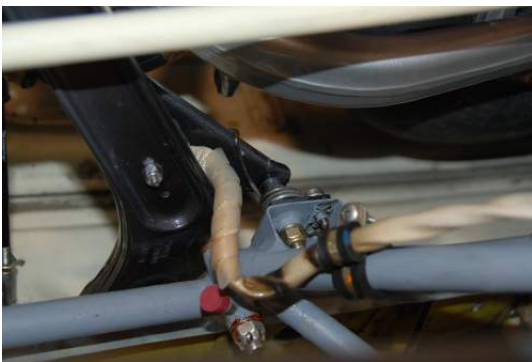
The nose wheel switch cable has a unique routing to go through. I've seen so many variations of it... This is the way it should go:

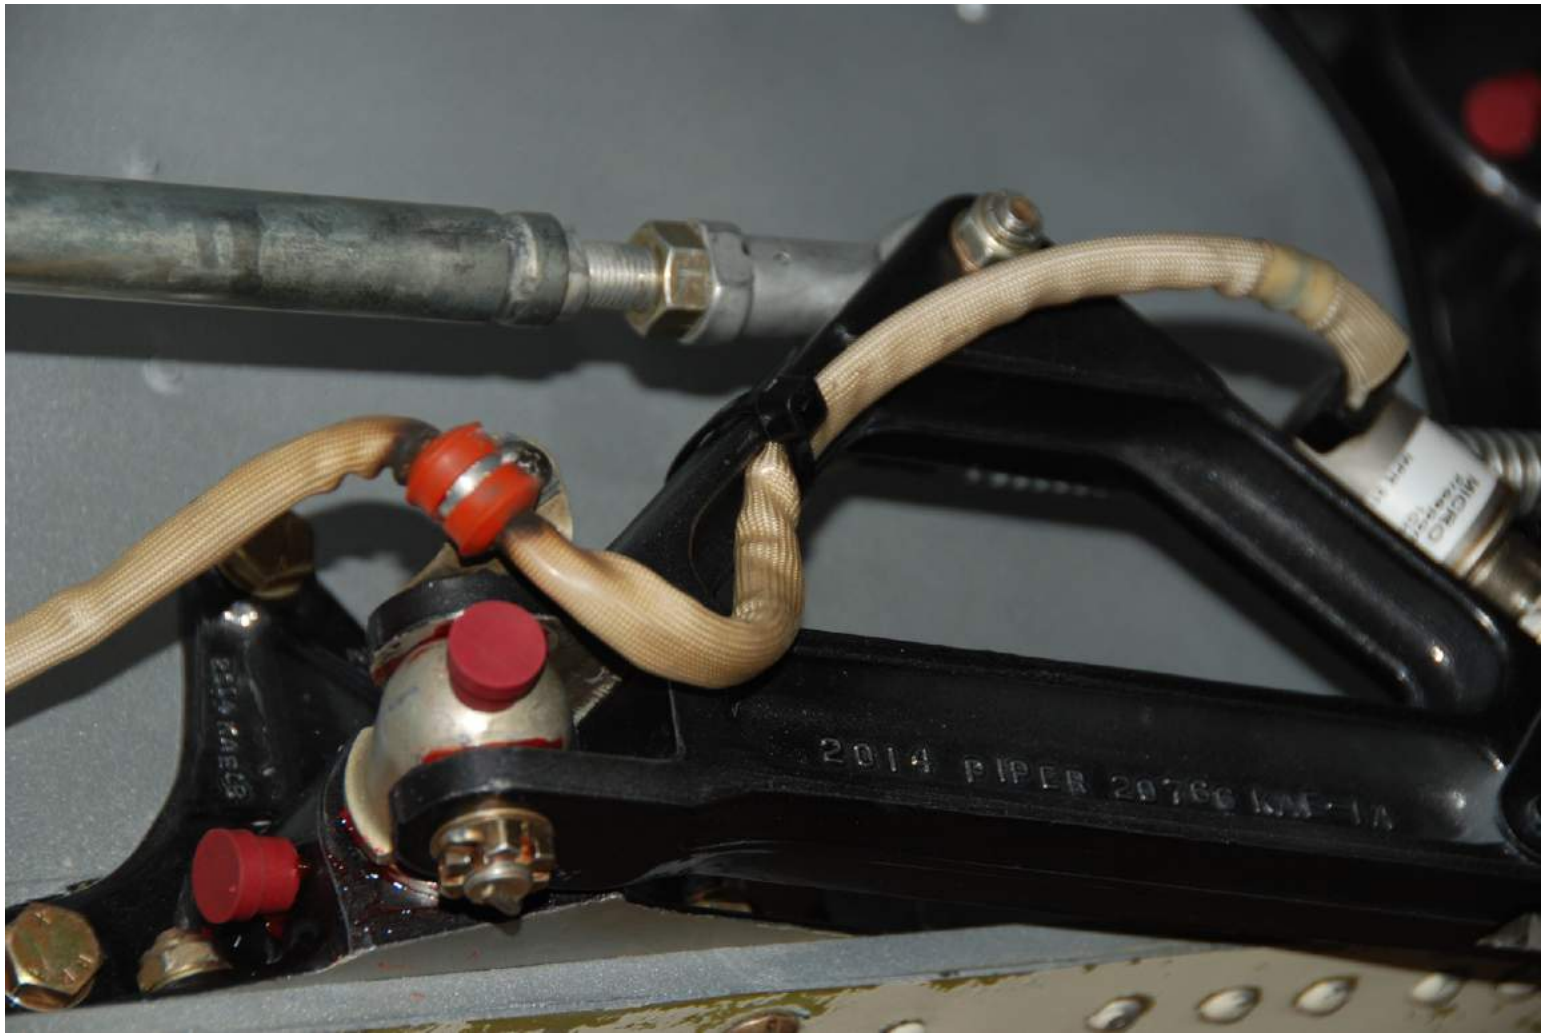
While on that subject, the same applies to the cable for the main gear switches. The proper way is like following. Out of the left of picture is he cable is also attached to the top of the trapezoidal member with an adel clamp.

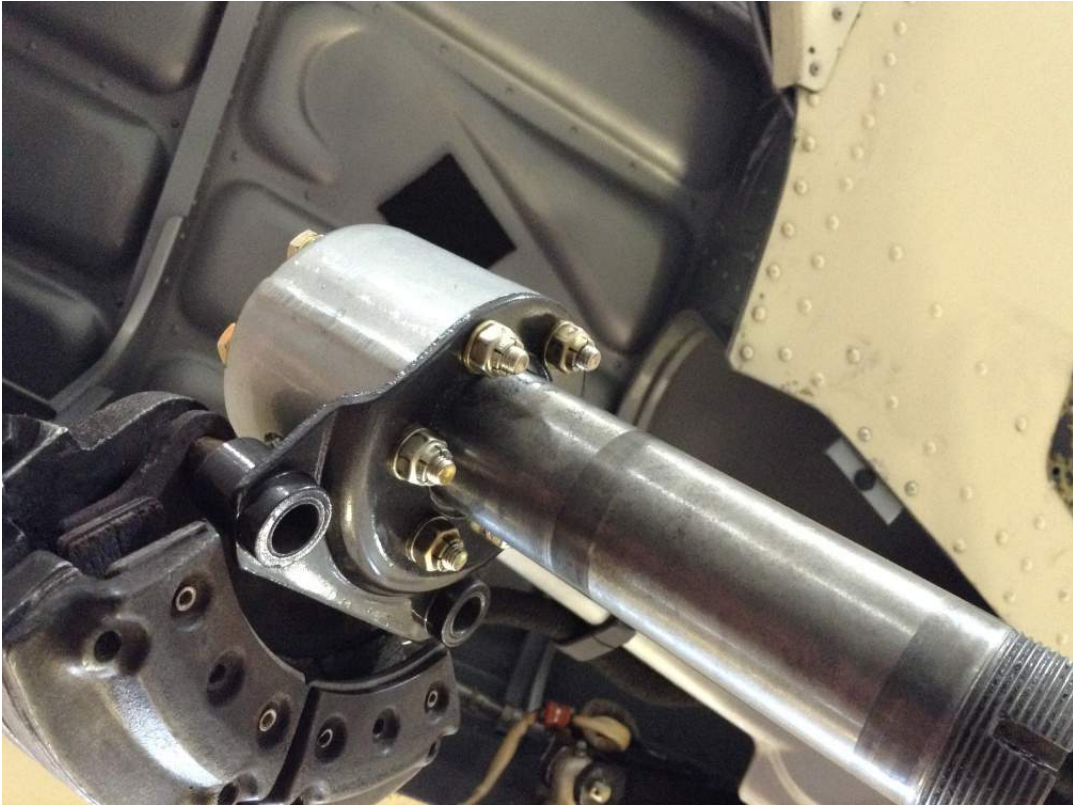
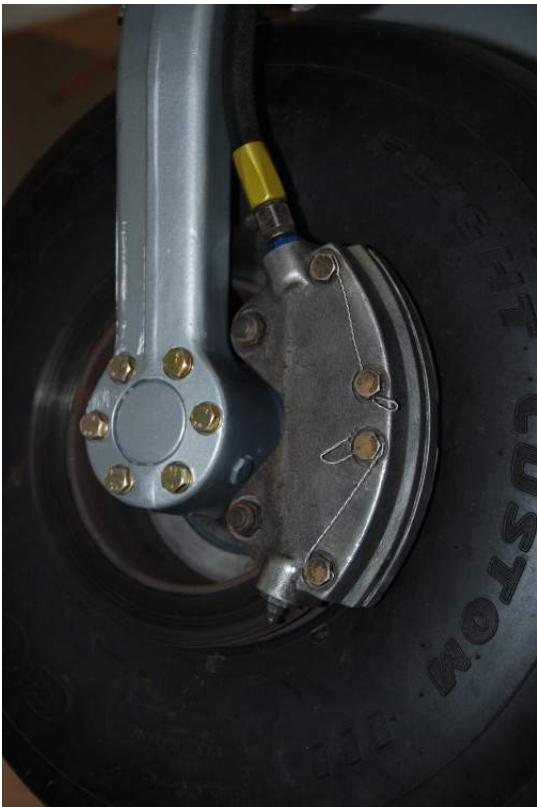
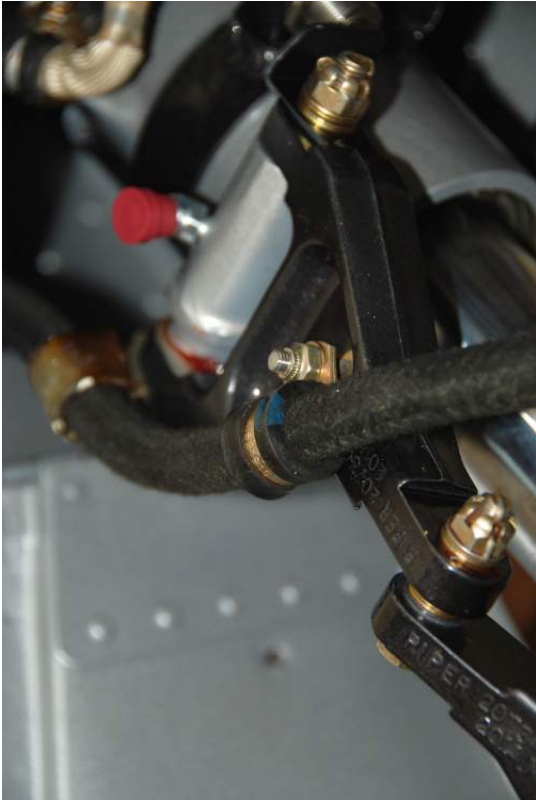
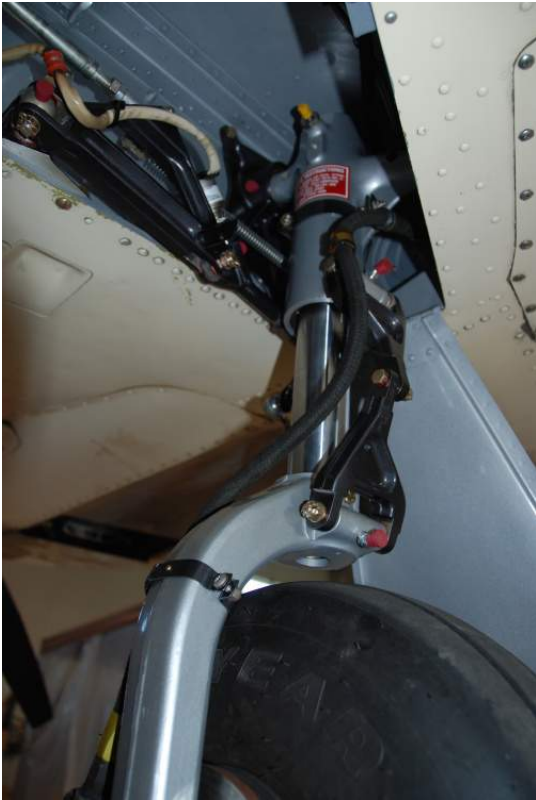
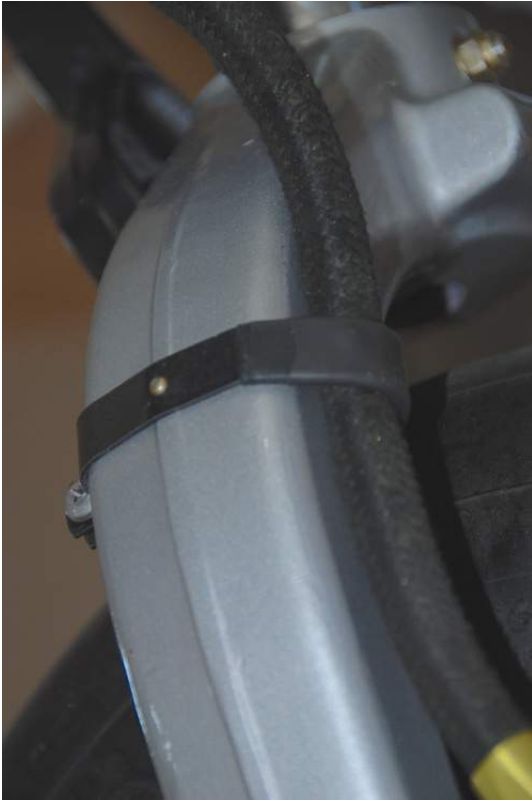
New brake lines, new tires&tubes, new brake linings completes the endeavour. Note the brake line routing. Again, this is the only way they should be routed. Note for the brake line leg strap, I used heat shrink tubing, but the variety that is UV resistant (and has glue inside). The wall are much thicker than the normal electronics variants and they should age well.

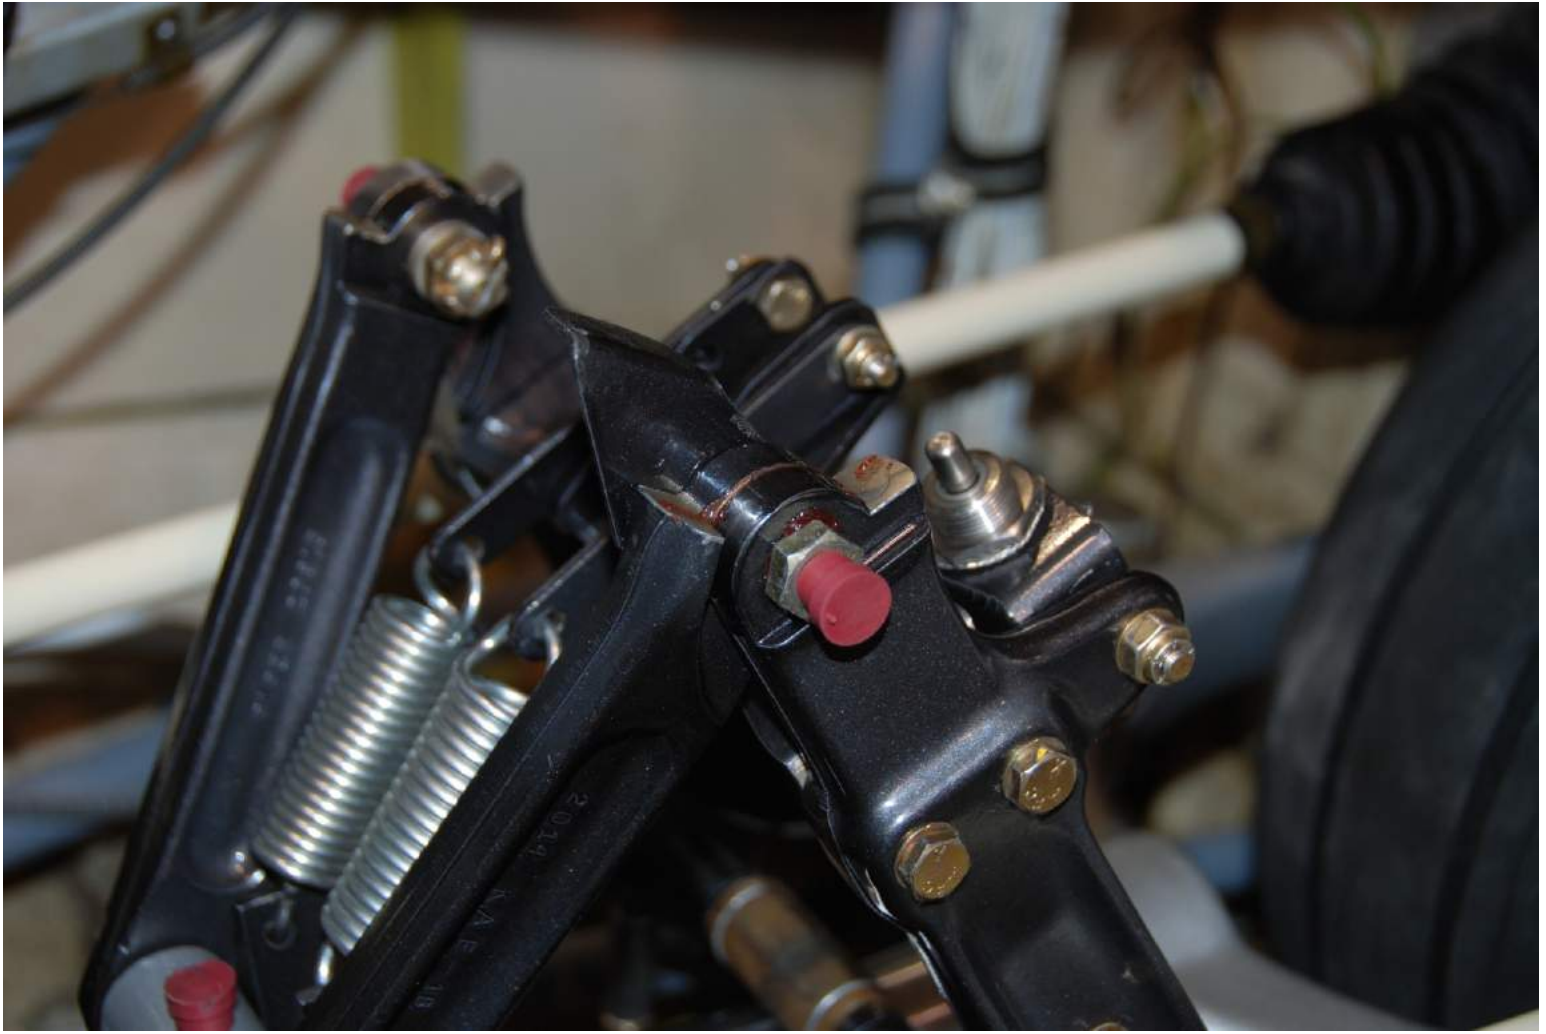
This is the dreaded part. The SM is so vague as how to do the adjustments that some common sense is required here. The goal is to have the switches to click in the over center position. Not on top, not before but after the overcenter position is reached. With the sidebar stud clevis removed and the rest of the assembly in position, it is easy to feel the overcenter position. It is also relatively easy to sense whenever we are past that point and also the end of the travel. The goal is to have the switch trigger about 1/8 inch past the neutral point. That would be very close if not on to the endpoint. This is where the switch must be set. A few trial and errors should suffice to reach the point. Any lock washer should be placed on the switch exterior jamnut. The inboard can be secured using lock wire against the outer one. For the nose gear, we are looking for 3/16 past the neutral point and is best done with both the springs and pushrod disconnected. This was in my case very much on the endpoint of the arms.

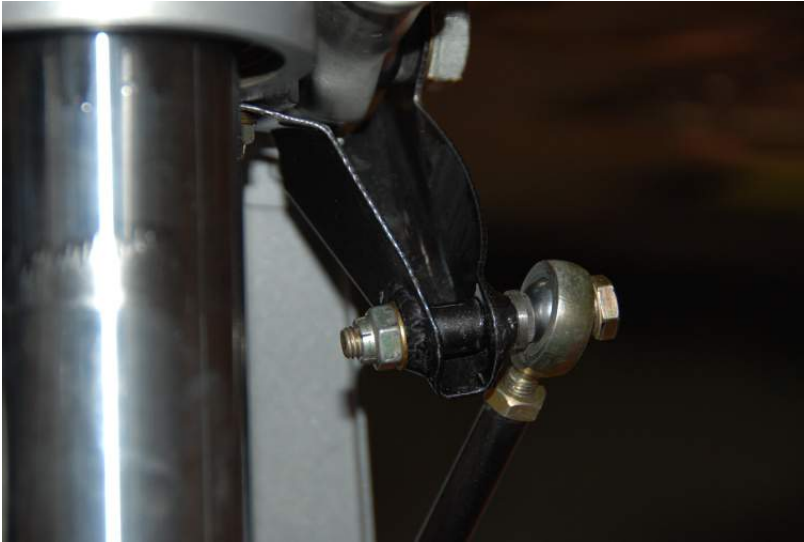
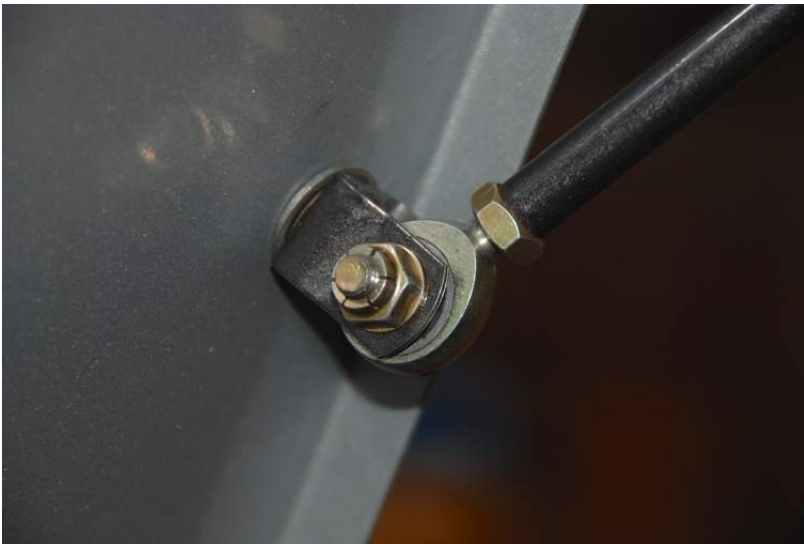
The up limit switch will also require adjustment and the SM describes the method to do that. The transmission can be re-connected and the gears swung. The gear doors that can now be re-rigged as per the SM.

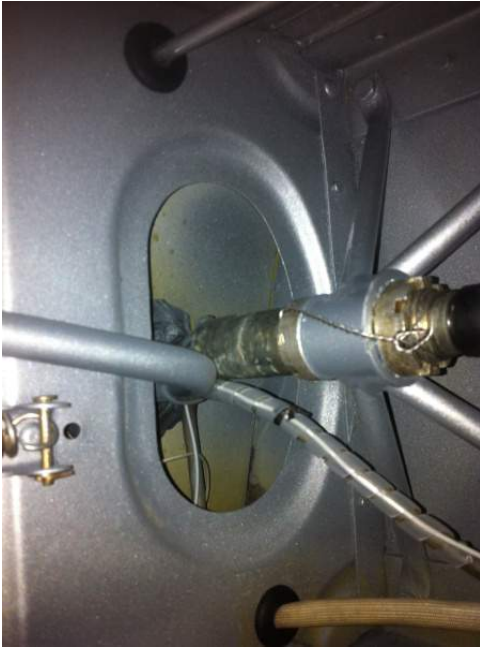
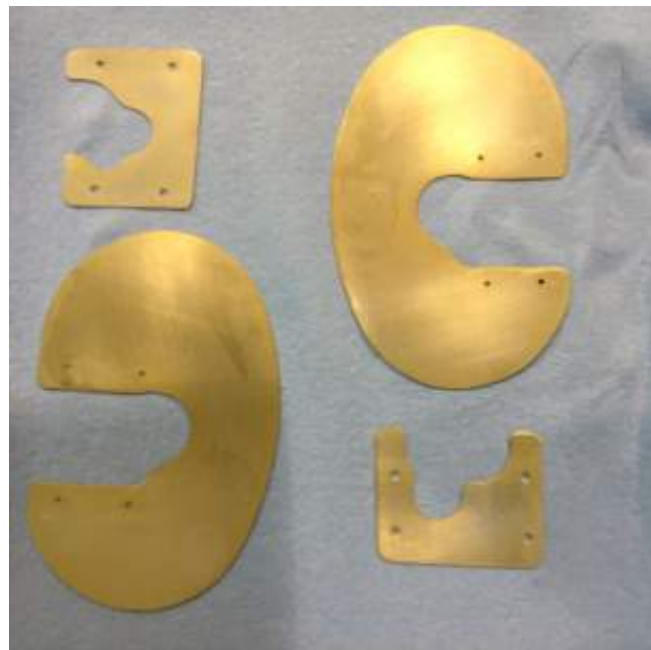
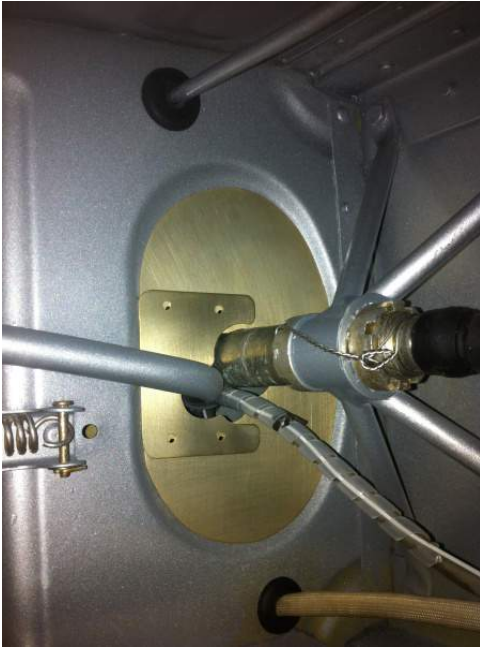
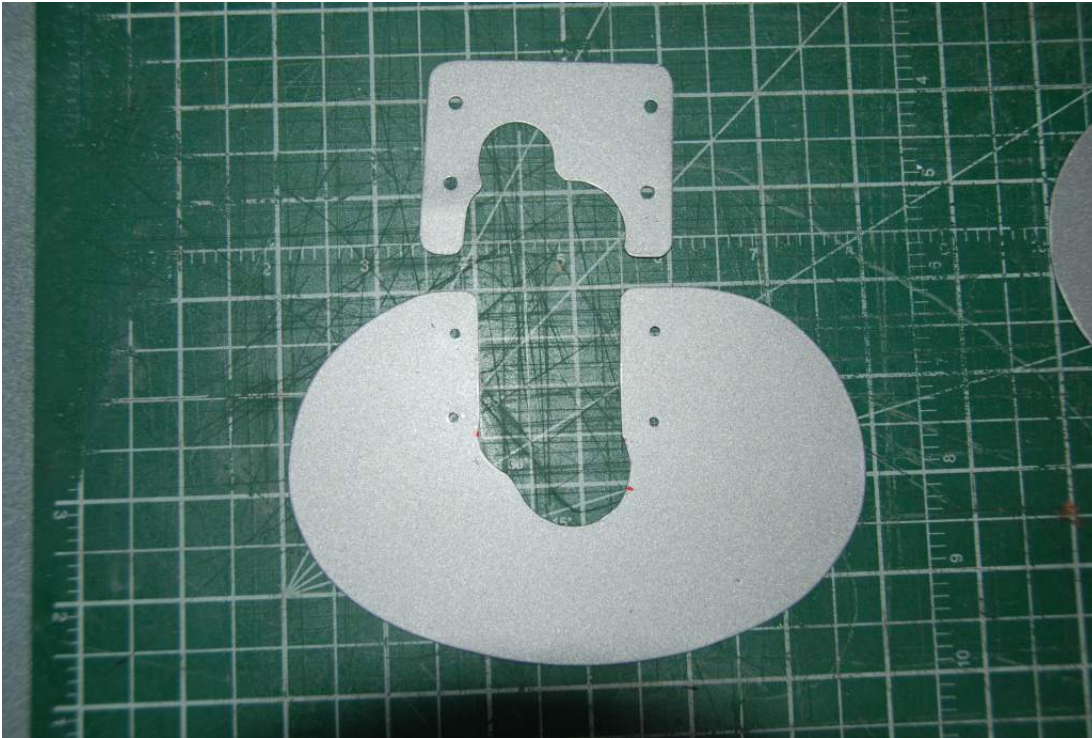
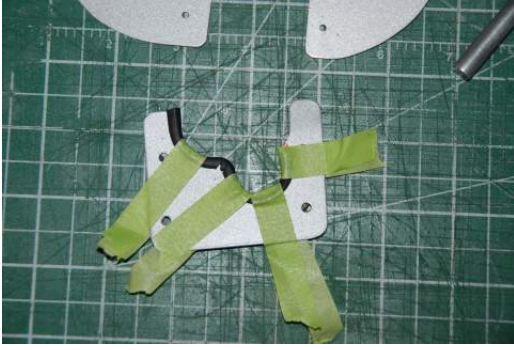
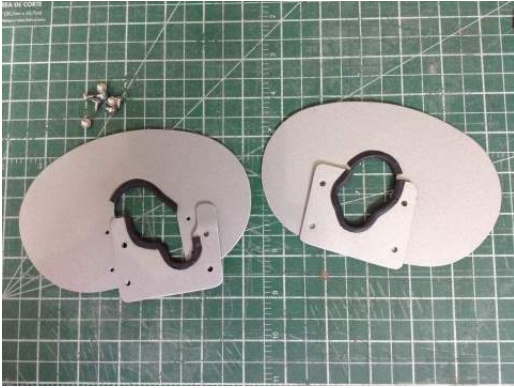
I elected to do some closeout on the gear wells. Particularly where the conduits and a few cables goes out. The kidney shaped plates are glued with a dab of silicone. Here are some pictures of their construction and the actual finish.
