## VENDOR SERVICE PUBLICATION

**SUBJECT:** **SLICK (CHAMPION AEROSPACE) SERVICE BULLETIN SB1-19,  
'MANDATORY INSPECTION OF IMPULSE COUPLED SLICK MAGNETOS'**

**SUBJECT:** Mandatory inspection of impulse coupled Slick magnetos

Service Bulletin No. 637  
Engineering Aspects are  
FAA Approved

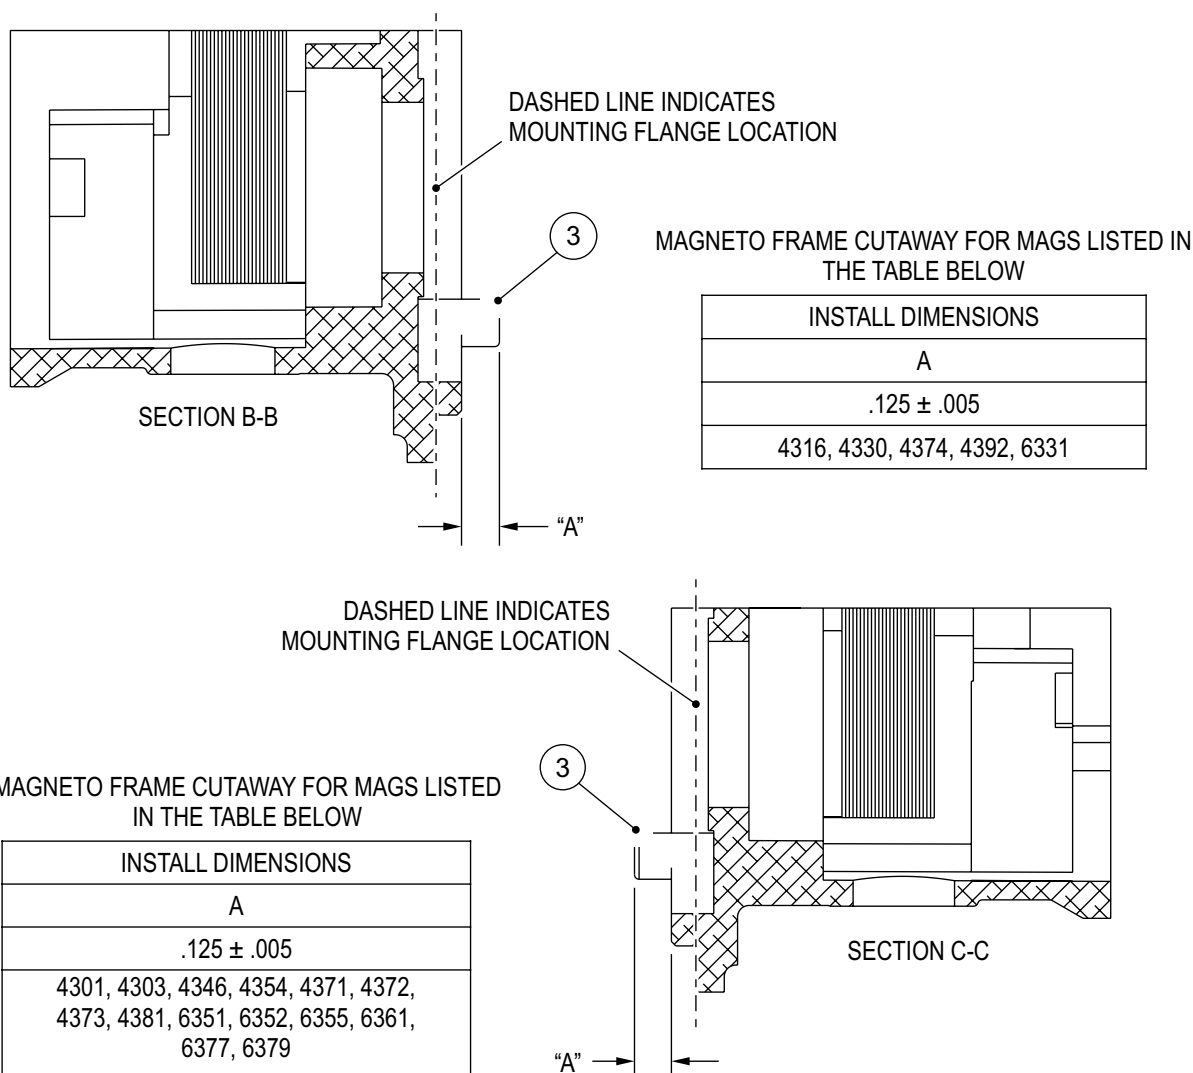
**FIGURE 1. MAGNETO FRAME CUTAWAY SECTIONS B-B AND C-C**

USE A CALIBRATED MEASURING DEVICE TO MEASURE DISTANCE "A", AS SHOWN IN CUTAWAY SECTIONS B-B AND C-C. MAKE SURE THE FRAME SURFACE IS FREE OF CONTAMINANTS. ANY MEASUREMENT GREATER THAN 0.130 INCH OF ANY PART OF THE STOP PIN (3), THE MAGNETO SHOULD BE REMOVED FROM SERVICE AND RETURNED TO CHAMPION FOR WARRANTY.

- B. Inspect the magneto to confirm the necessary recess/projection (based on individual magneto type) of the stop pin. If the stop pin installation depth is not in compliance with the dimension shown in Figures 1 through 6, the magneto must be replaced with a new or serviceable unit that is in compliance with this service bulletin.

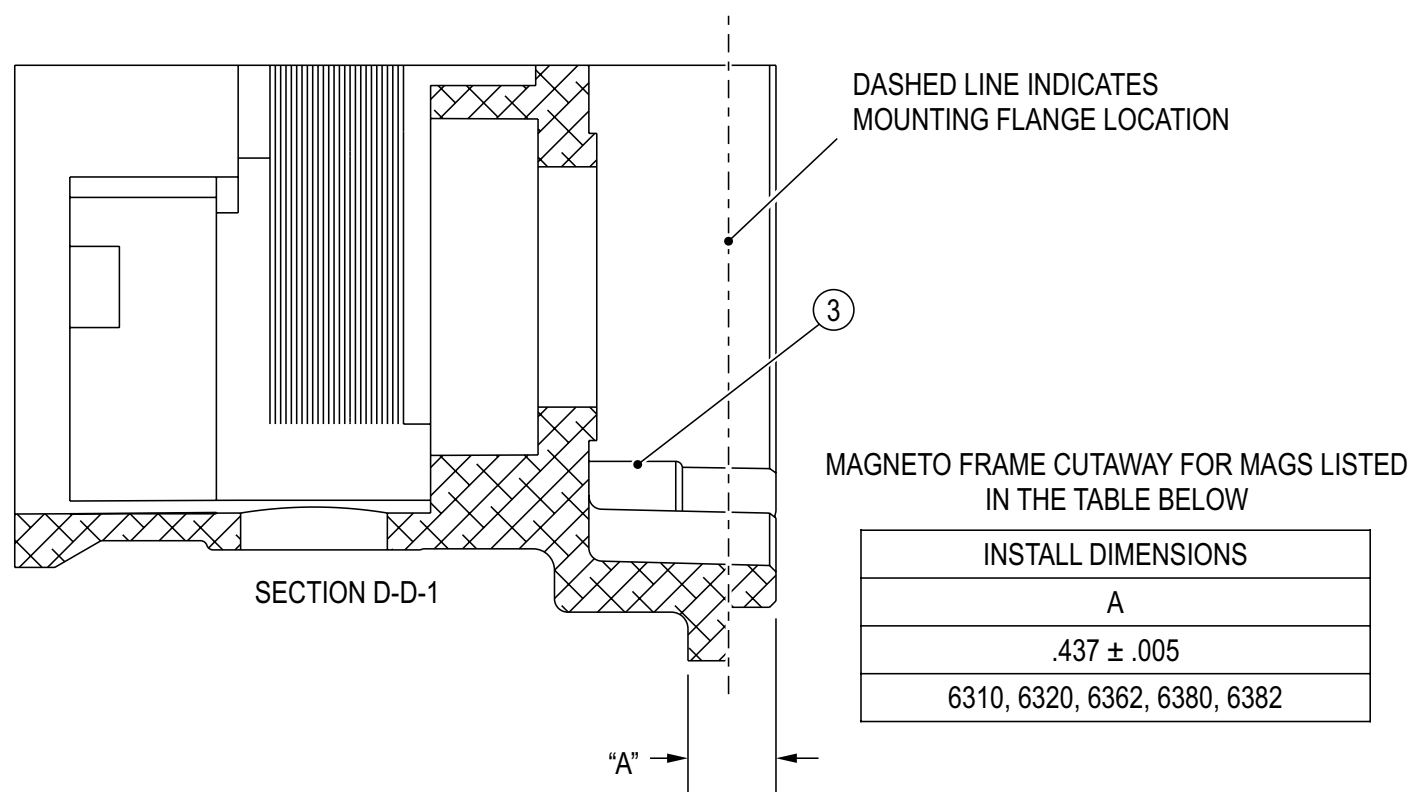
**FIGURE 2. MAGNETO FRAME CUTAWAY SECTION D-D-1**

USE A CALIBRATED MEASURING DEVICE TO MEASURE DISTANCE "A", AS SHOWN IN CUTAWAY SECTION D-D-1. MAKE SURE THE FRAME SURFACE IS FREE OF CONTAMINANTS. ANY MEASUREMENT LESS THAN 0.432 INCH OF ANY PART OF THE STOP PIN (3), THE MAGNETO SHOULD BE REMOVED FROM SERVICE AND RETURNED TO CHAMPION FOR WARRANTY.

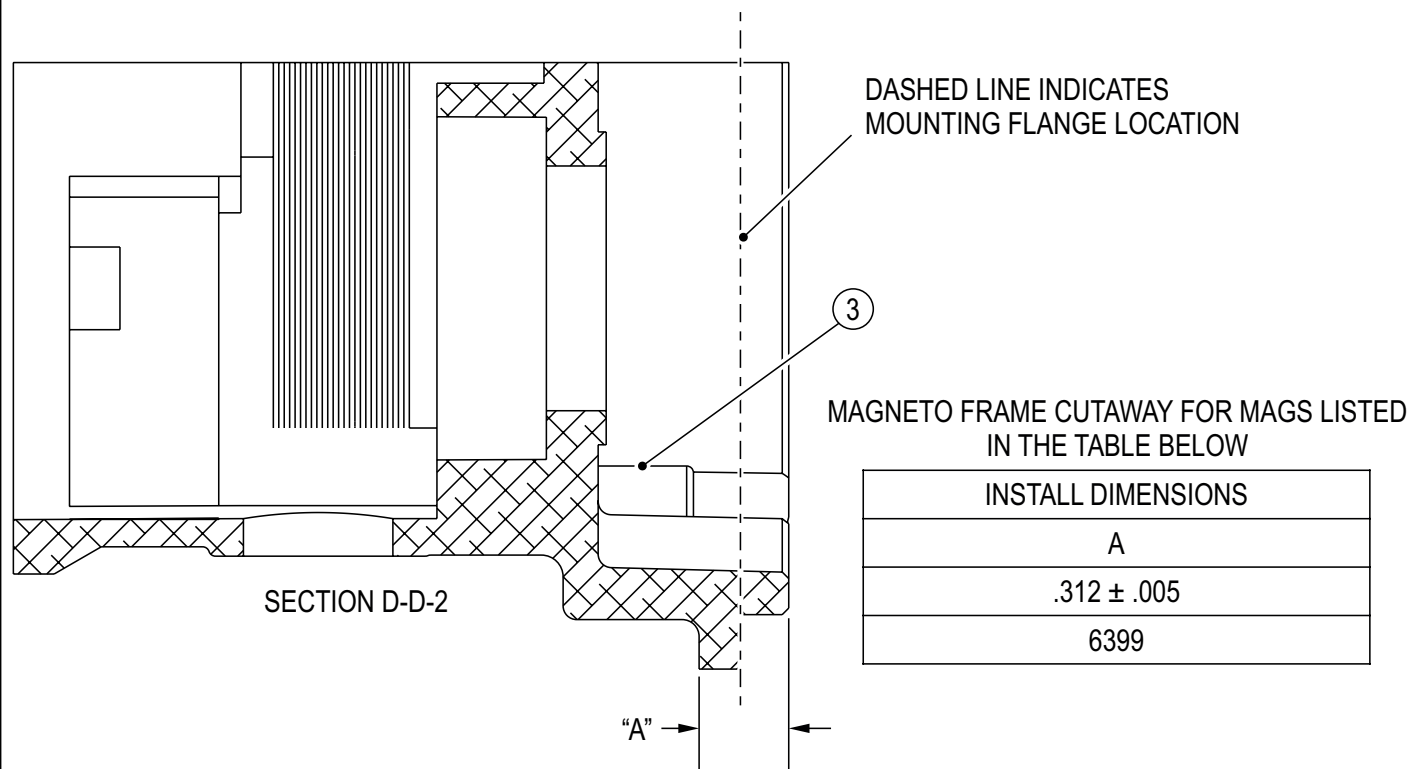
**FIGURE 3. MAGNETO FRAME CUTAWAY SECTION D-D-2**

USE A CALIBRATED MEASURING DEVICE TO MEASURE DISTANCE "A", AS SHOWN IN CUTAWAY SECTION D-D-2. MAKE SURE THE FRAME SURFACE IS FREE OF CONTAMINANTS. ANY MEASUREMENT LESS THAN 0.307 INCH OF ANY PART OF THE STOP PIN (3), THE MAGNETO SHOULD BE REMOVED FROM SERVICE AND RETURNED TO CHAMPION FOR WARRANTY.

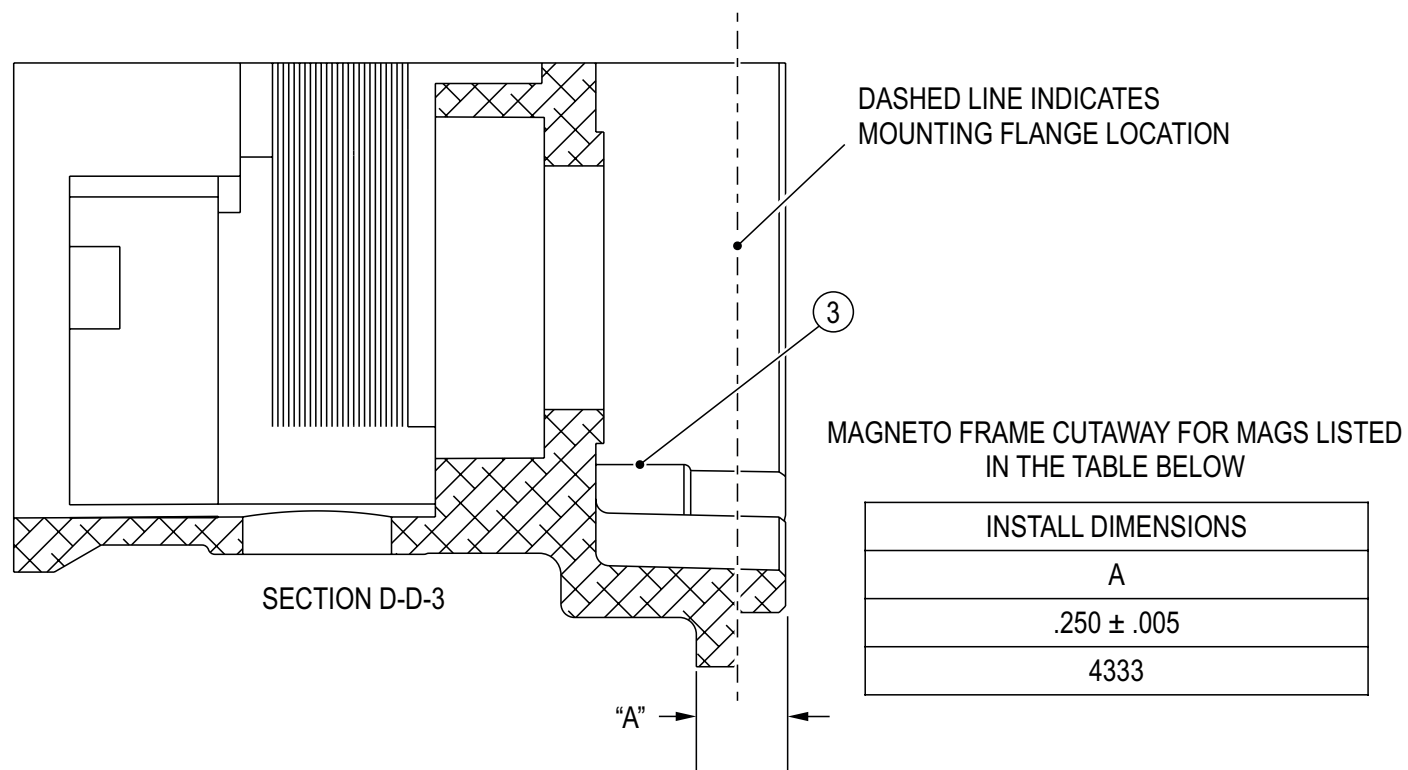
**FIGURE 4. MAGNETO FRAME CUTAWAY SECTION D-D-3**

USE A CALIBRATED MEASURING DEVICE TO MEASURE DISTANCE "A", AS SHOWN IN CUTAWAY SECTION D-D-3. MAKE SURE THE FRAME SURFACE IS FREE OF CONTAMINANTS. ANY MEASUREMENT LESS THAN 0.245 INCH OF ANY PART OF THE STOP PIN (3), THE MAGNETO SHOULD BE REMOVED FROM SERVICE AND RETURNED TO CHAMPION FOR WARRANTY.

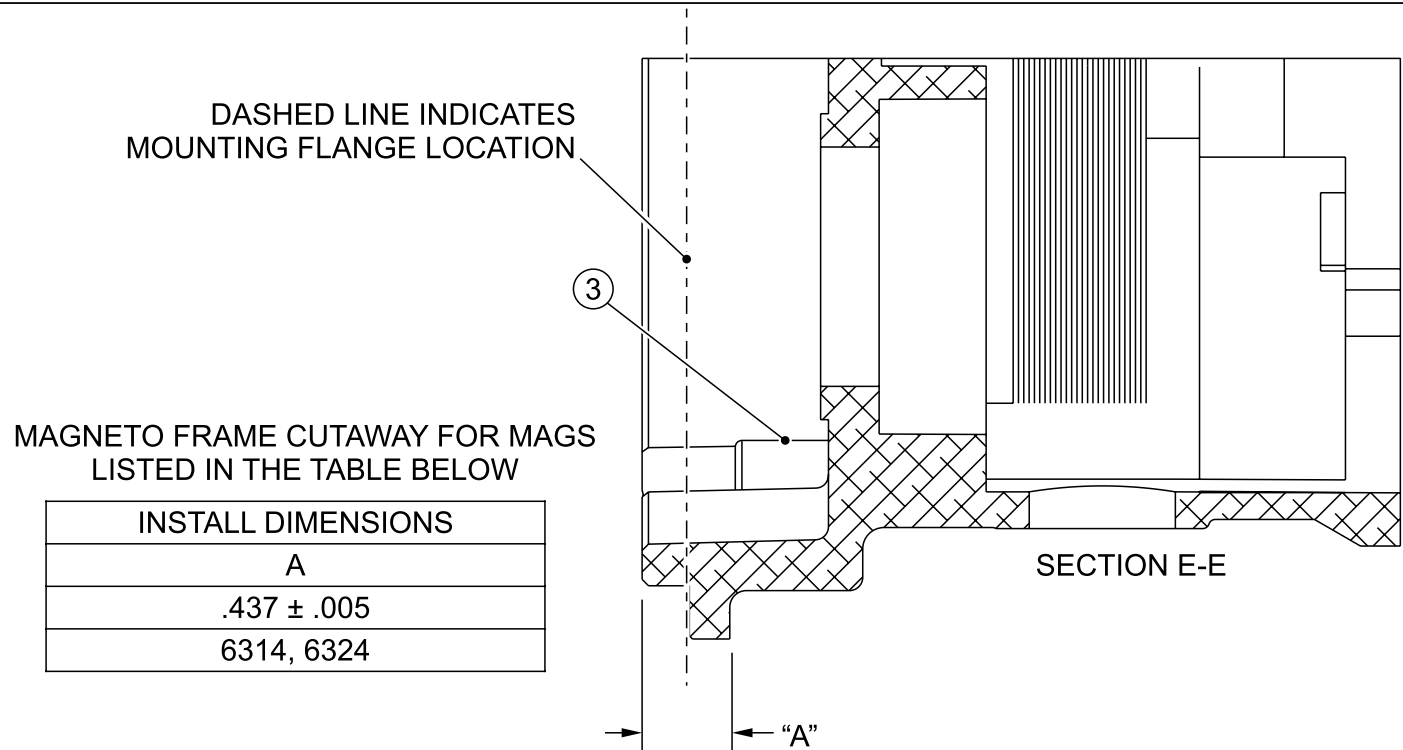
**FIGURE 5. MAGNETO FRAME CUTAWAY SECTION E-E**

USE A CALIBRATED MEASURING DEVICE TO MEASURE DISTANCE “A”, AS SHOWN IN CUTAWAY SECTION E-E. MAKE SURE THE FRAME SURFACE IS FREE OF CONTAMINANTS. ANY MEASUREMENT LESS THAN 0.432 INCH OF ANY PART OF THE STOP PIN (3), THE MAGNETO SHOULD BE REMOVED FROM SERVICE AND RETURNED TO CHAMPION FOR WARRANTY.

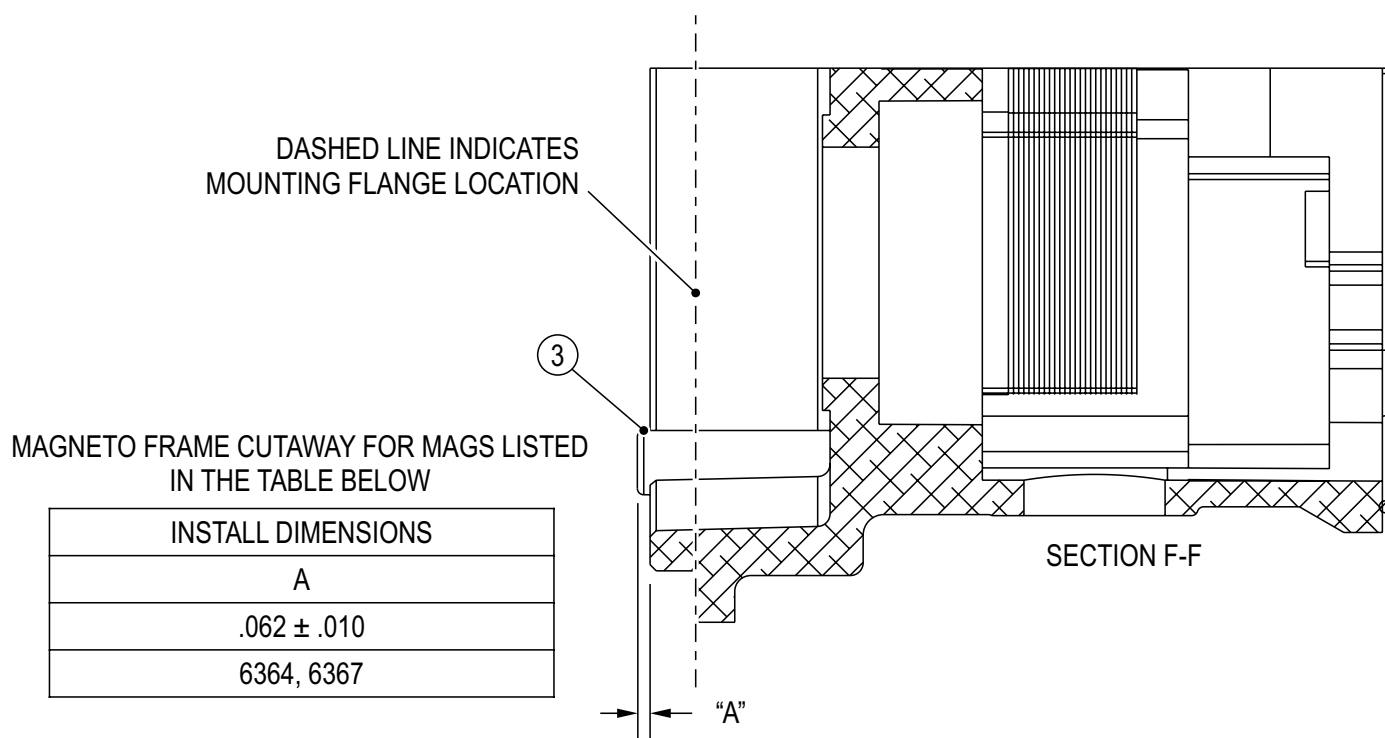
**FIGURE 6. MAGNETO FRAME CUTAWAY F-F**

USE A CALIBRATED MEASURING DEVICE TO MEASURE DISTANCE "A", AS SHOWN IN CUTAWAY SECTION F-F. MAKE SURE THE FRAME SURFACE IS FREE OF CONTAMINANTS. ANY MEASUREMENT GREATER THAN .072 INCH OF ANY PART OF THE STOP PIN (3), THE MAGNETO SHOULD BE REMOVED FROM SERVICE AND RETURNED TO CHAMPION FOR WARRANTY.

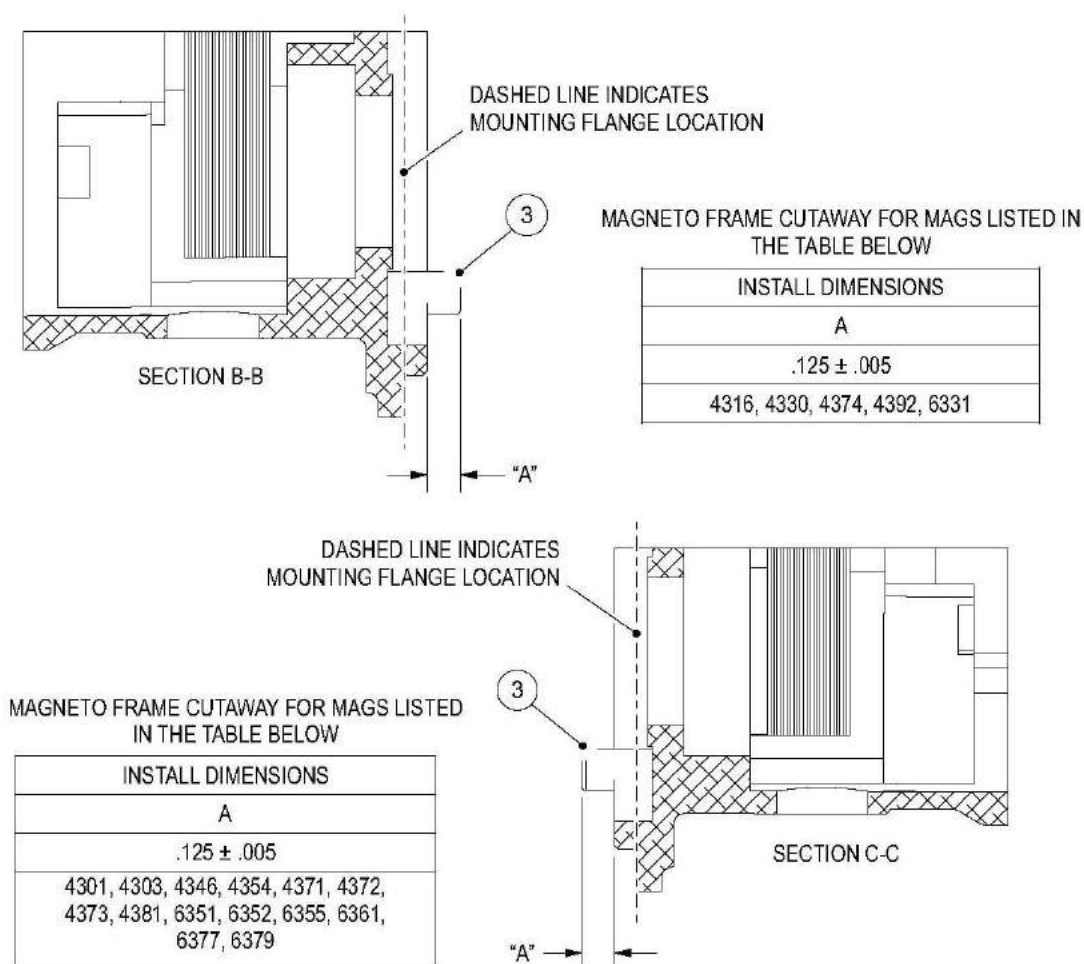
**FIGURE 1. MAGNETO FRAME CUTAWAY SECTIONS B-B AND C-C**

USE A CALIBRATED MEASURING DEVICE TO MEASURE DISTANCE "A", AS SHOWN IN CUTAWAY SECTIONS B-B AND C-C. MAKE SURE THE FRAME SURFACE IS FREE OF CONTAMINANTS. ANY MEASUREMENT GREATER THAN 0.130 INCH OF ANY PART OF THE STOP PIN (3), THE MAGNETO SHOULD BE REMOVED FROM SERVICE AND RETURNED TO CHAMPION FOR WARRANTY.

- B. Inspect the magneto to confirm the necessary recess/projection (based on individual magneto type) of the stop pin. If the stop pin installation depth is not in compliance with the dimension shown in Figures 1 through 6, the magneto must be replaced with a new or serviceable unit that is in compliance with this service bulletin.

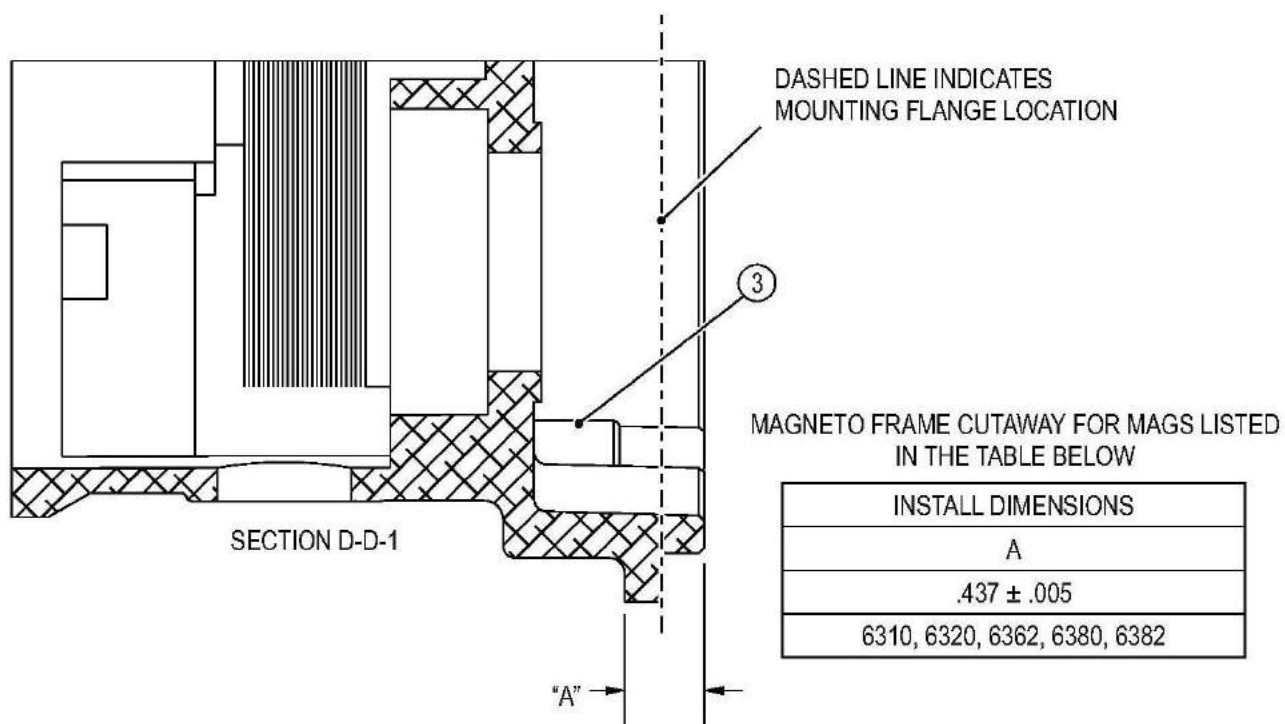
**FIGURE 2. MAGNETO FRAME CUTAWAY SECTION D-D-1**

USE A CALIBRATED MEASURING DEVICE TO MEASURE DISTANCE "A", AS SHOWN IN CUTAWAY SECTION D-D-1. MAKE SURE THE FRAME SURFACE IS FREE OF CONTAMINANTS. ANY MEASUREMENT LESS THAN 0.432 INCH OF ANY PART OF THE STOP PIN (3), THE MAGNETO SHOULD BE REMOVED FROM SERVICE AND RETURNED TO CHAMPION FOR WARRANTY.

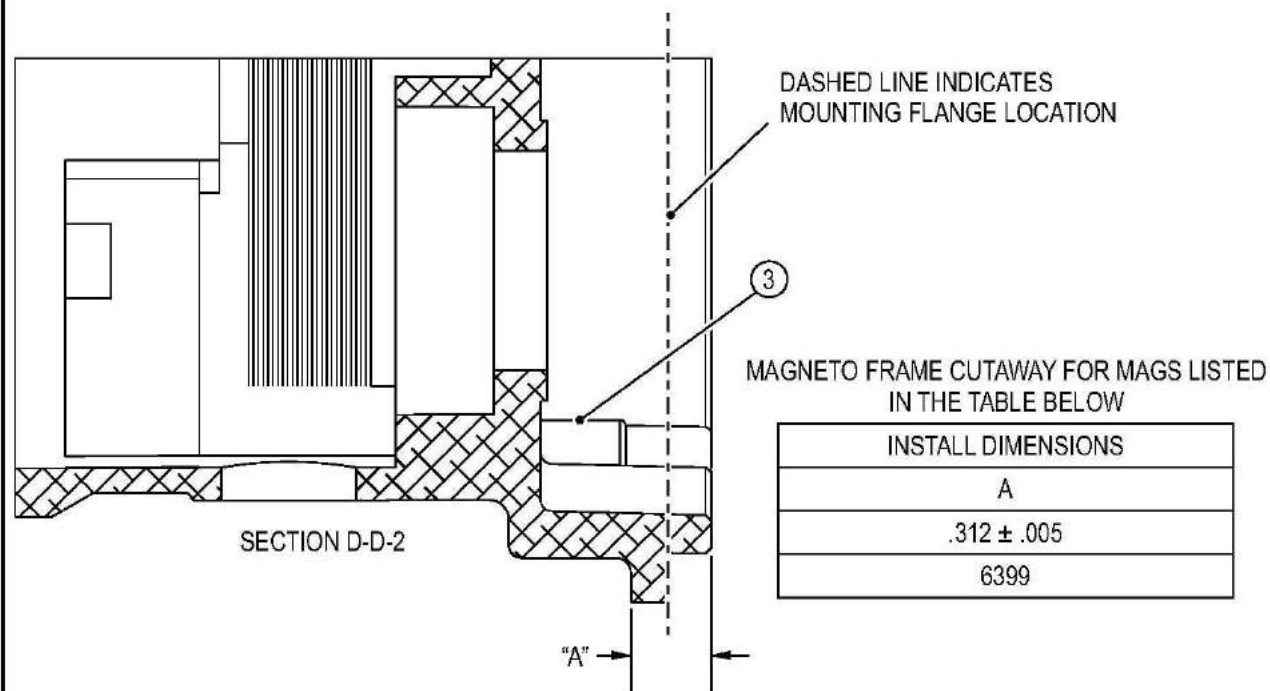
**FIGURE 3. MAGNETO FRAME CUTAWAY SECTION D-D-2**

USE A CALIBRATED MEASURING DEVICE TO MEASURE DISTANCE "A", AS SHOWN IN CUTAWAY SECTION D-D-2. MAKE SURE THE FRAME SURFACE IS FREE OF CONTAMINANTS. ANY MEASUREMENT LESS THAN 0.307 INCH OF ANY PART OF THE STOP PIN (3), THE MAGNETO SHOULD BE REMOVED FROM SERVICE AND RETURNED TO CHAMPION FOR WARRANTY.

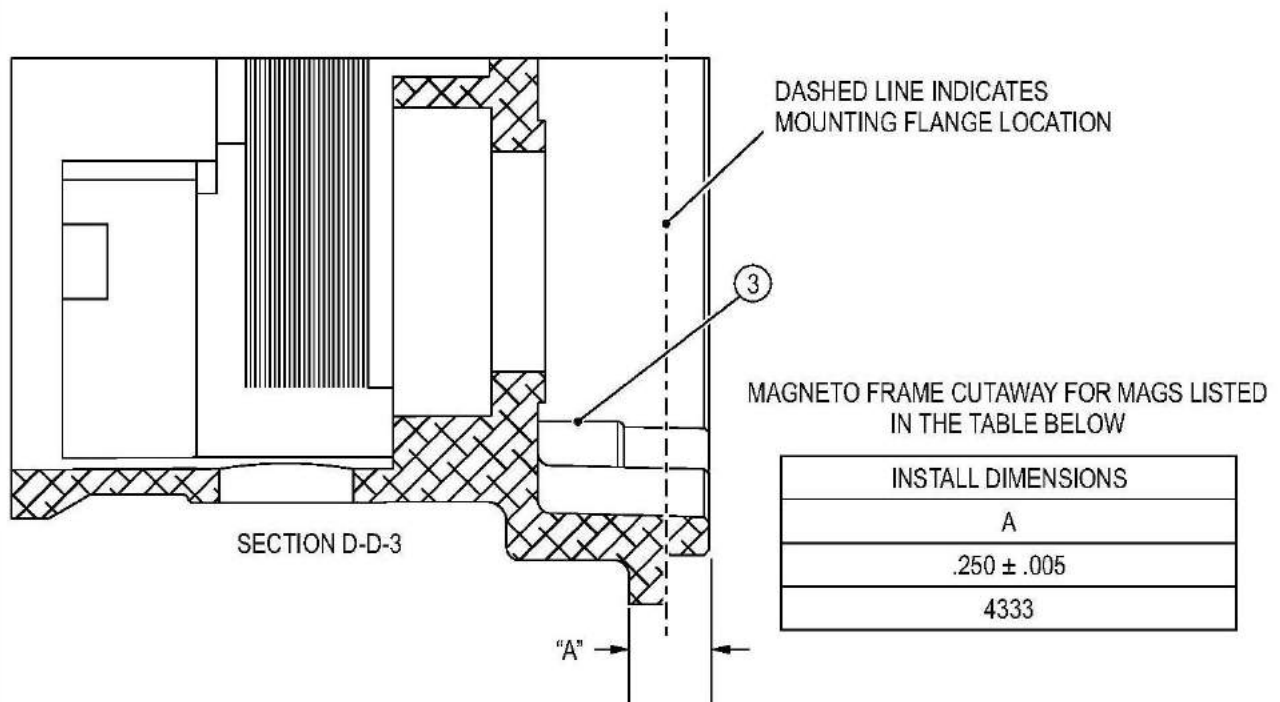
**FIGURE 4. MAGNETO FRAME CUTAWAY SECTION D-D-3**

USE A CALIBRATED MEASURING DEVICE TO MEASURE DISTANCE "A", AS SHOWN IN CUTAWAY SECTION D-D-3. MAKE SURE THE FRAME SURFACE IS FREE OF CONTAMINANTS. ANY MEASUREMENT LESS THAN 0.245 INCH OF ANY PART OF THE STOP PIN (3), THE MAGNETO SHOULD BE REMOVED FROM SERVICE AND RETURNED TO CHAMPION FOR WARRANTY.

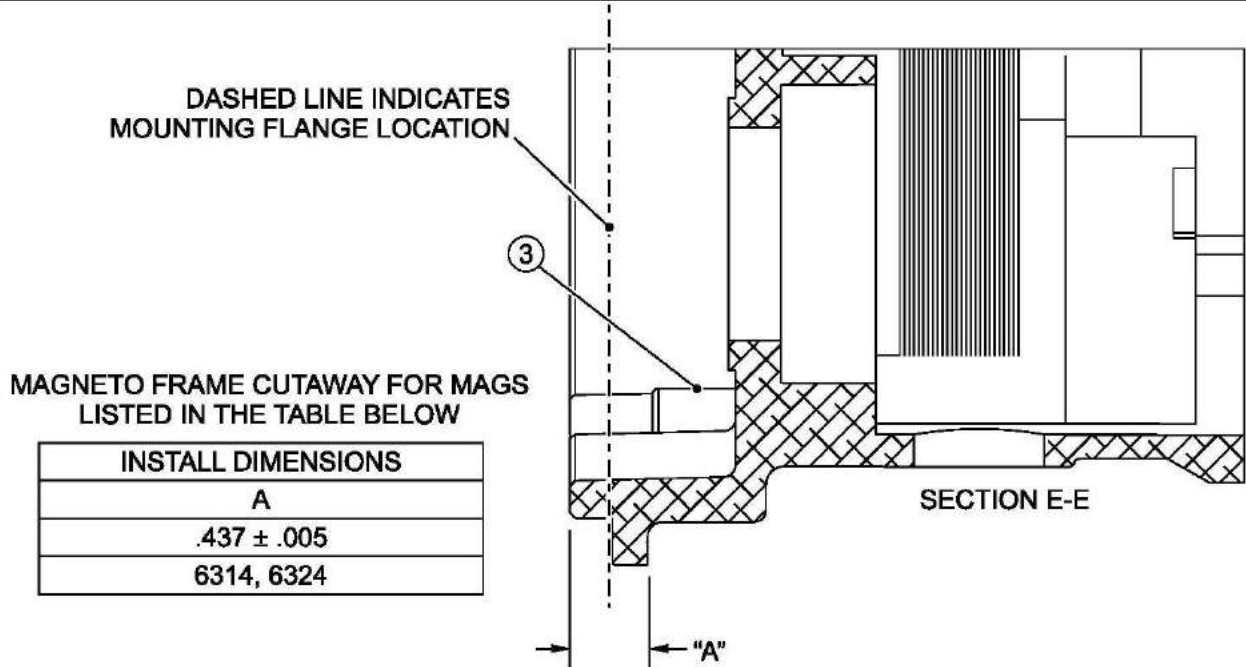
**FIGURE 5. MAGNETO FRAME CUTAWAY SECTION E-E**

USE A CALIBRATED MEASURING DEVICE TO MEASURE DISTANCE "A", AS SHOWN IN CUTAWAY SECTION E-E. MAKE SURE THE FRAME SURFACE IS FREE OF CONTAMINANTS. ANY MEASUREMENT LESS THAN 0.432 INCH OF ANY PART OF THE STOP PIN (3), THE MAGNETO SHOULD BE REMOVED FROM SERVICE AND RETURNED TO CHAMPION FOR WARRANTY.

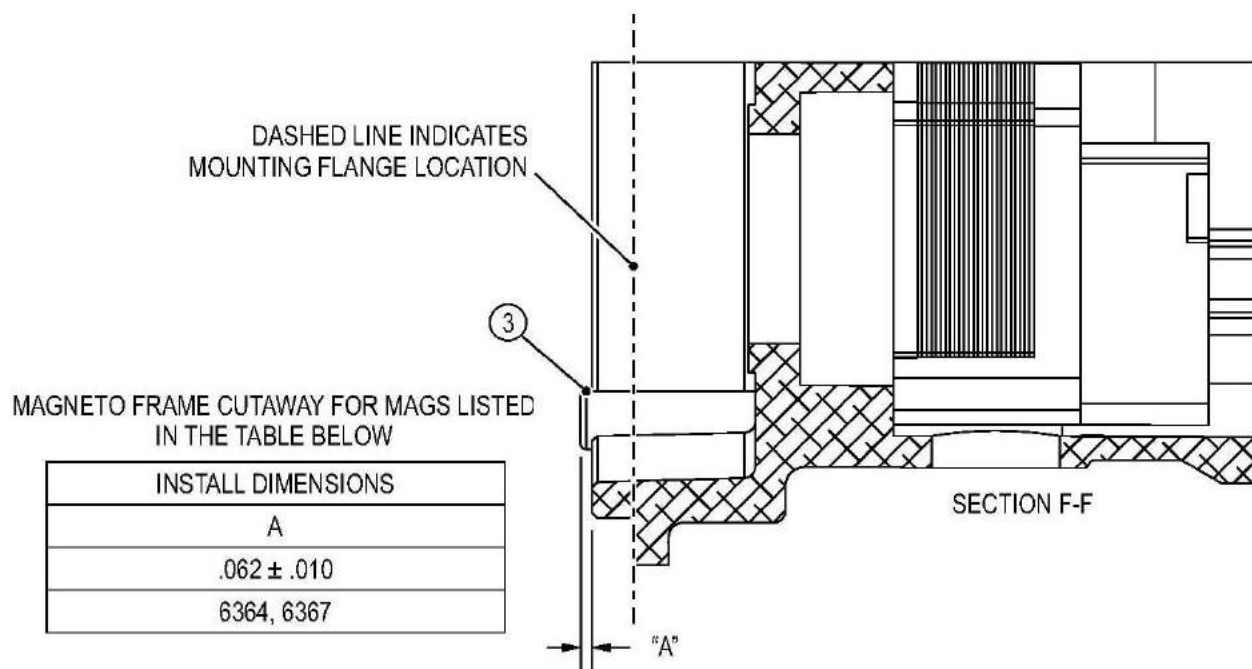
**FIGURE 6. MAGNETO FRAME CUTAWAY F-F**

USE A CALIBRATED MEASURING DEVICE TO MEASURE DISTANCE "A", AS SHOWN IN CUTAWAY SECTION F-F. MAKE SURE THE FRAME SURFACE IS FREE OF CONTAMINANTS. ANY MEASUREMENT GREATER THAN .072 INCH OF ANY PART OF THE STOP PIN (3), THE MAGNETO SHOULD BE REMOVED FROM SERVICE AND RETURNED TO CHAMPION FOR WARRANTY.
